**SALVAGE REPORT - CH135119**

## SALVAGE REPORT -CH135119

Reference: C-05-010-002/AG-000

PHOTOGRAPHS OF SALVAGE OPERATION

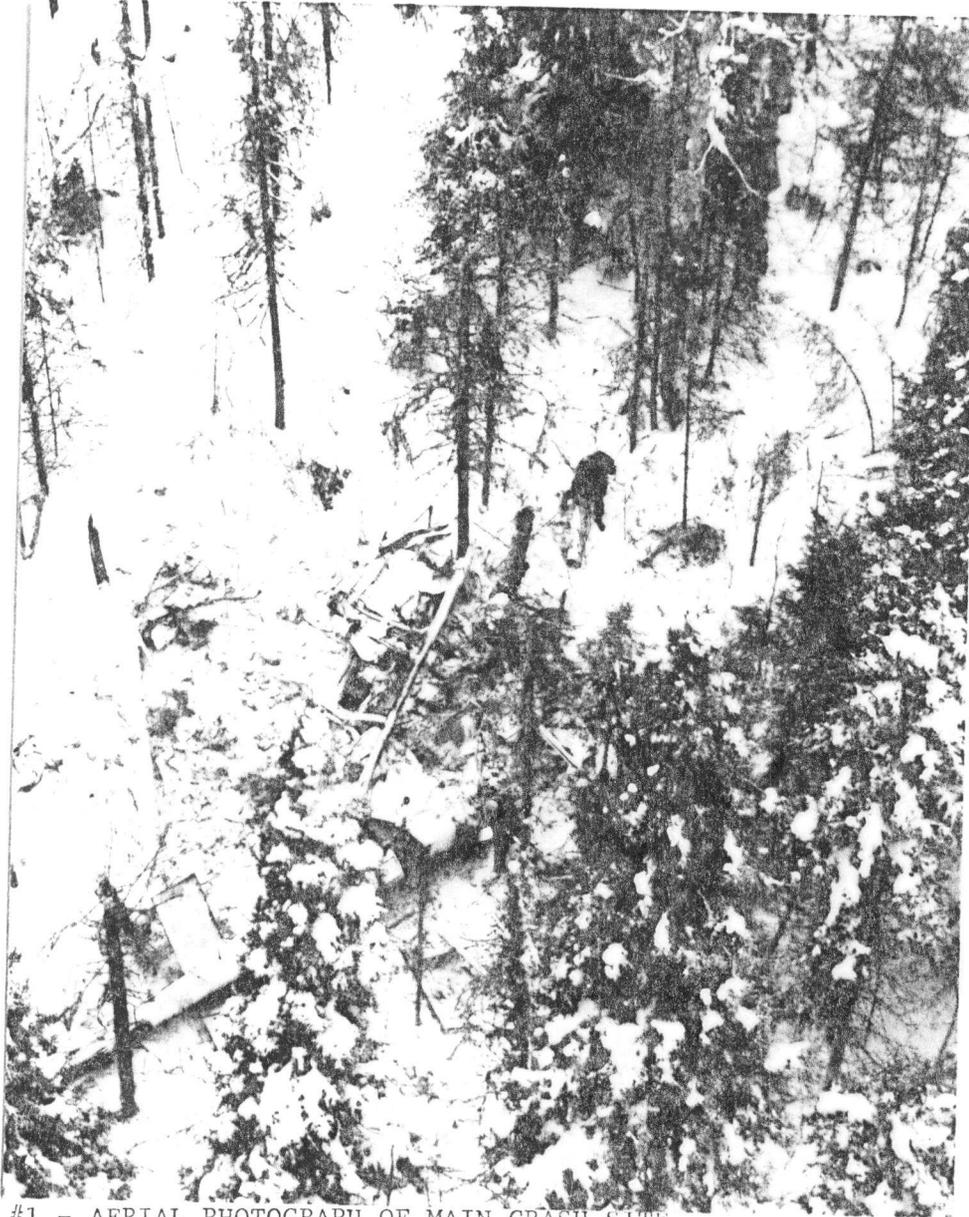
PHOTO #1 - AERIAL PHOTOGRAPH OF MAIN CRASH SITE

Note tail boom visible lower left corner. Forward and Aft Fuselage sections visible centre left.

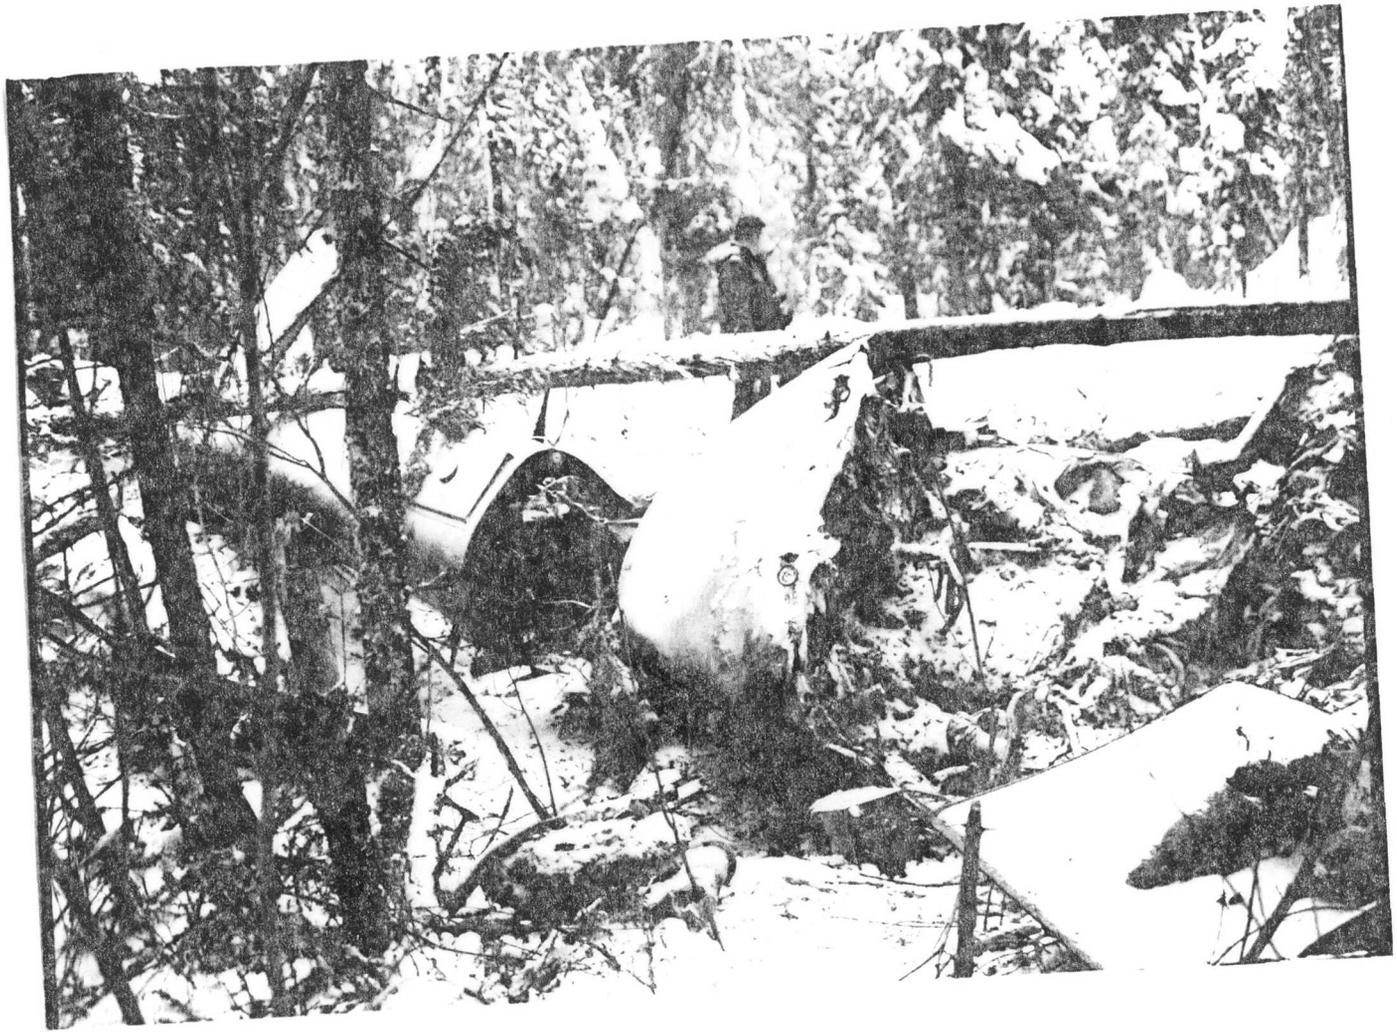
PHOTO # 2 - MAIN CRASH SITE VIEWED LOOKING AFT

Note dense forest and new snowfall. Centre fuselage section almost totally consumed by fire. Tail boom and aft fuselage section retain sufficient integrity for slinging.

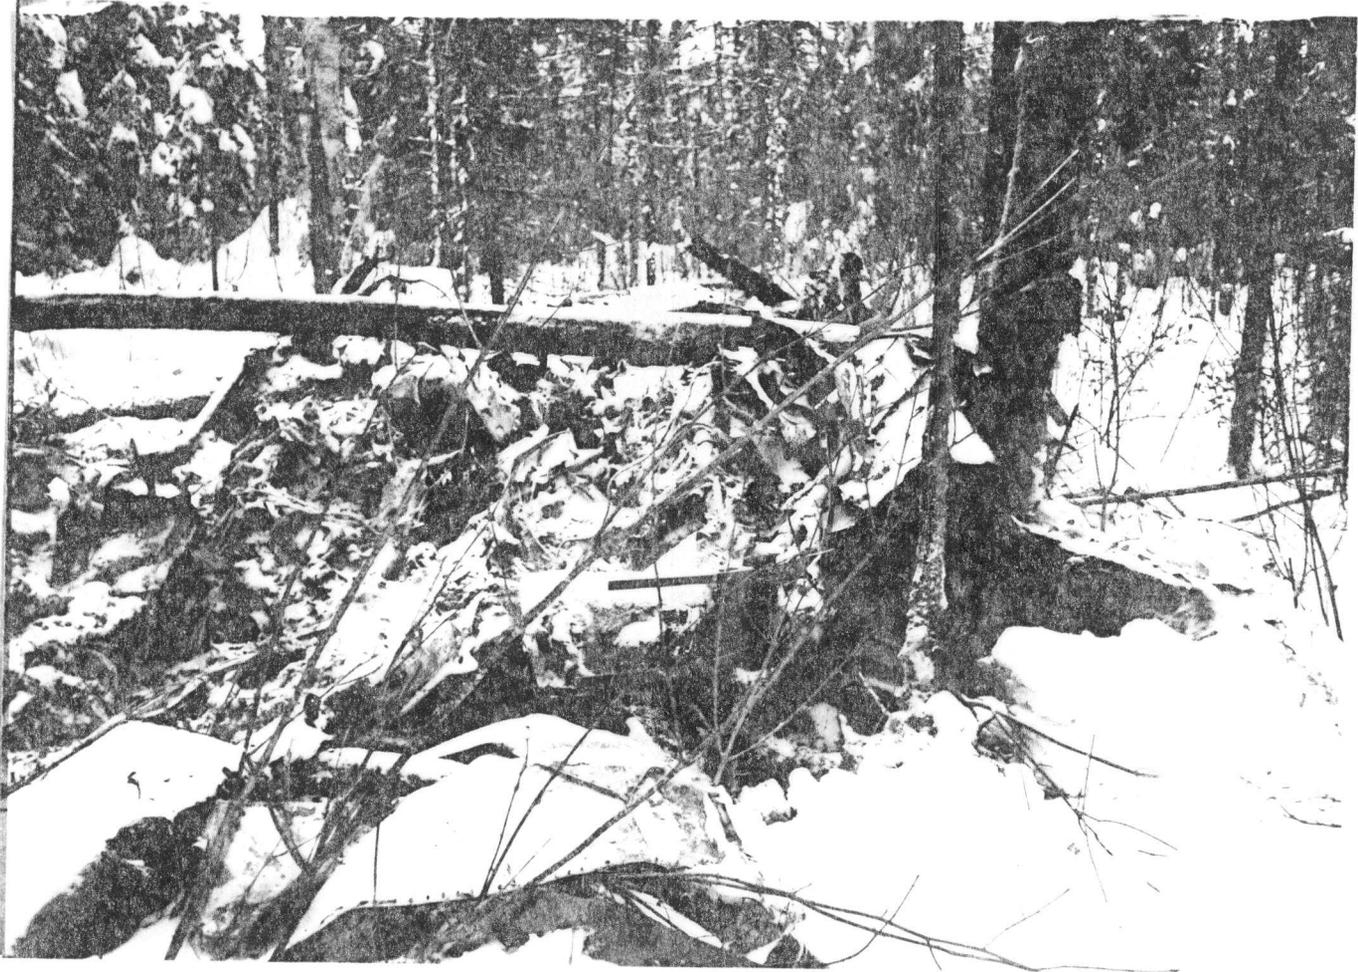
PHOTO # 3 - MAIN CRASH SITE VIEWED LOOKING FORWARD

General destruction of forward fuselage section is evident. This section was rolled onto a steel sling for transportation.

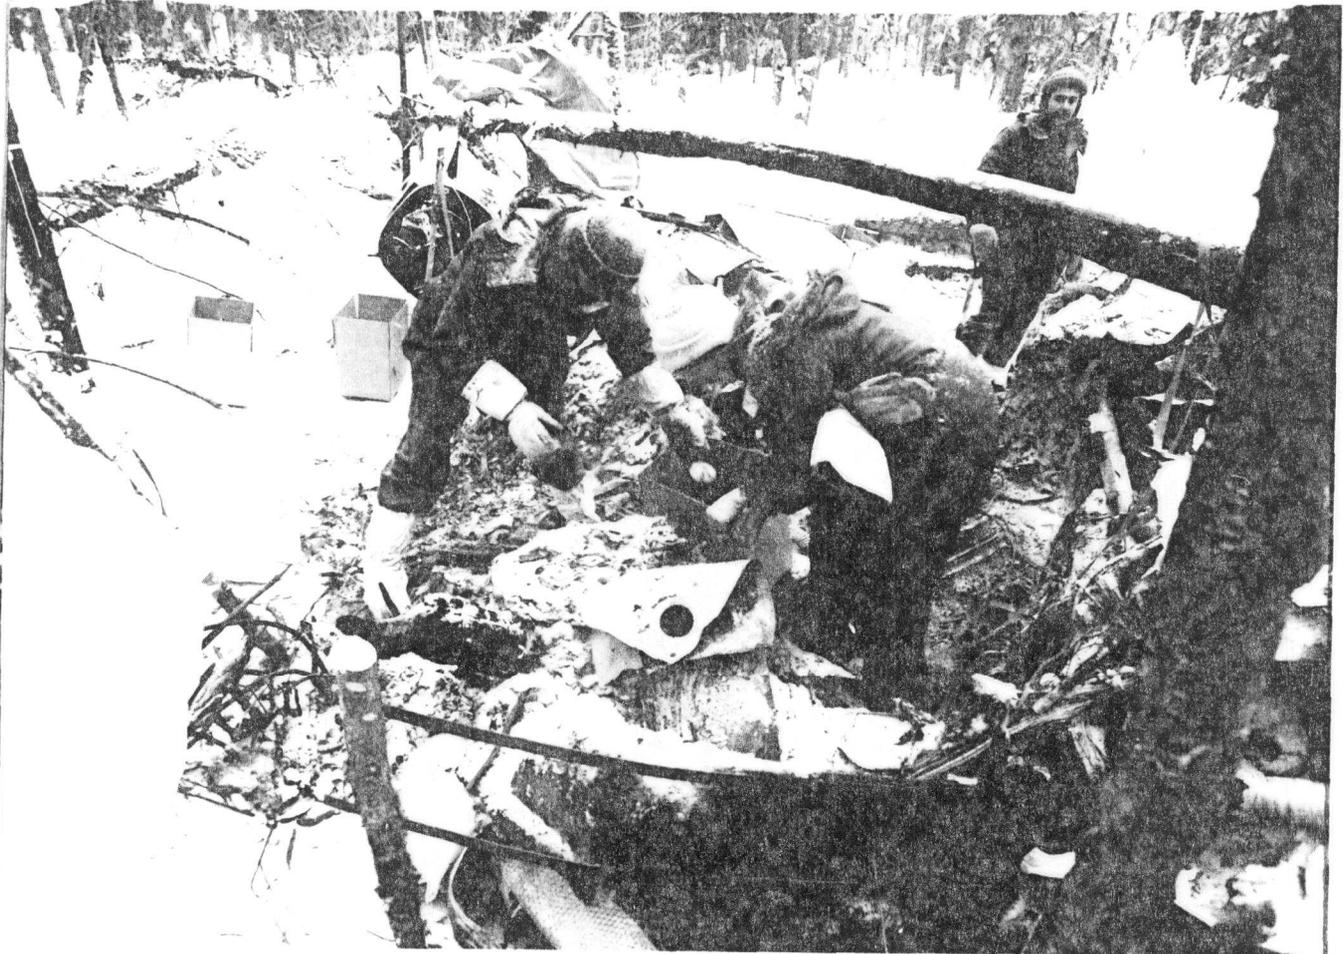
PHOTO # 4 - REMOVAL OF LOOSE DEBRIS

Before slinging operations could commence all loose wreckage was removed, packaged, and identified as applicable.

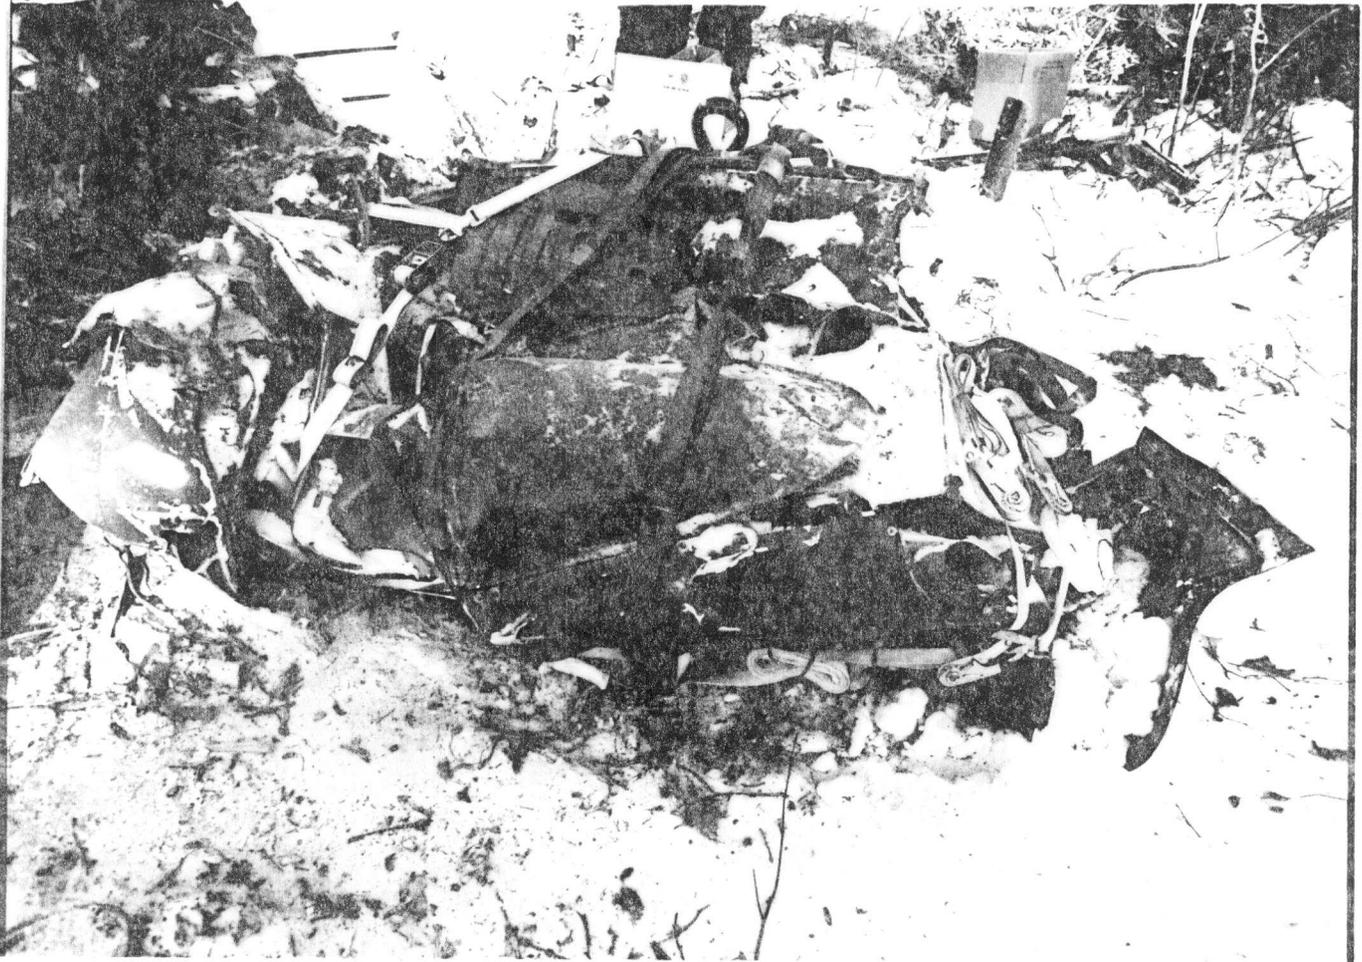
PHOTO # 5 - AFT FUSELAGE SECTION

Aft fuselage section as prepared by TAMS pers for slinging.

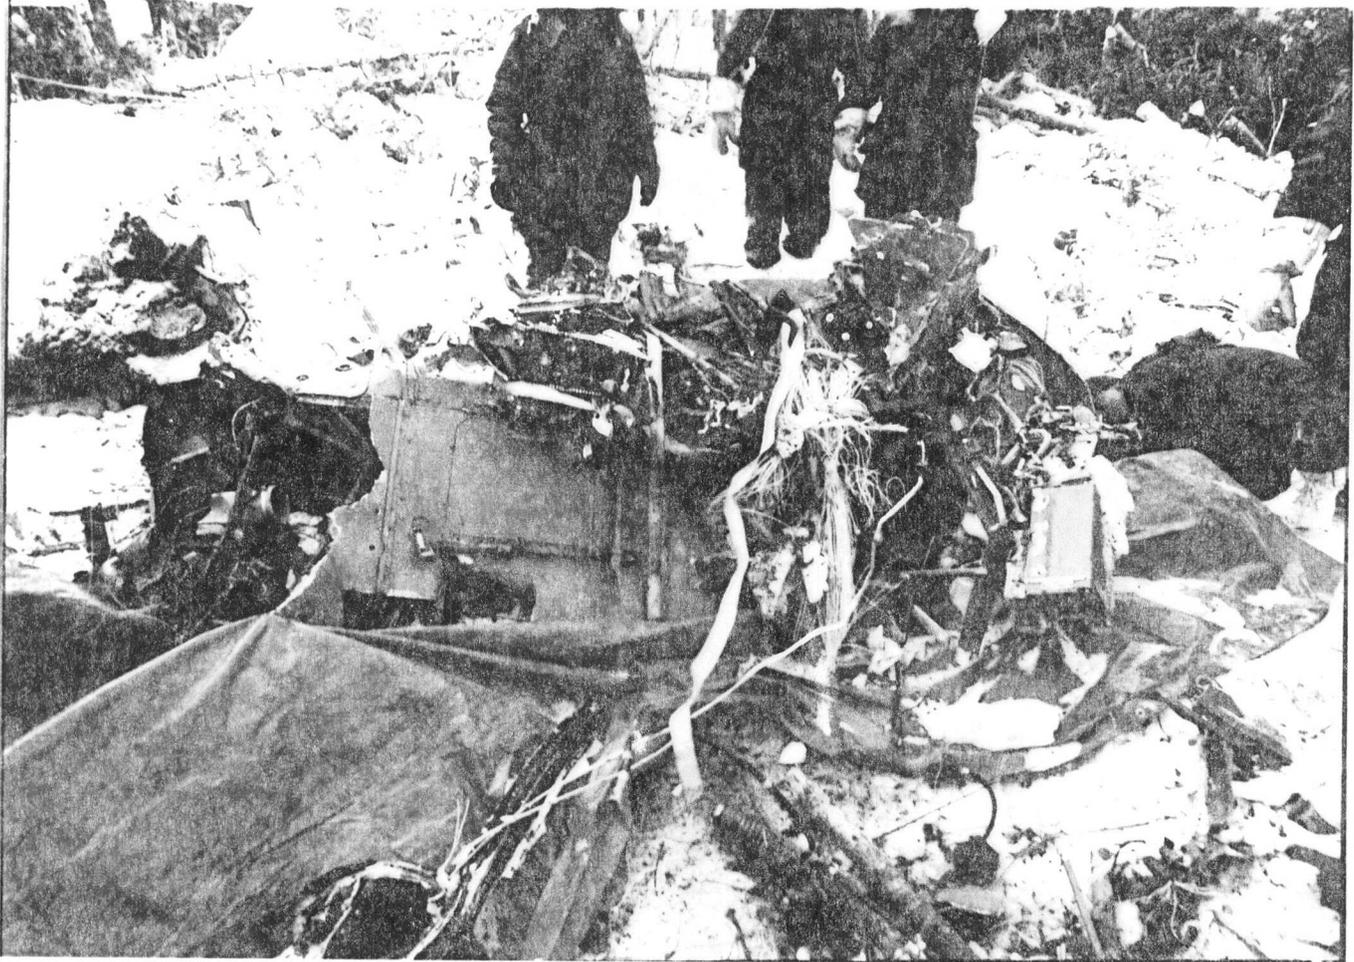
PHOTO # 6 - FORWARD FUSELAGE SECTION

Forward fuselage section after having been rolled onto steel sling and plastic tarp by CER and TAMS pers.

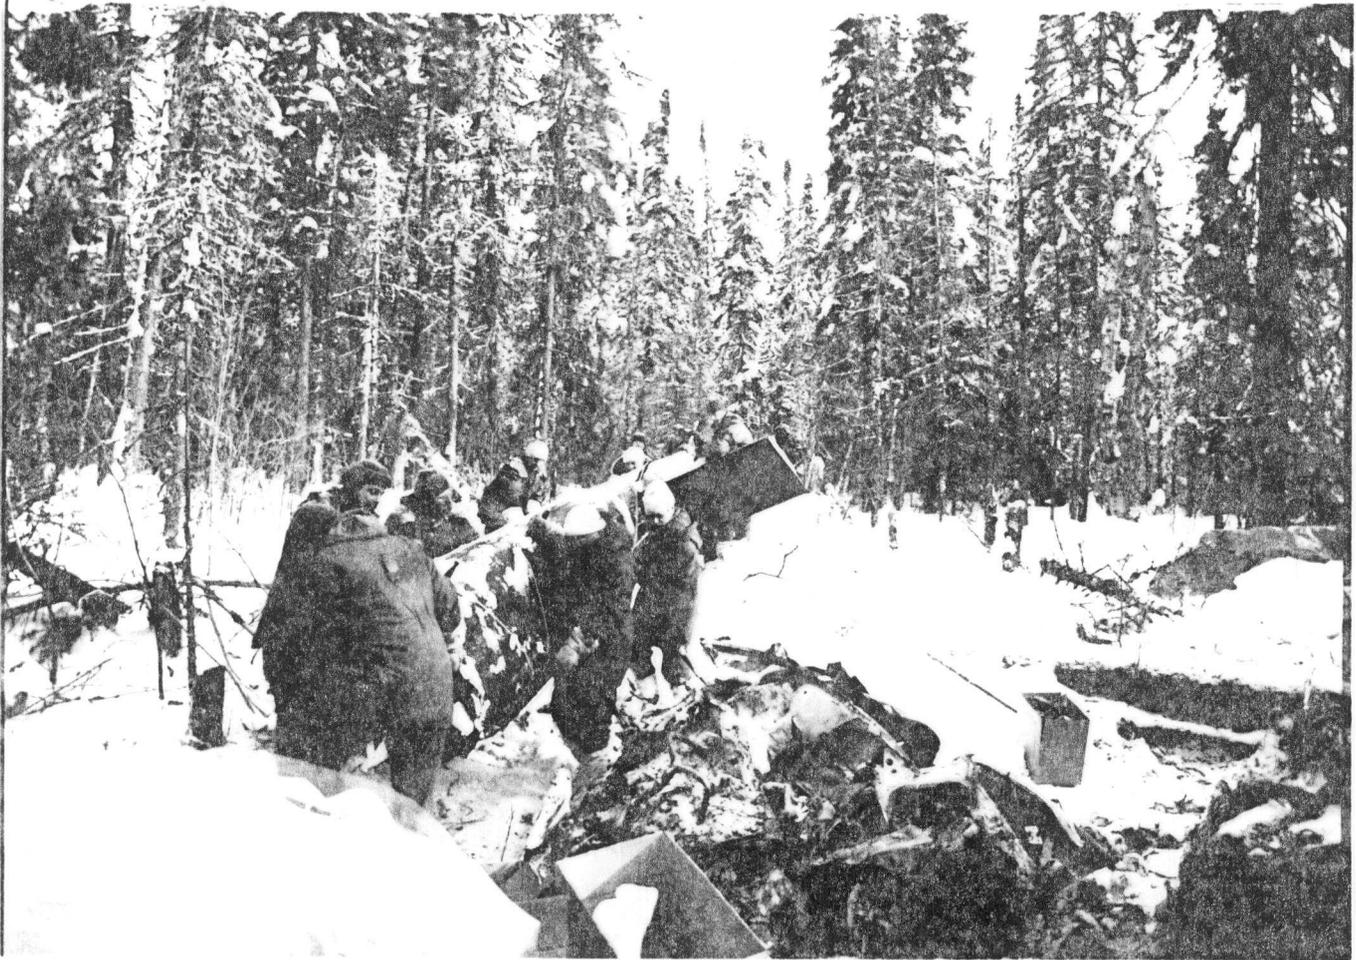
PHOTO # 7 - REMOVAL OF TAIL BOOM

Tail boom was carried 30M to lake to ease slinging operations. Note some trees have been felled to permit slinging.

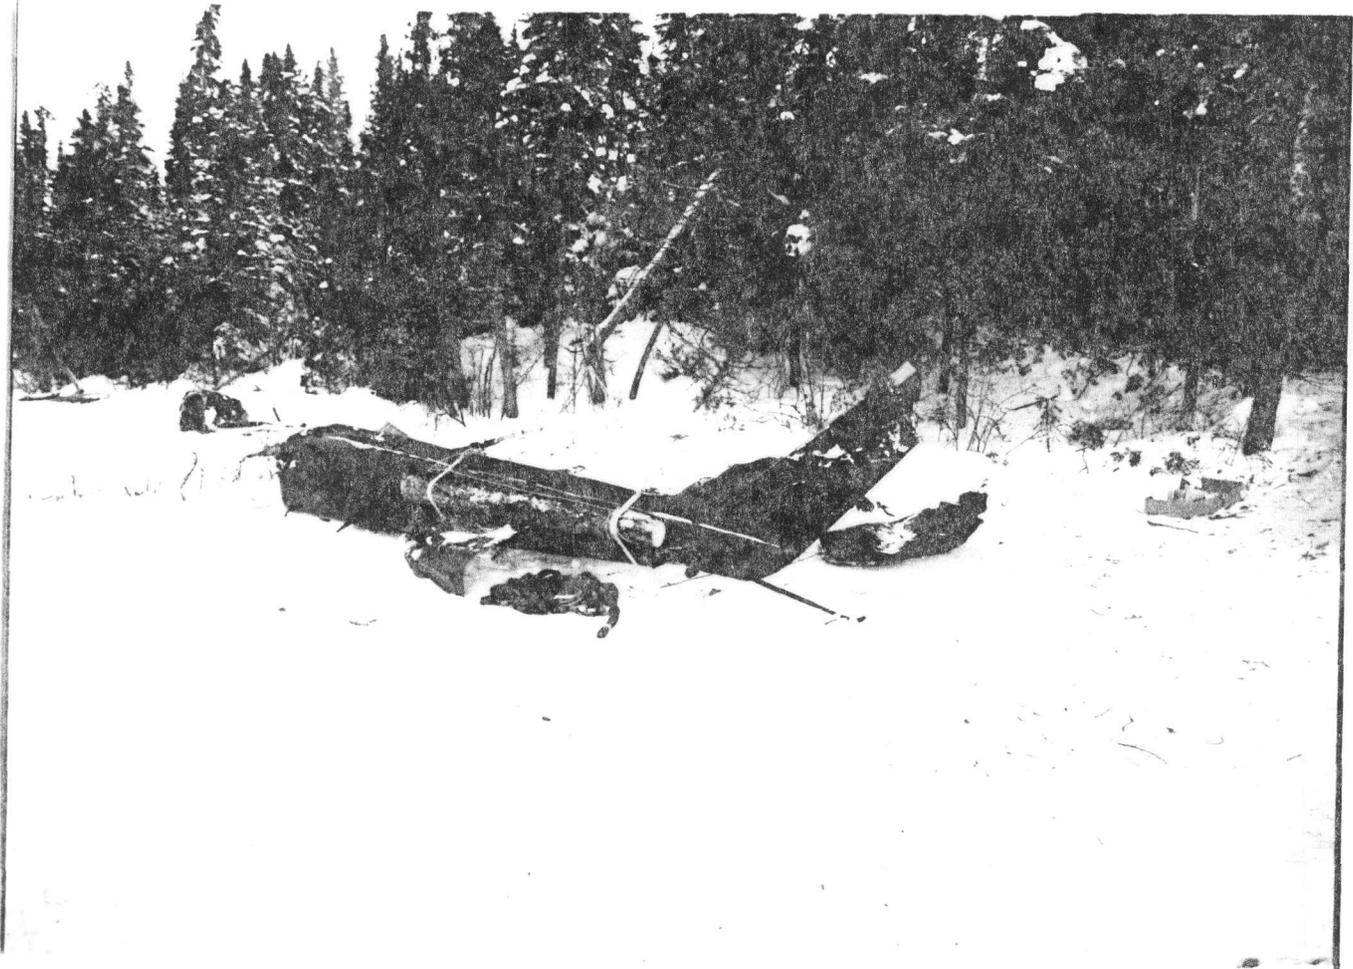
PHOTO # 8 - PREPARATION OF TAIL BOOM FOR SLINGING

11. All sections of wreckage with the exception of the main rotor blades were slung by CH 135 from the crash site to the road junction. A total of 10 sorties was required to transport wreckage and a final 3 sorties for the assorted TAMS and CER equipment. Although heavy logs were lashed to the tail boom section this load still proved to be very unstable. The main rotor blades were lashed to tobaggans and dragged to the road junction by snowmobiles.

Note addition of logs to each side of tail boom to increase weight and stability.

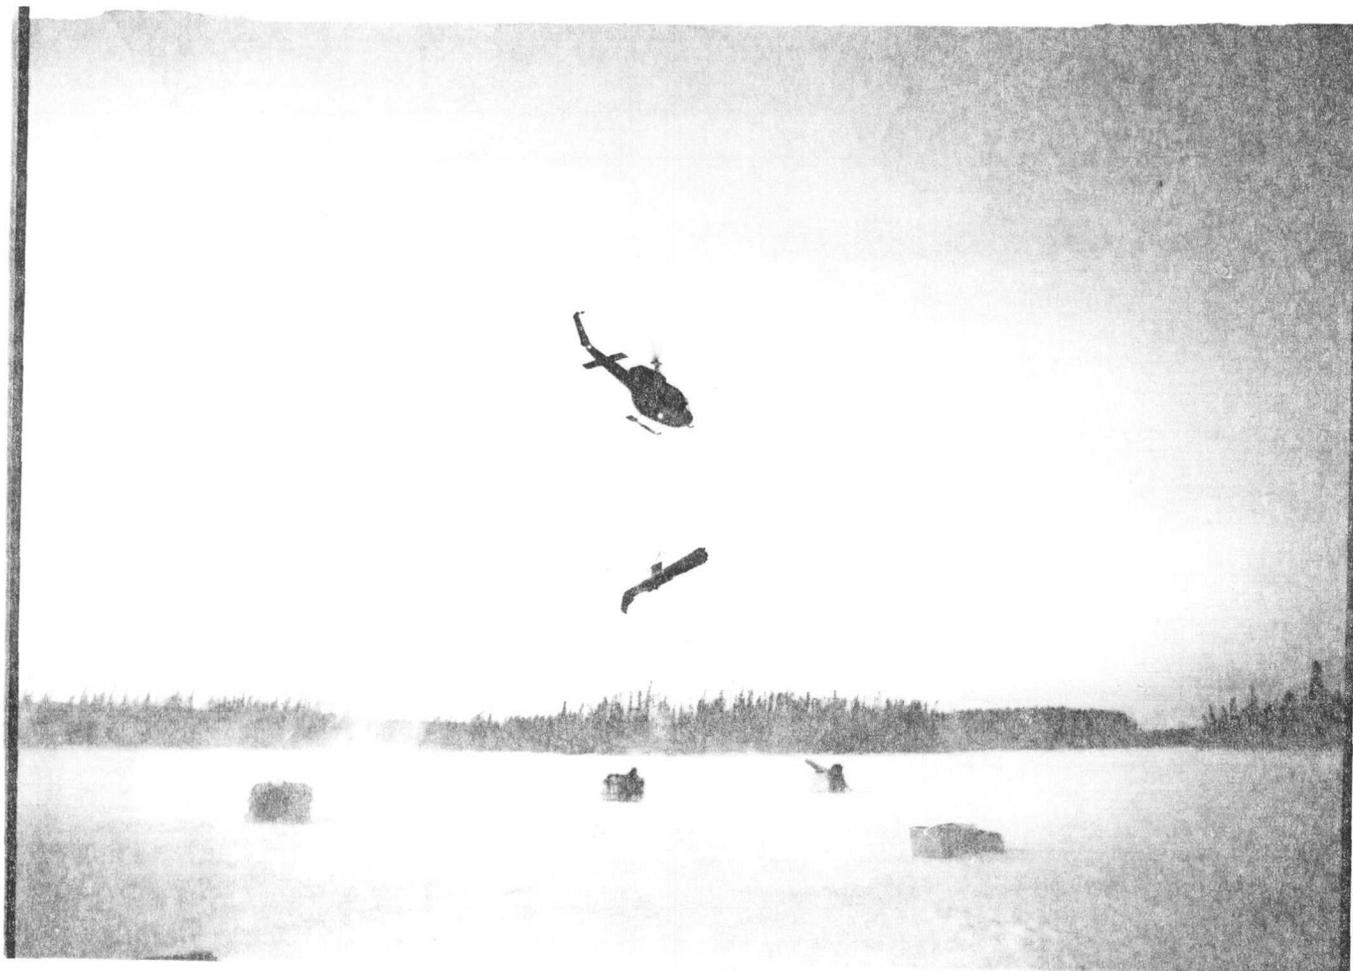
PHOTO # 9 - SLINGING OF TAIL BOOM

Note CCC1 containers and tri-walls prepared for slinging.

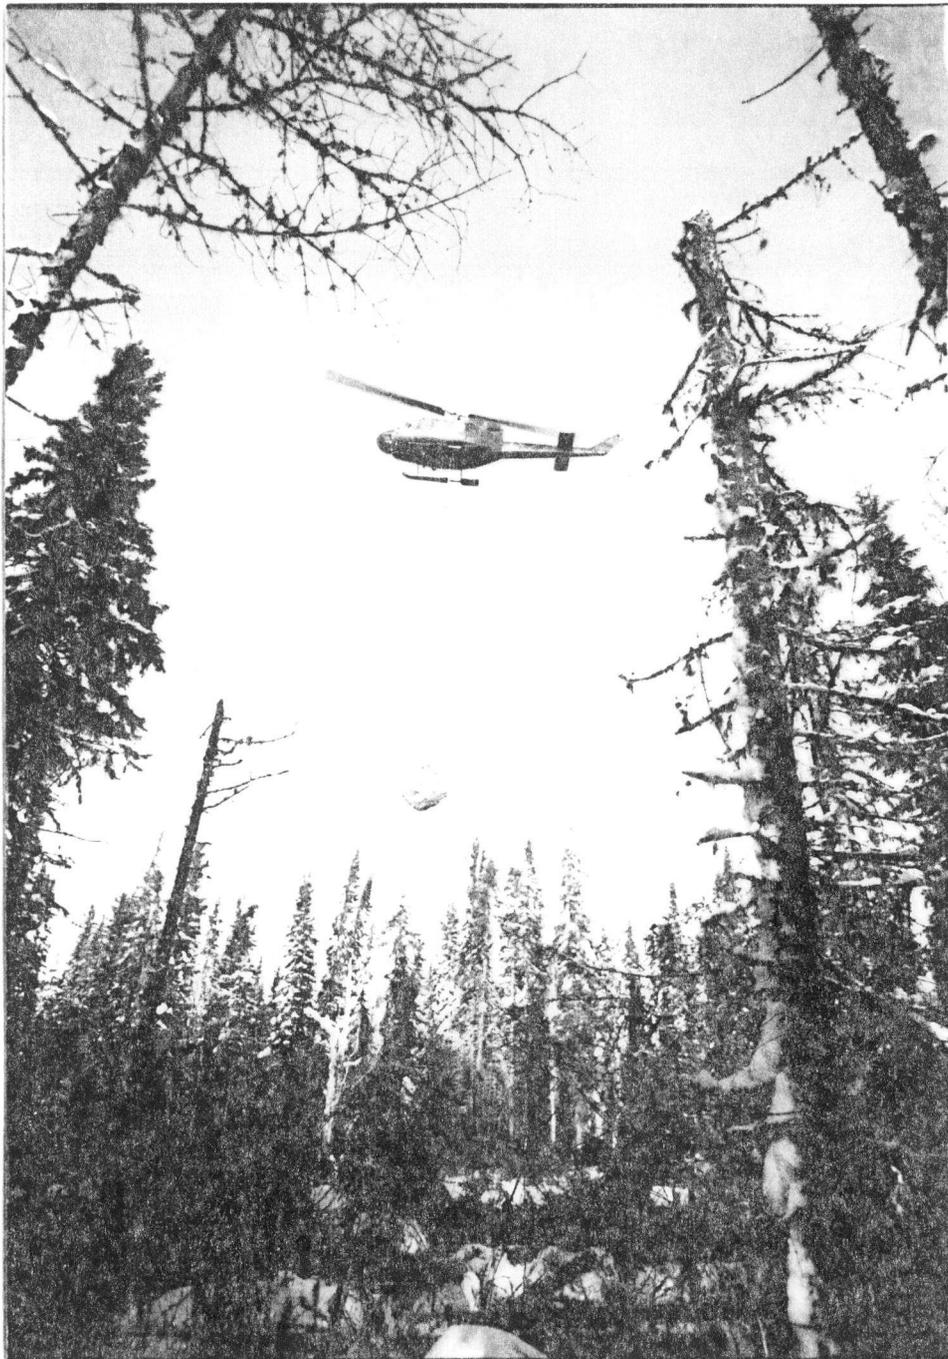
PHOTO # 10 - SLINGING OF FORWARD FUSELAGE SECTION

The weight of the forward and aft fuselage sections prevented them from being carried to the lake. These two sections were slung directly from the main crash site

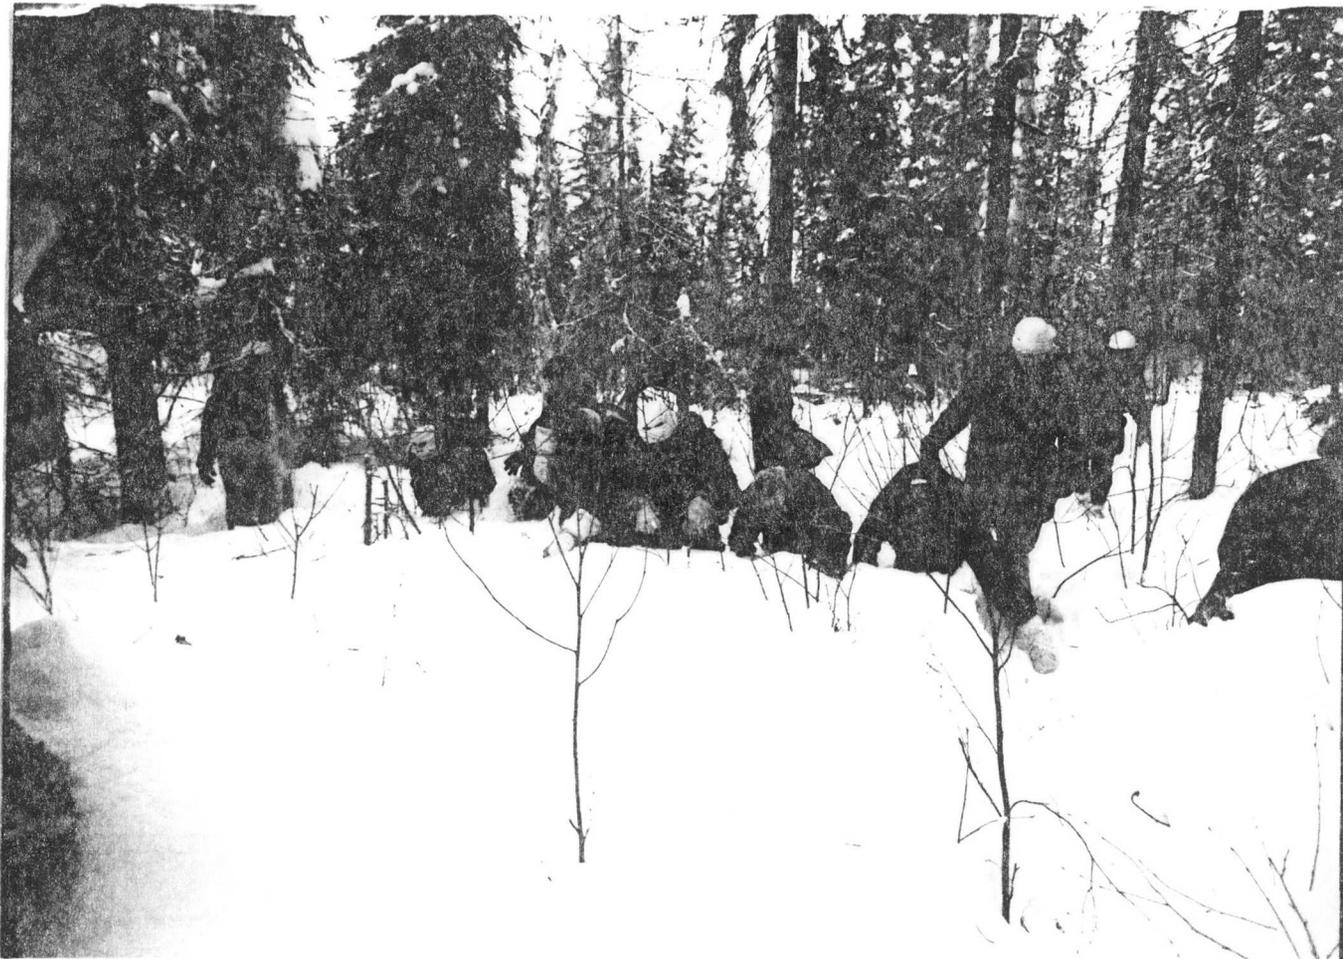
PHOTO # 11 - SEARCH FOR WRECKAGE BY GROUND SEARCH TEAM

Note depth of snow and clothing worn. Most wreckage was found under 15-30cm of snow. The ground search team conducted a search for at least 400M in all directions.

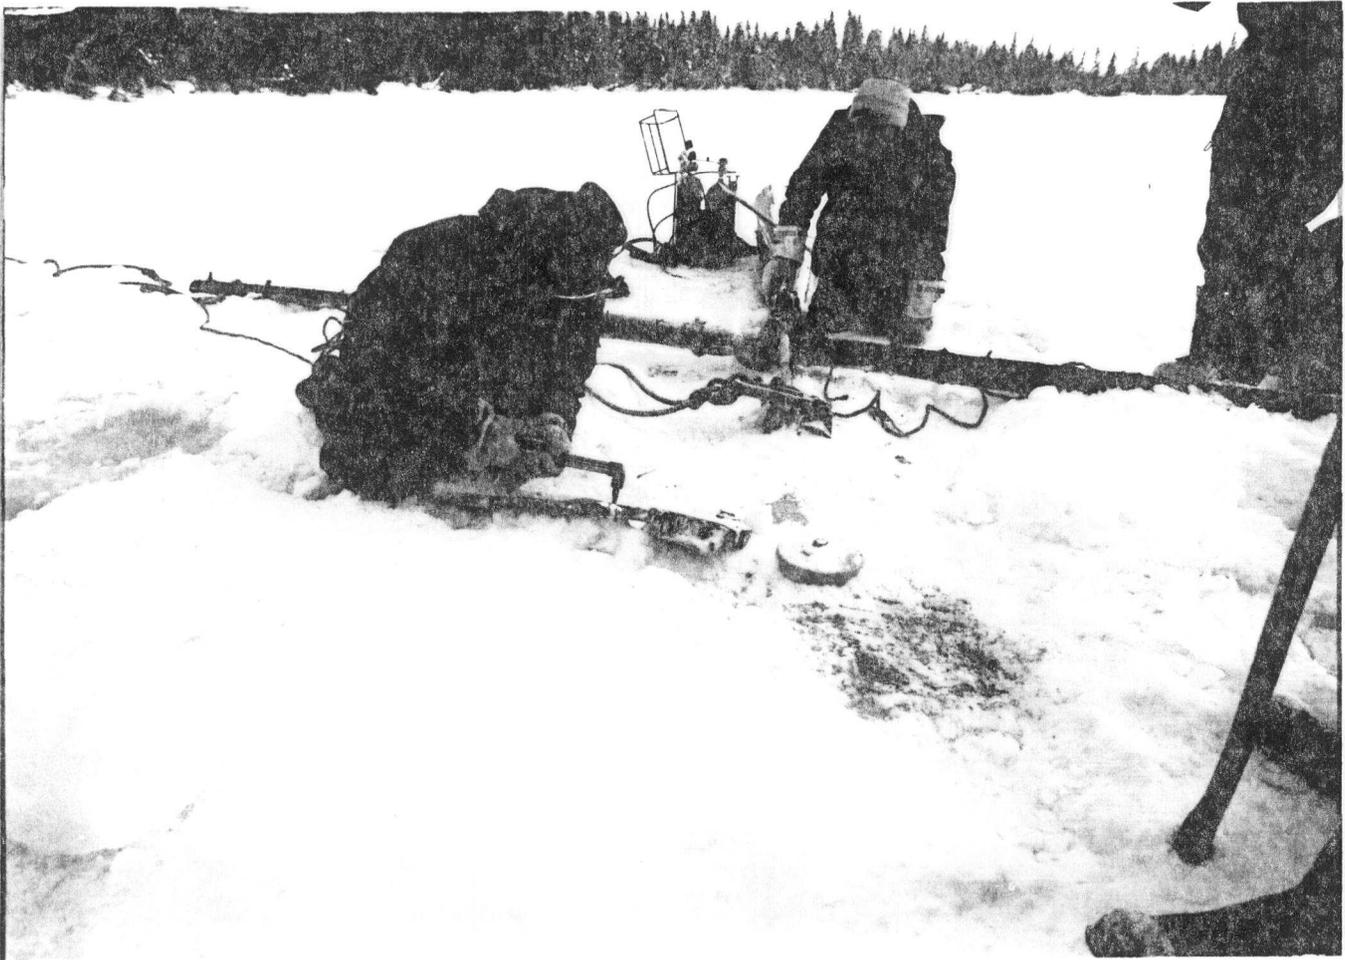
PHOTO # 12 - CUTTING OF MAIN ROTOR BLADES

9. The salvage of the main rotor head and stab bar assemblies presented unique problems as these two assemblies were frozen in the ice and slush on Byng Lake. Field Engineers from 2 CER recovered these assemblies by cutting the ice with axes, picks and chainsaws. The main rotor blades were cut from the hub then lifted in a block of ice. The hub and stab bar were recovered in a similar fashion.

Note safety line and hoisting clevis attached to main rotor hub (centre).  
Note long pole under drag brace to support assembly in case of cracking  
ice.

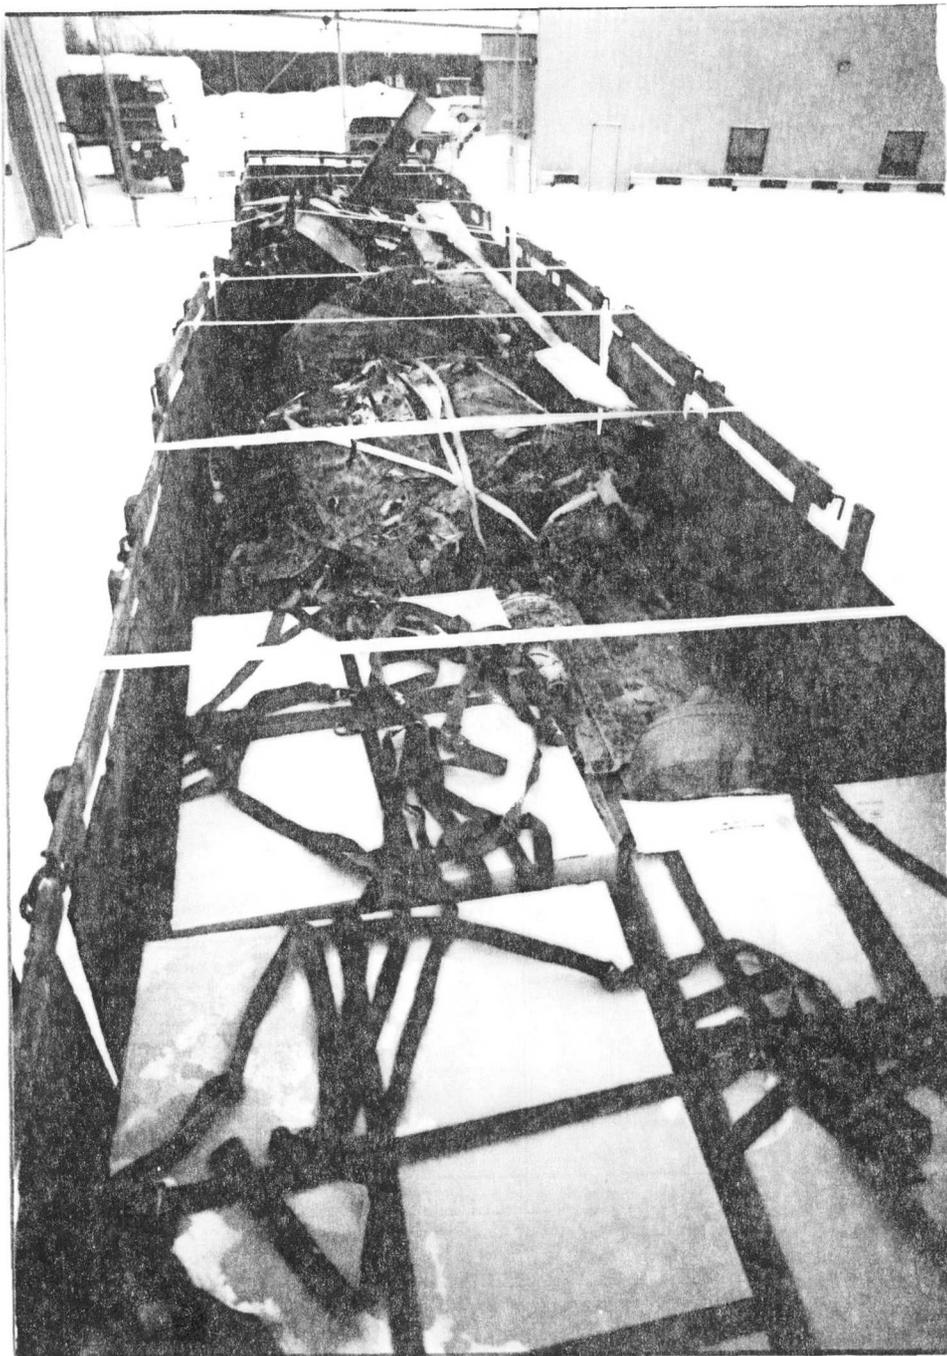
PHOTO # 14 - VIEW OF LOADED FLAT BED TRAILER

CCC7 and tri-walls are visible in foreground, aft and forward fuselage sections are visible at centre with tail boom at left rear and rotor blades right rear.
