LOSS OF THE "GULF MASTER" NEAR MERRY ISLAND, STRAIT OF GEORGIA, B.C..
WITH LOSS OF LIFE 11-1-67

"GULF MASTER"
Investigation of Tidal Streams in Area of Presumed Foundering

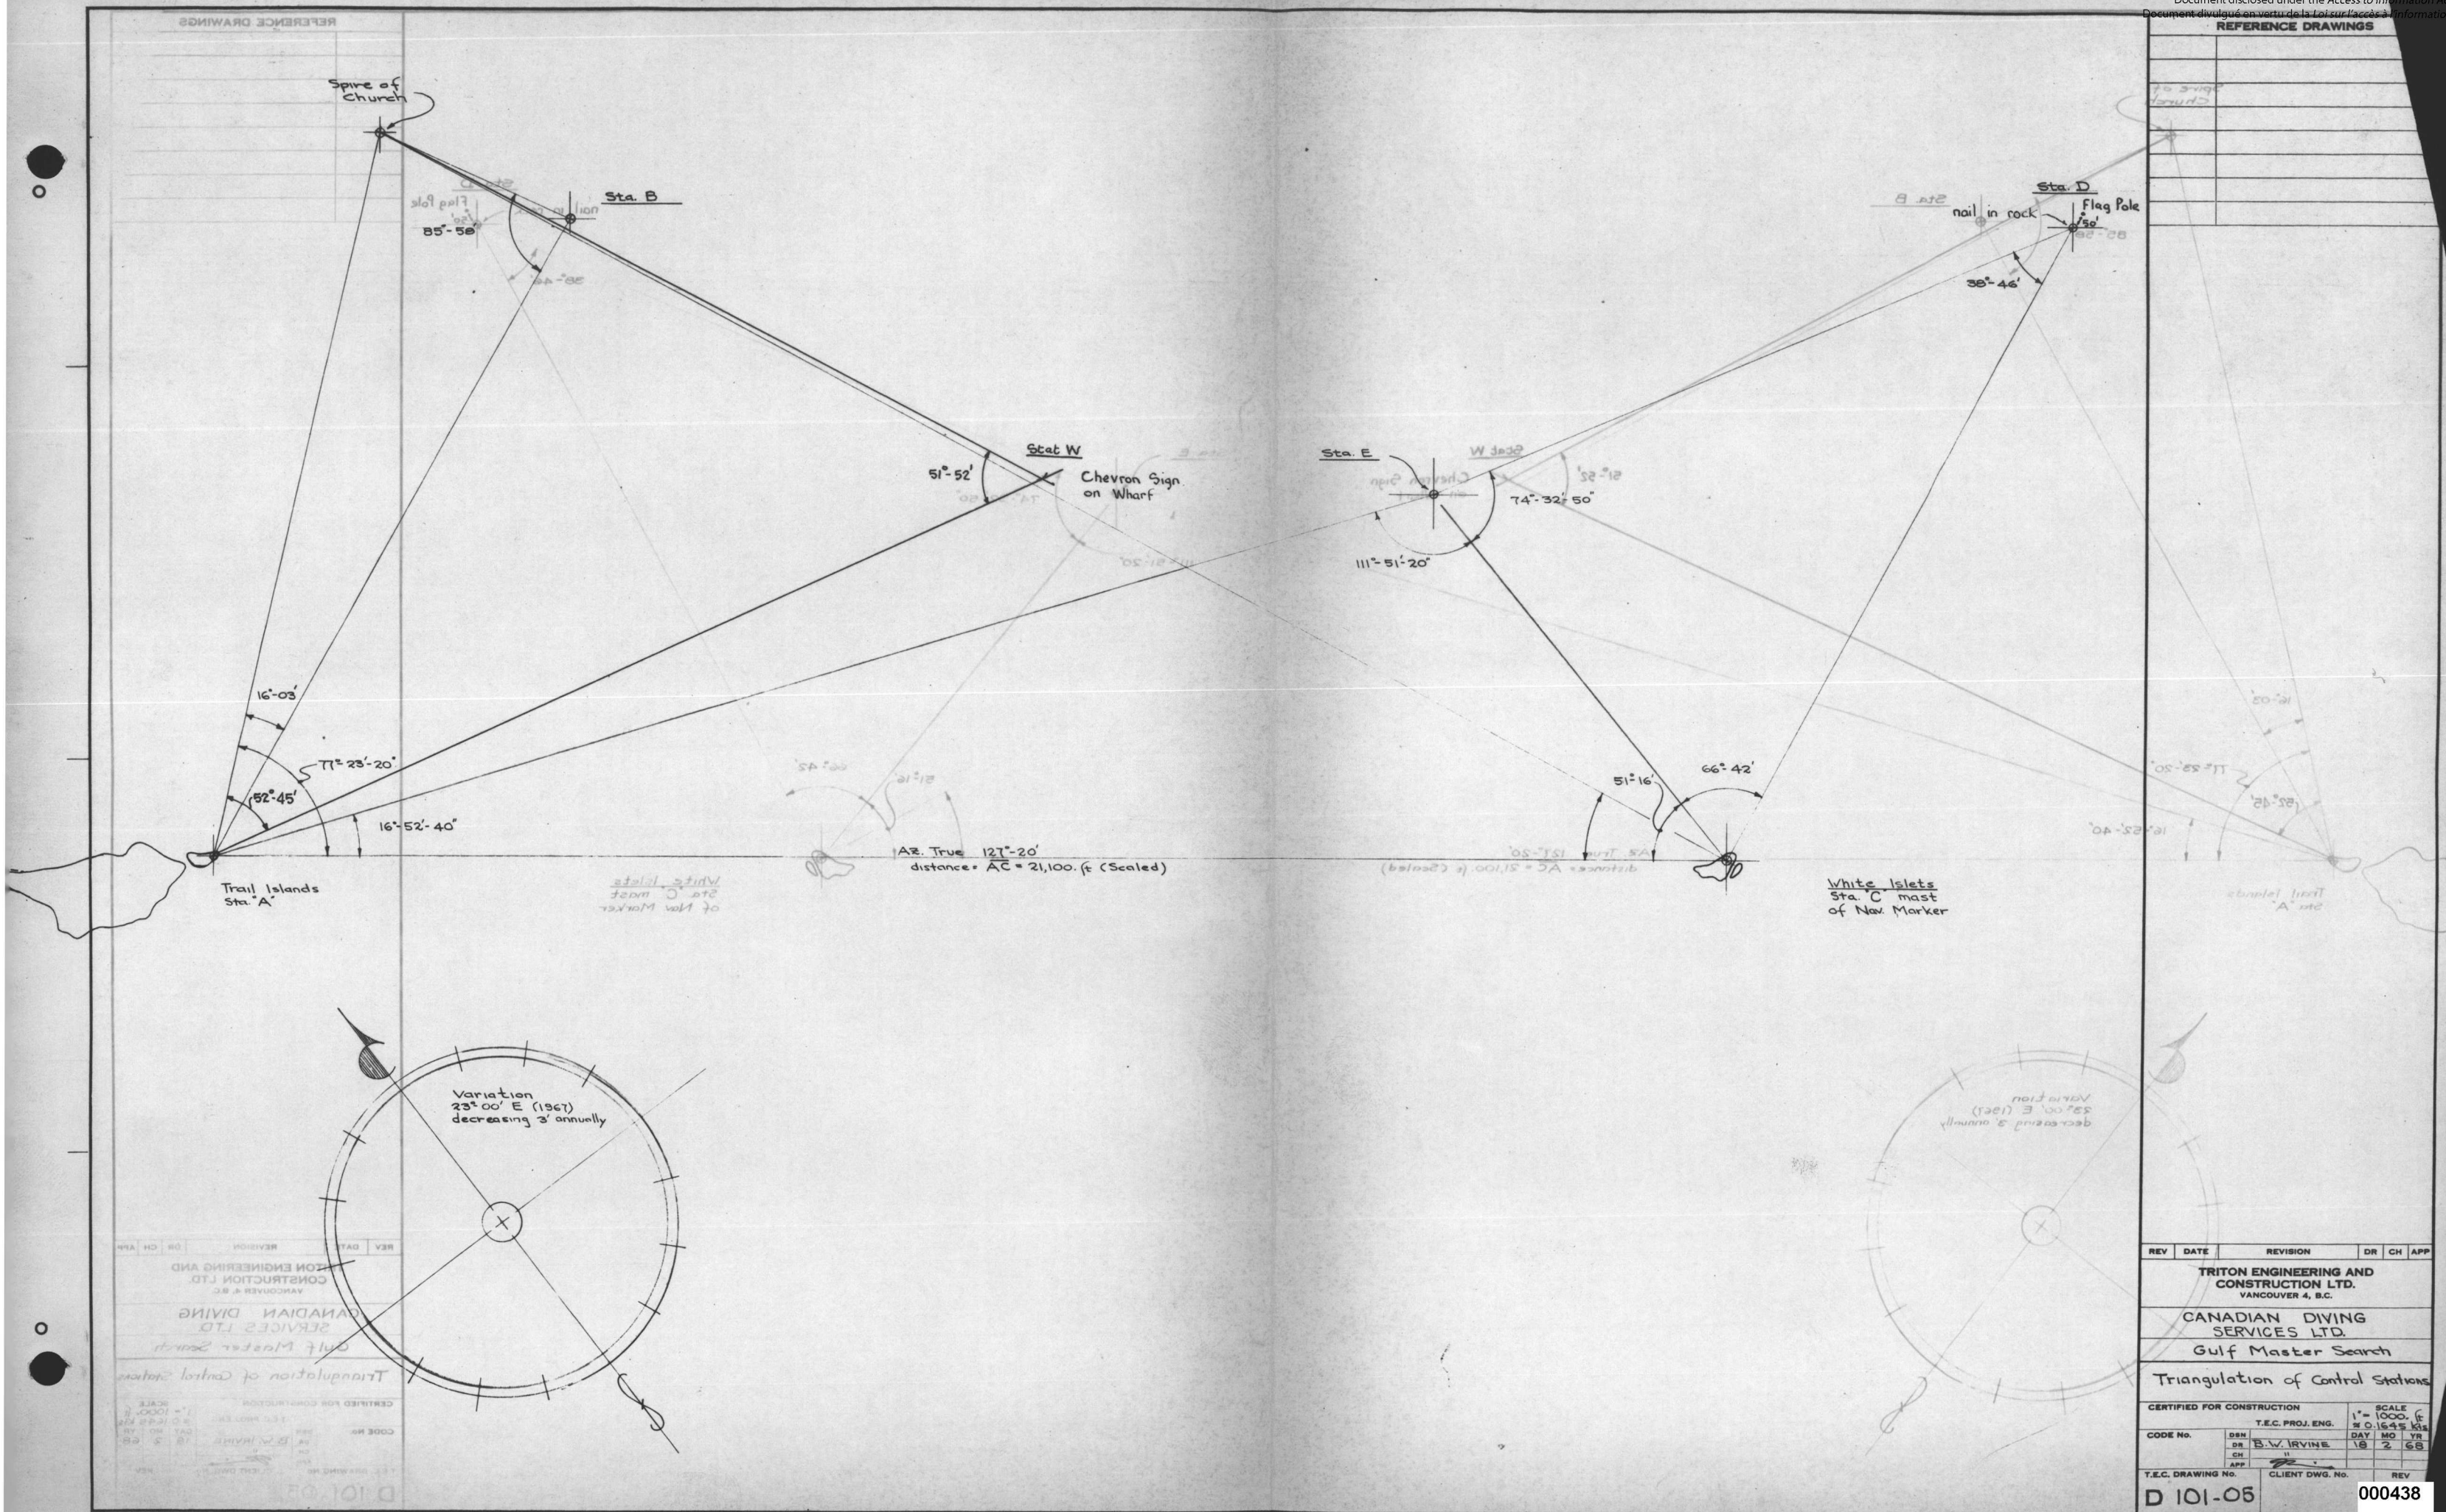
TIDE FLOW PATTERNS.

No. 5 - Scotchman with large Sea Anchor attached. At 15.54 hrs. 1 pt diesel fuel poured out. Oil slick produced = 40' x 20' in center was Scotchman. At 16.34 hrs in 84 fathoms the Oil slick was 52 feet down current from buoy.

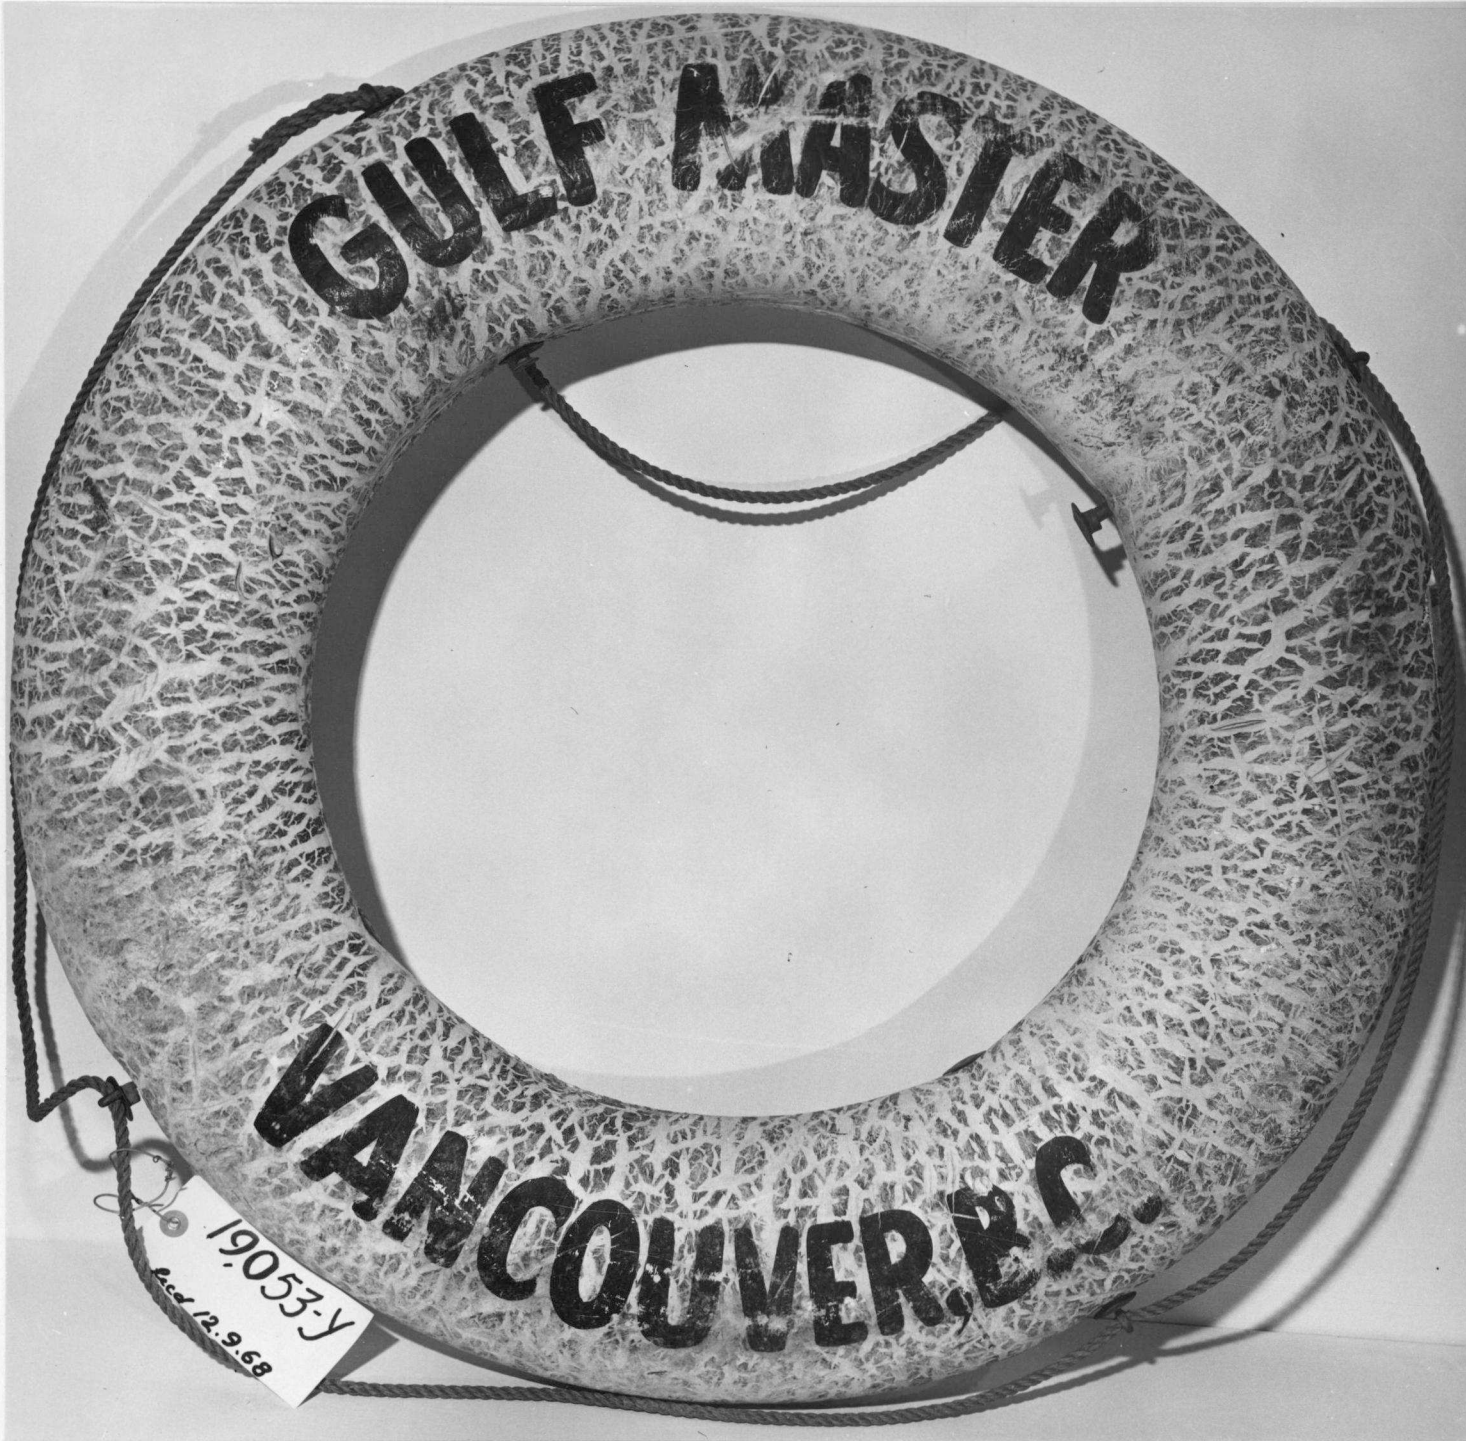
FIGURE 1

GULF MASTER LIFE RING
(AS RECEIVED)

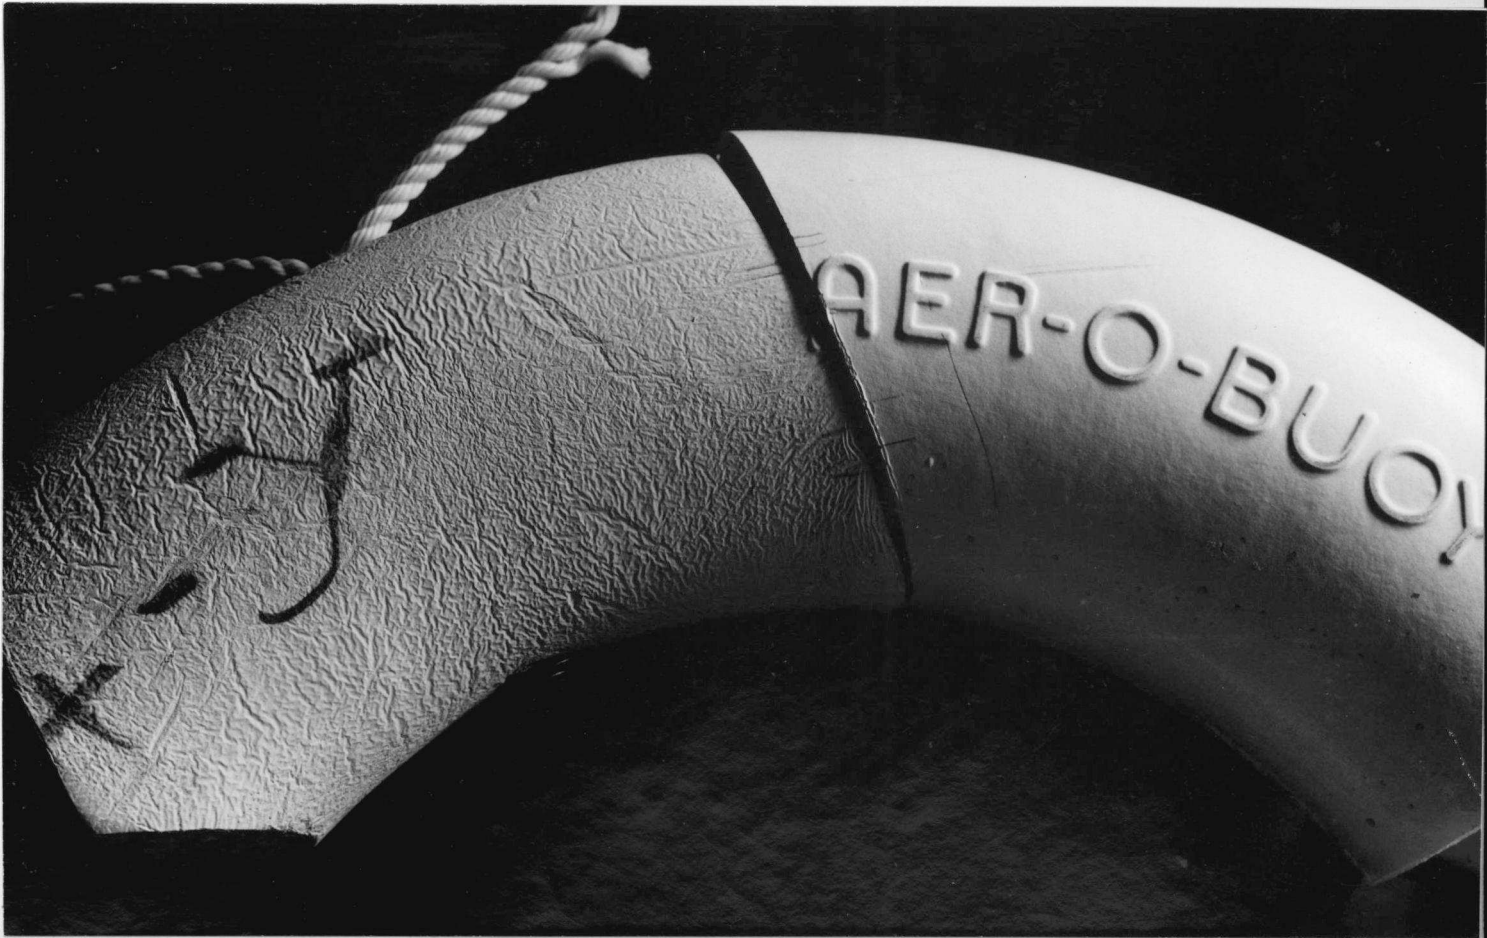
FIGURE 2

SECTIONS OF NEW LIFE RING BEFORE (RIGHT) AND AFTER (LEFT)
PRESSURE TESTING

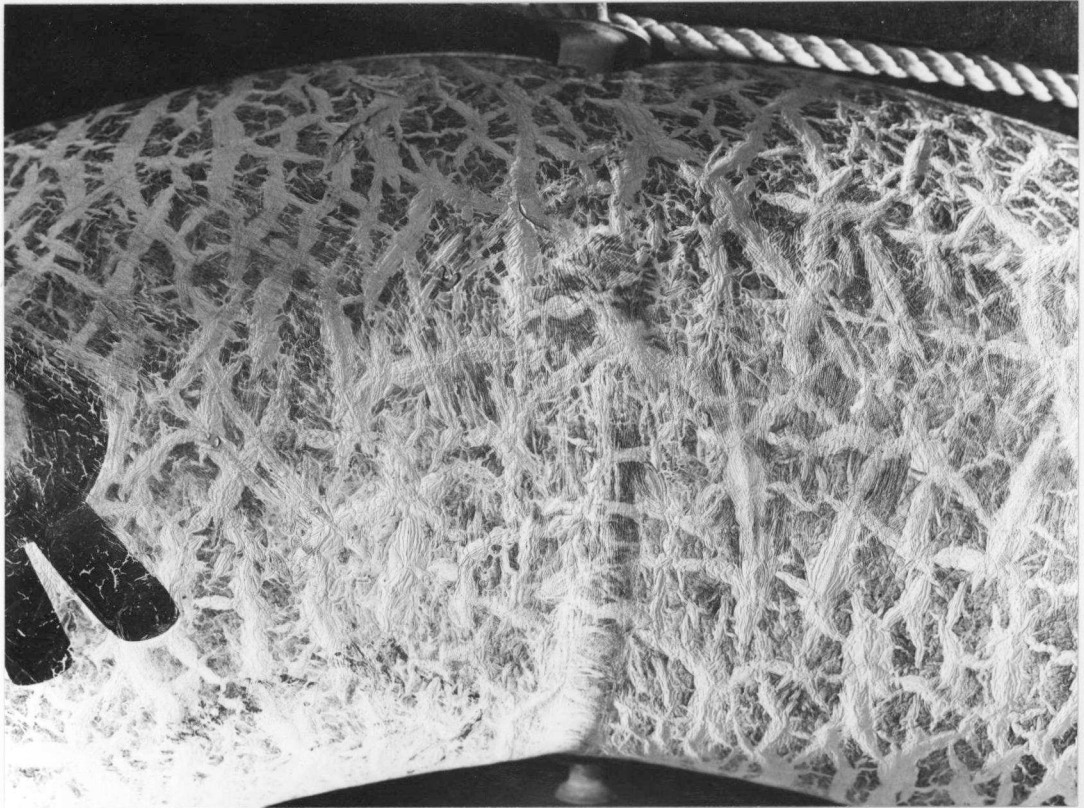
FIGURE 3: CLOSE-UP OF GULF MASTER RING (AS RECEIVED)
SHOWING SHRINKAGE AROUND PIN

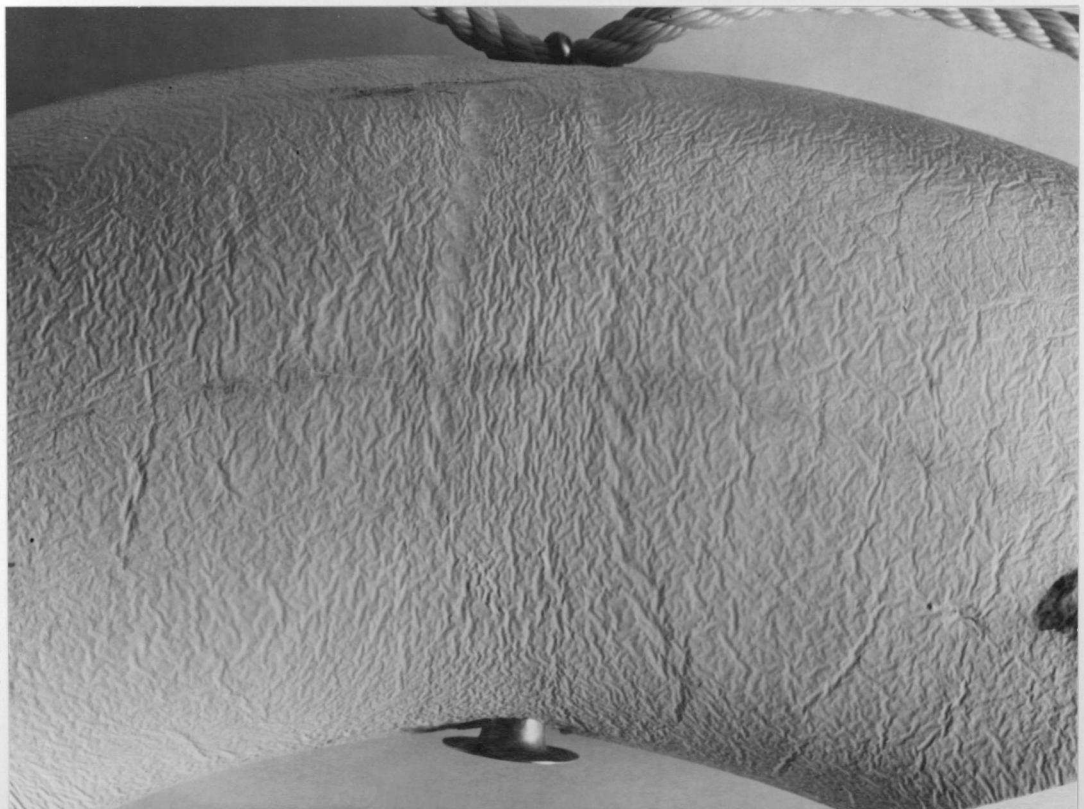
FIGURE 4: CLOSE-UP OF NEW RING (AFTER PRESSURE TESTING)
SHOWING SHRINKAGE AROUND PIN

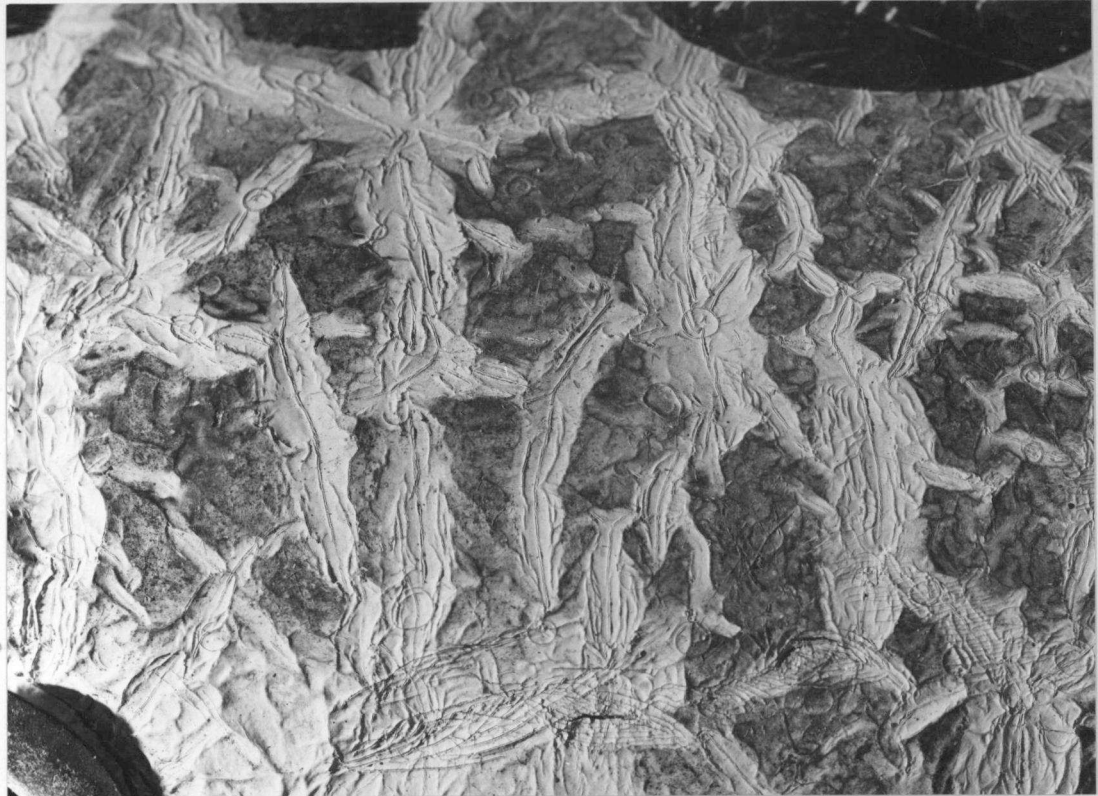
③ C.N.P. ② D.A.R. *[initials]* 22/7 The wrinkled surface of the life-buoy indicates that it has been subjected to pressure, hence it probably is from the Gulfmaster. I see no justification, however, for removing the search on this date. *[initials]*
I don't think that this should prompt any resumption of search, do you? Should think that condition of buoy suggests that it must have been recently separated from the wreck. Does absence of marks
000391
(over)

FIGURE 5: MAGNIFIED (2X) VIEW OF SURFACE OF GULF MASTER LIFE RING
AS RECEIVED

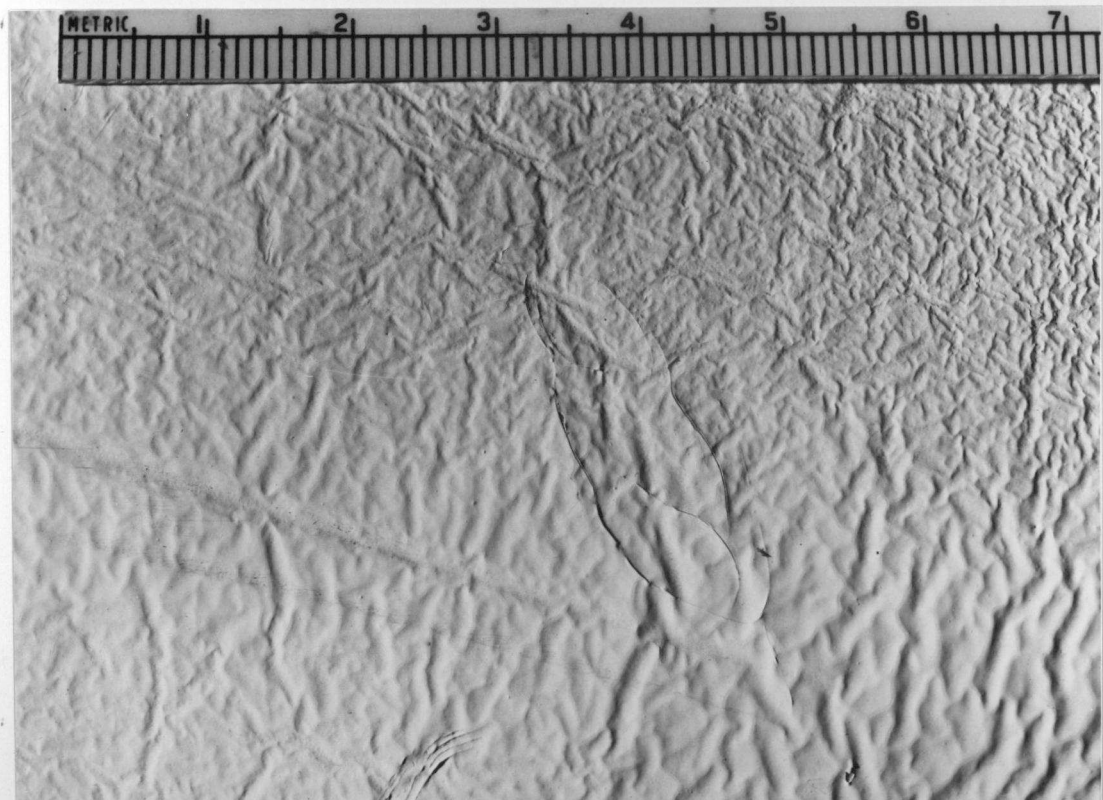
FIGURE 6: MAGNIFIED (2X) VIEW OF SURFACE OF NEW LIFE RING AFTER
PRESSURE TESTING

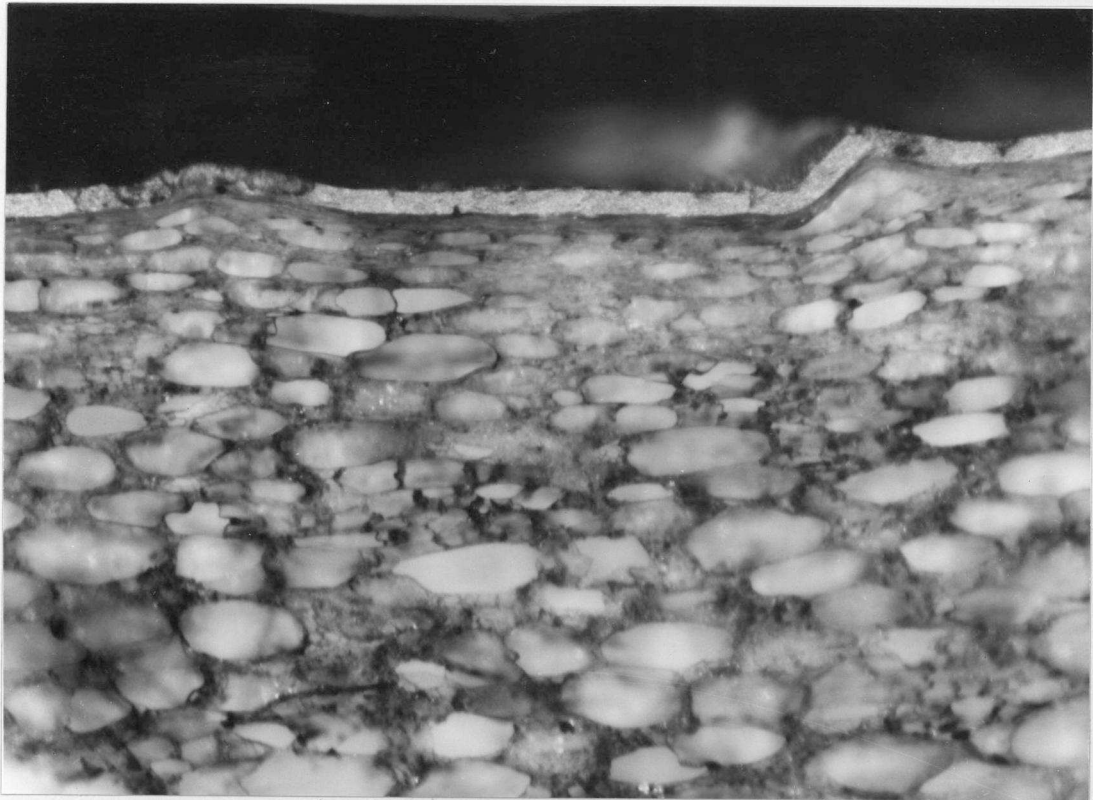
FIGURE 7

CROSS-SECTION OF FOAM CELLS IN GULF MASTER LIFE RING (AS RECEIVED)
98 X MAGNIFICATION

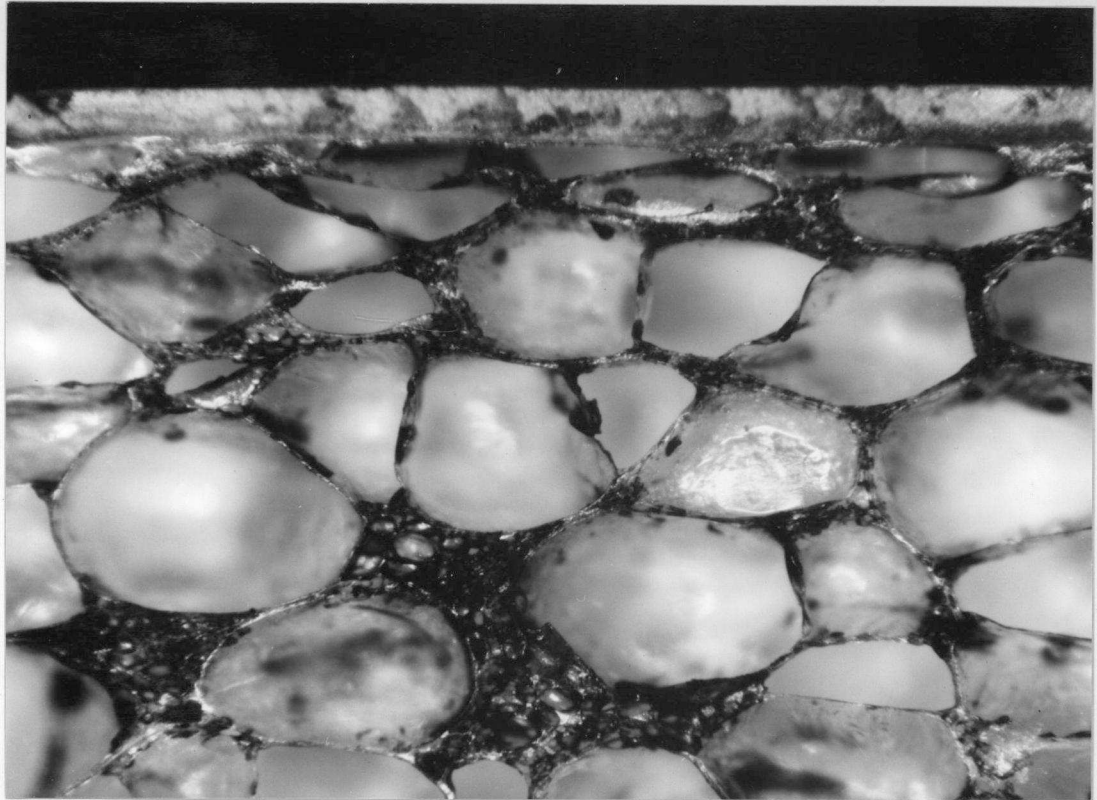
FIGURE 8: CROSS-SECTION OF FOAM CELLS IN NEW LIFE RING BEFORE PRESSURE TESTING 98 X MAGNIFICATION.

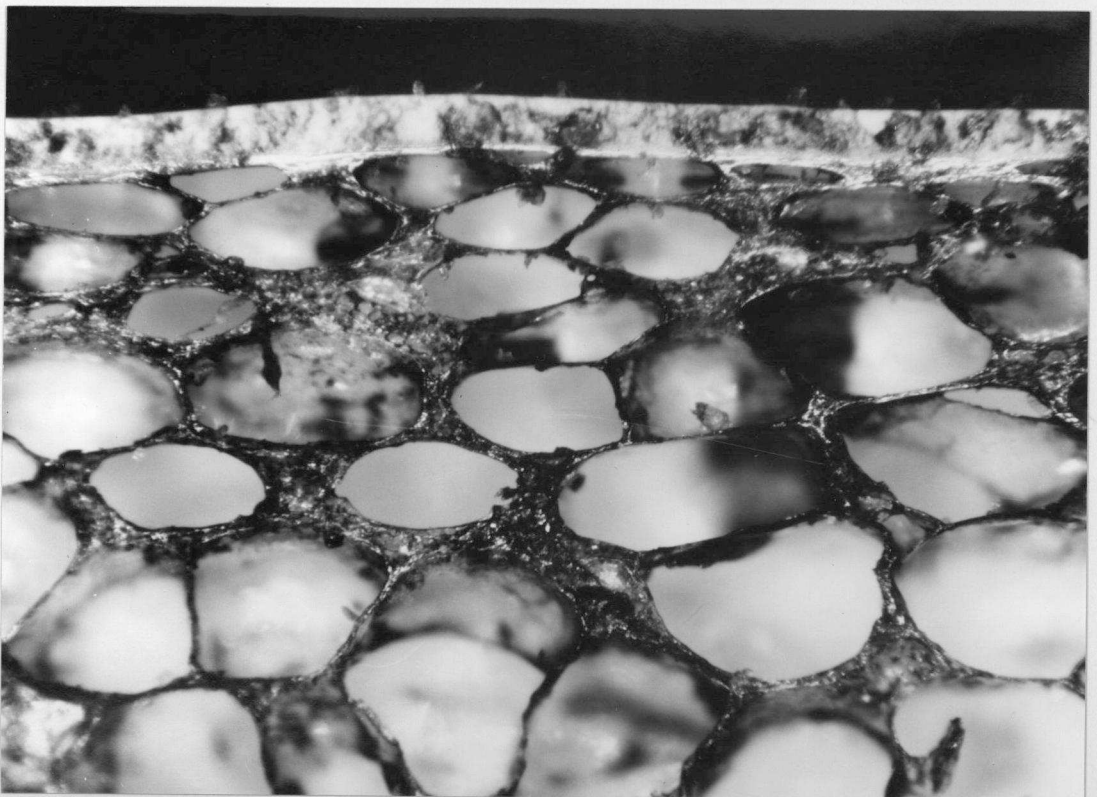
FIGURE 9: CROSS-SECTION OF FOAM CELLS IN NEW LIFE RING AFTER PRESSURE TESTING 98 X MAGNIFICATION.
