DRB 105-15/0

DIRECTORATE OF CENTRAL REGISTRIES

Report of the Board of Enquiry on the
Accident at Bldg 240 on Wednesday 29th July 1959

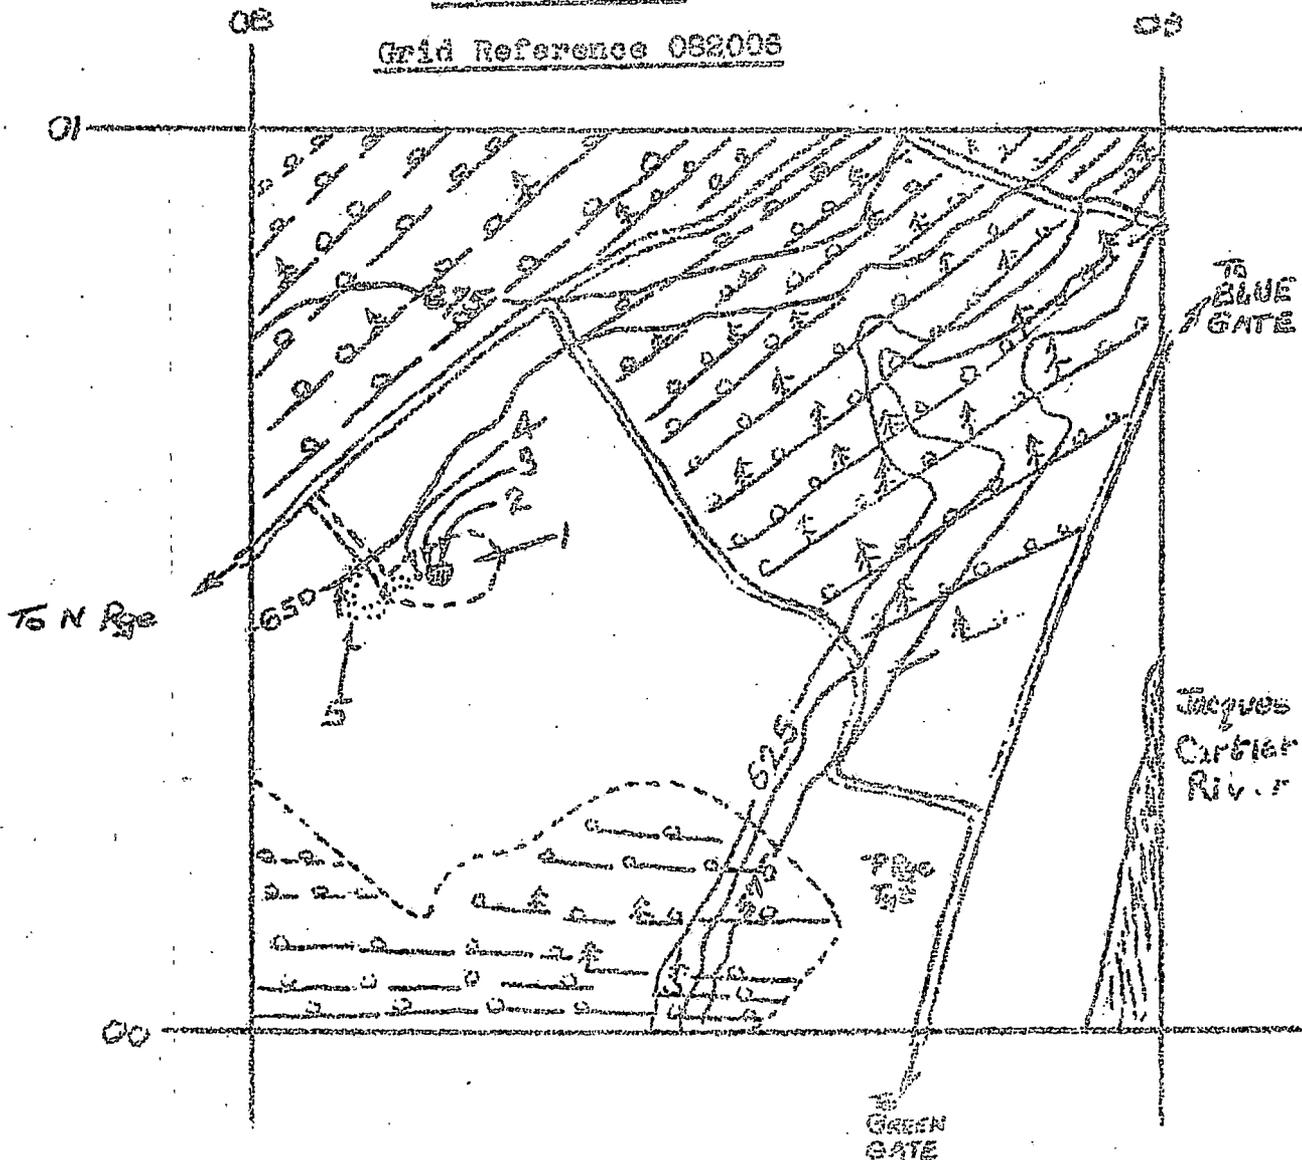
Site of Accident 10 Oct 58

1. Debris Area, 150-ft x 100-ft approximately
2. Burned area, 30-ft x 20-ft approximately
3. Hole, 37-in x 26-in x 18-in deep dug by shovel
4. Mound of earth from hole, 41-in x 33-in x 12-in high
5. Path of vehicle leaving scene of accident; vehicle was parked with rear towards explosives with rear wheels 22-ft from hole

Note; Fragments of boxes and burned igniter bags cover whole area also cartridges, primary, 3-in, mortar.
