SUBJECT AIRCRAFT

FILE TITLE N9812R BEECH 35U

NR OSHAWA AIRPORT, ONT.

AIRCRAFT ACCIDENT REPORT
RAPPORT D'ACCIDENT D'AVIATION

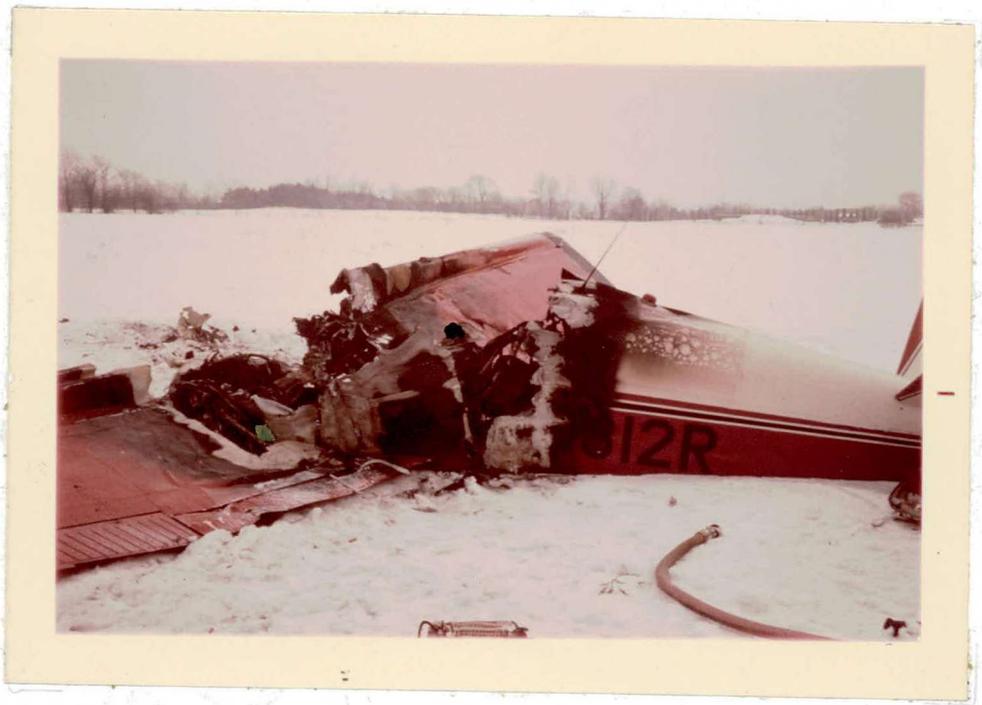
Looking south east.

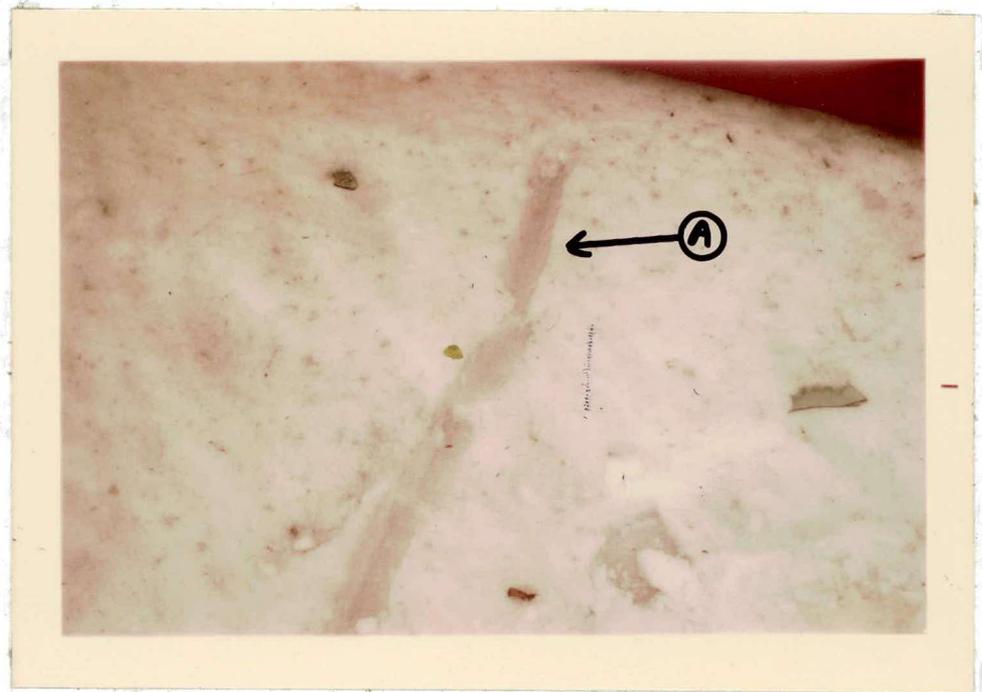
Photograph of the area directly beneath the leading edge of the V tail.

"A" Note ice formation conforming to the shape of the leading edge.

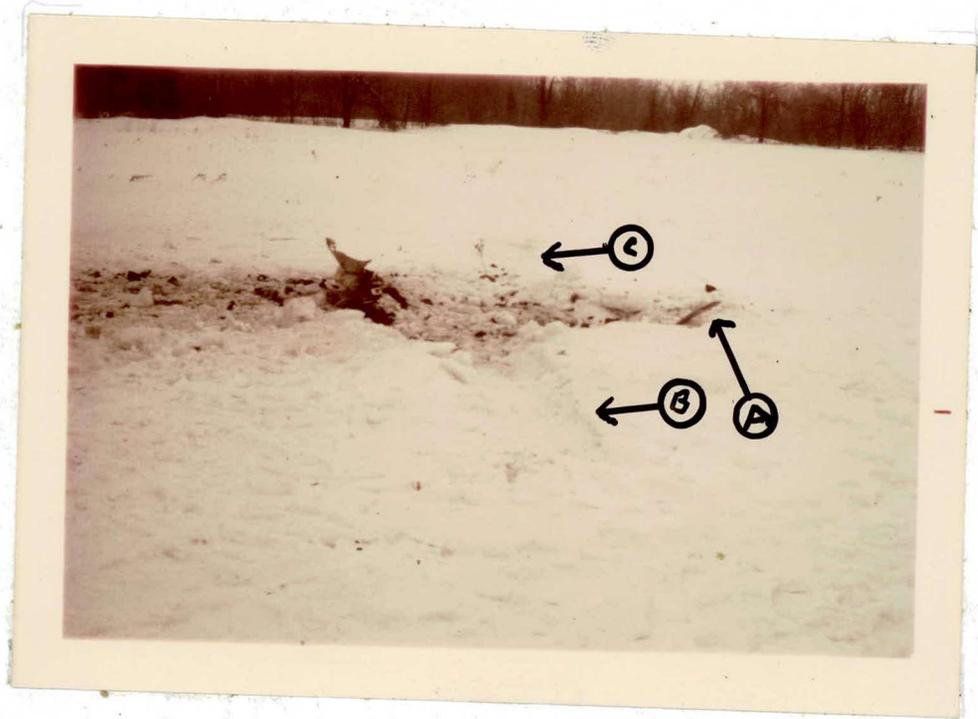
Ground impact marks and damage to the leading edge of the wings indicate the aircraft struck the ground in a wings level, steep nose down attitude, indicative of a stall at low altitude. The main undercarriage was found in the down position. The nose wheel gear was torn off at ground impact.

Looking East.

- "A" Propeller blade
- "B" Impact mark from port wing.
- "C" Impact mark from starboard wing.

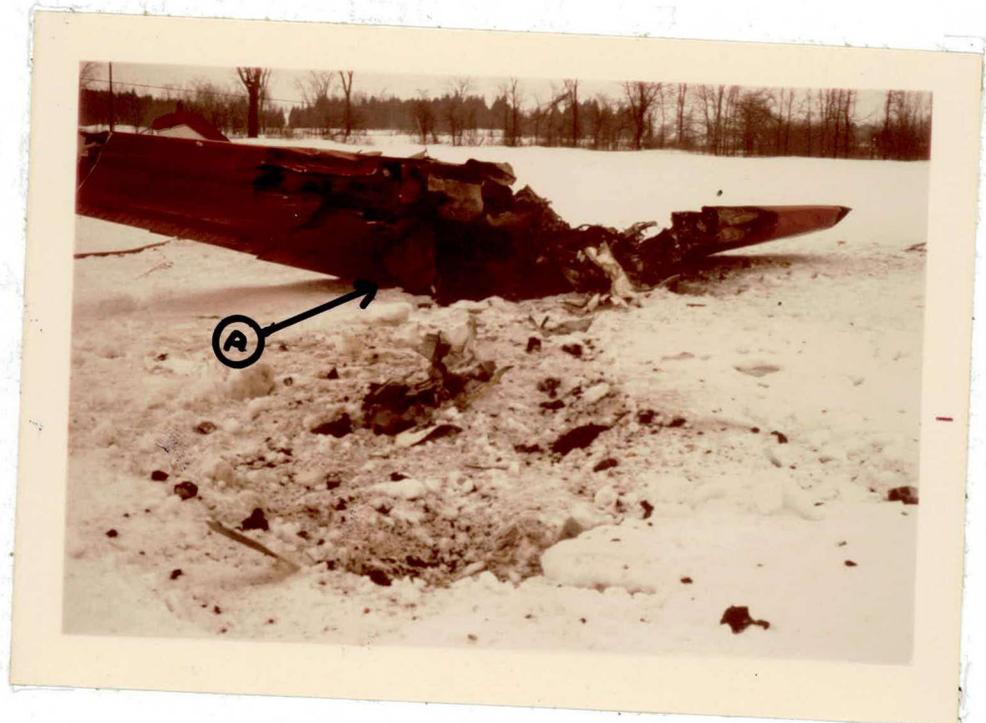
Looking north west.

- "A" Note landing gear in the down position.
