## AIRCRAFT ACCIDENT INVESTIGATION DIVISION

File: C30166

Aircraft Type: Cessna A185E (Ski wheels)

Reg: CF-RZV

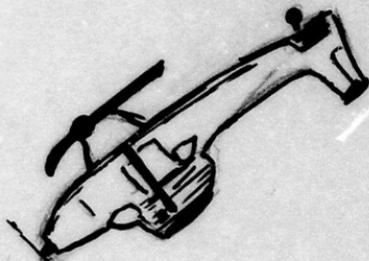
ALT CONTACTS  
GROUND INVERTED  
AT APPROX 70° ANGLE  
SPEED 125-132 MPH.

ELT IN LUGGAGE  
COMPARTMENT IS  
ENTIRELY SHIELDED.

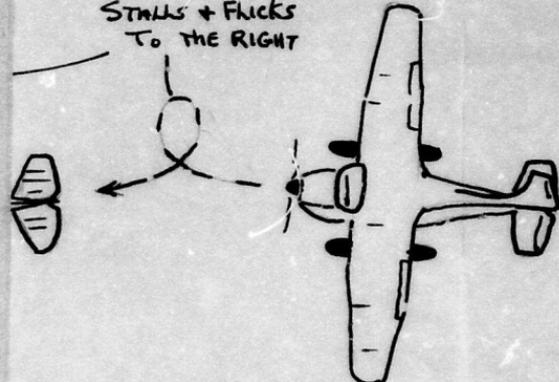
APPROX 125 MPH.

STALLS + FLICKS  
TO THE RIGHT
