BOARD OF TRANSPORT COMMISSIONERS FOR CANADA

C.PR. accident at Struthers ,Ont., mile 34.1

Heron Bay Subd, July 9th,1967.

ACCIDENT INVESTIGATION REPORT

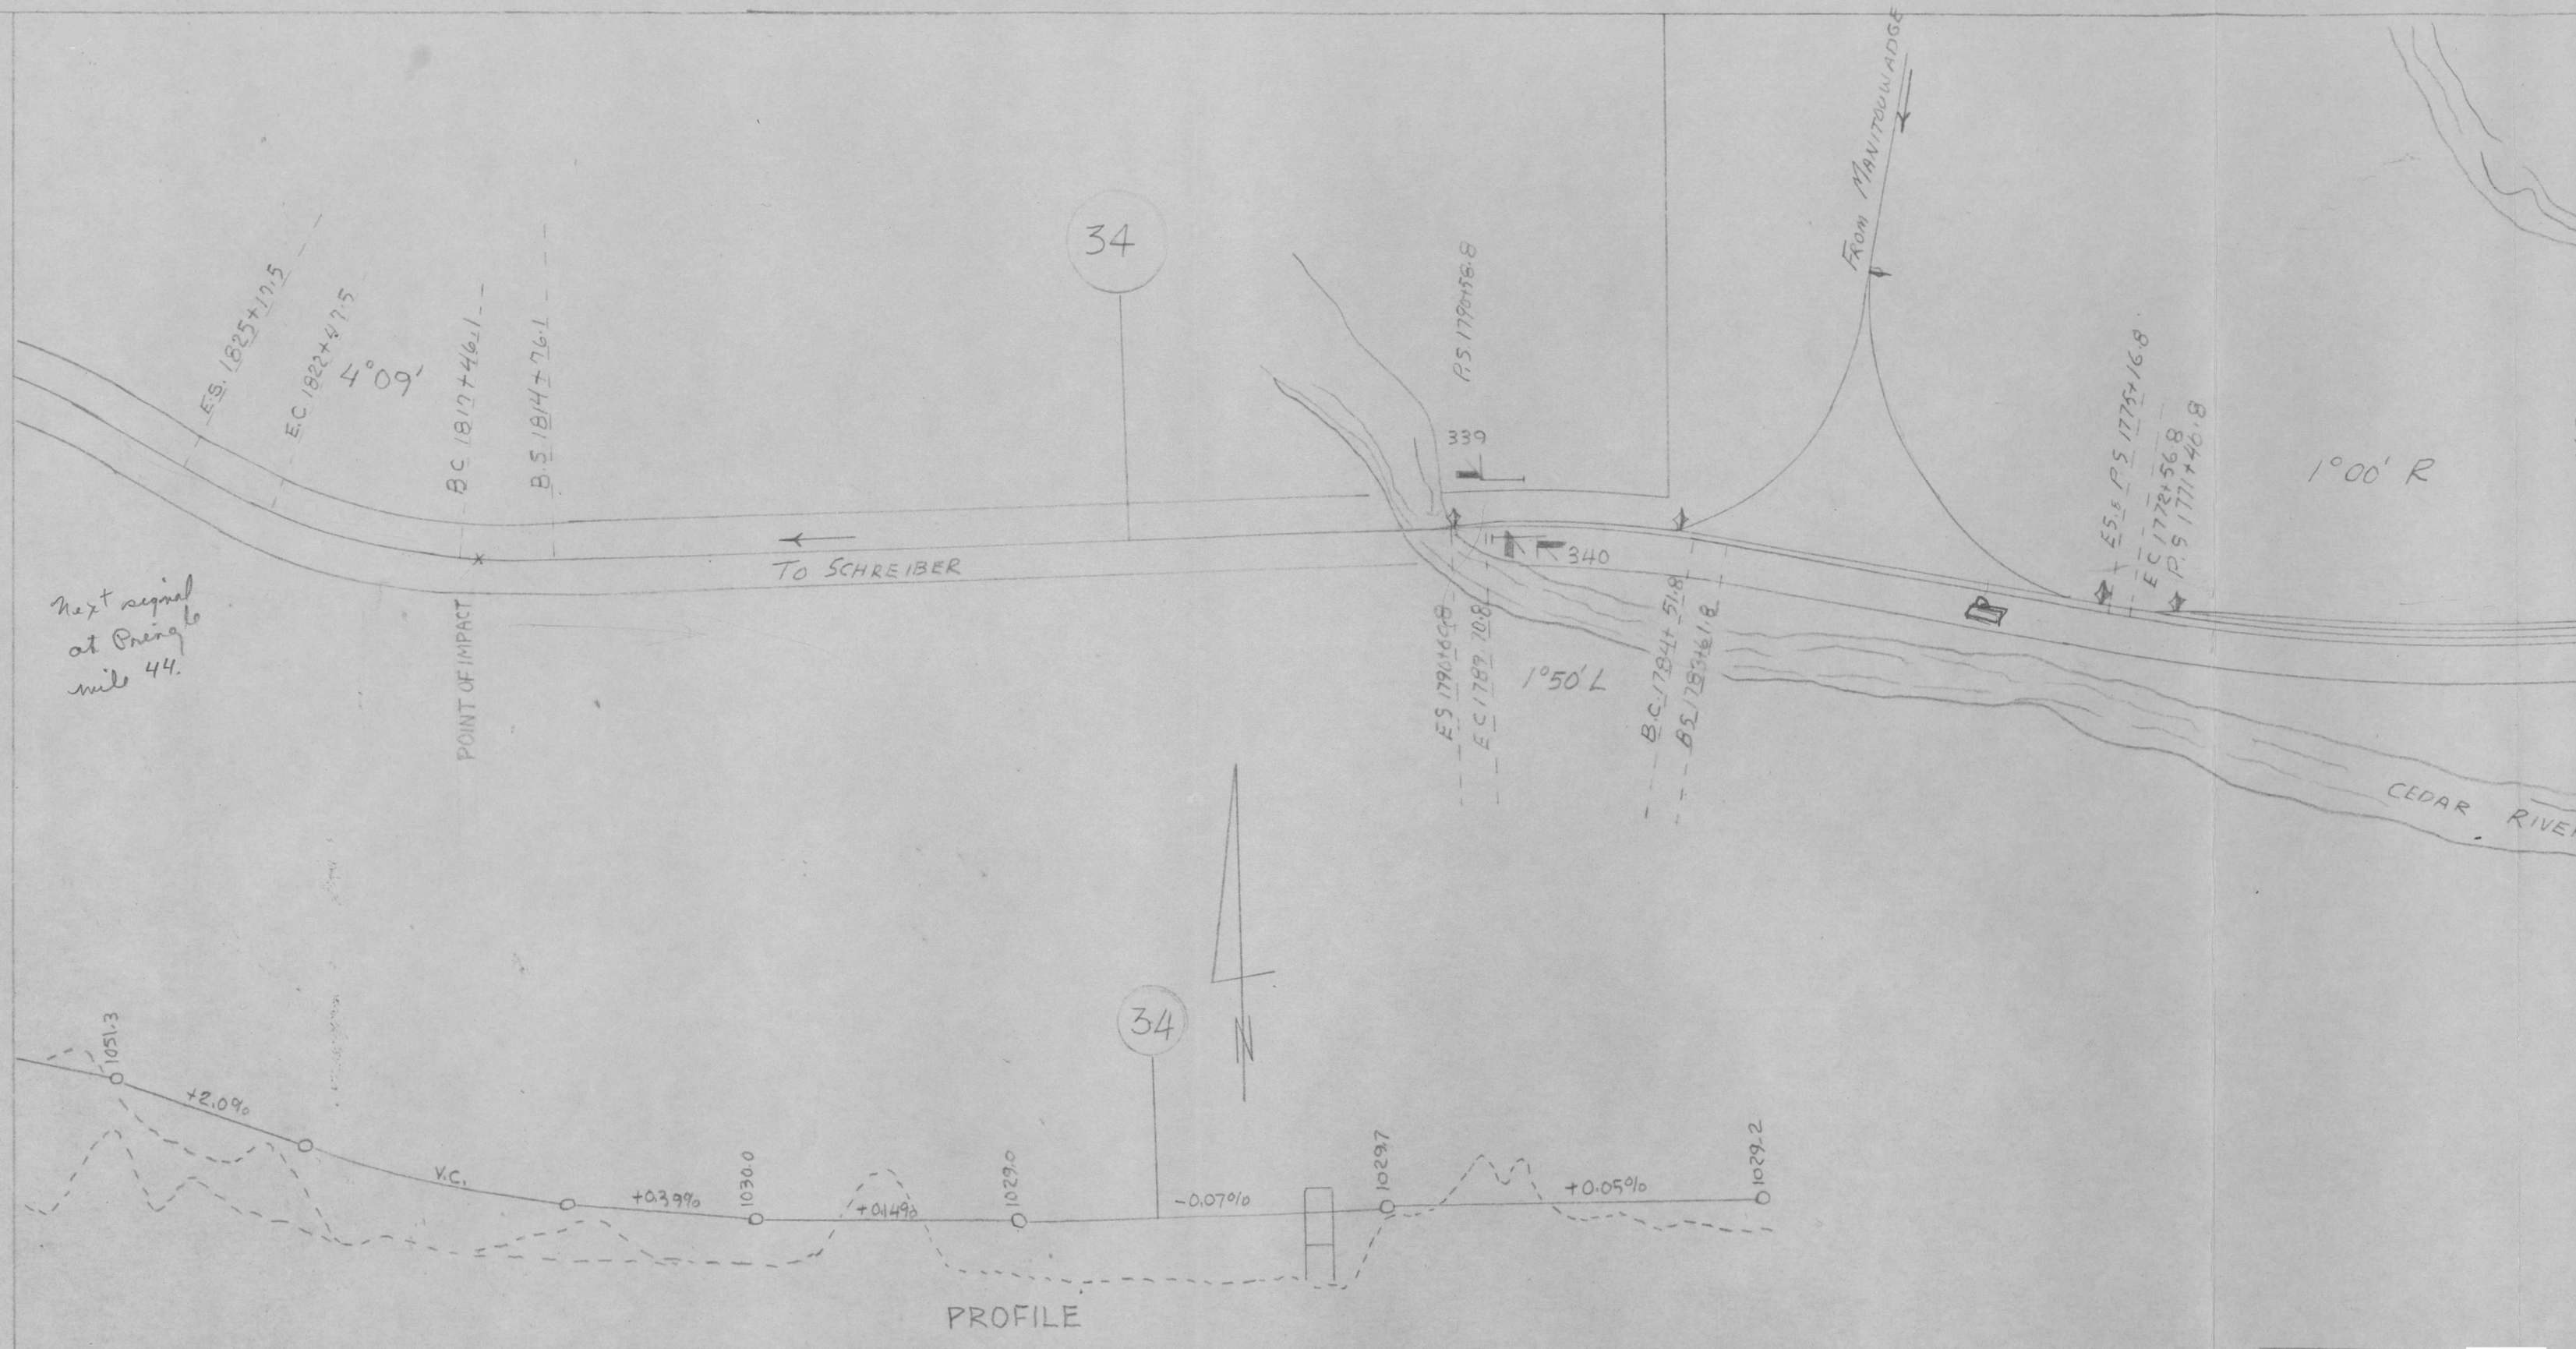
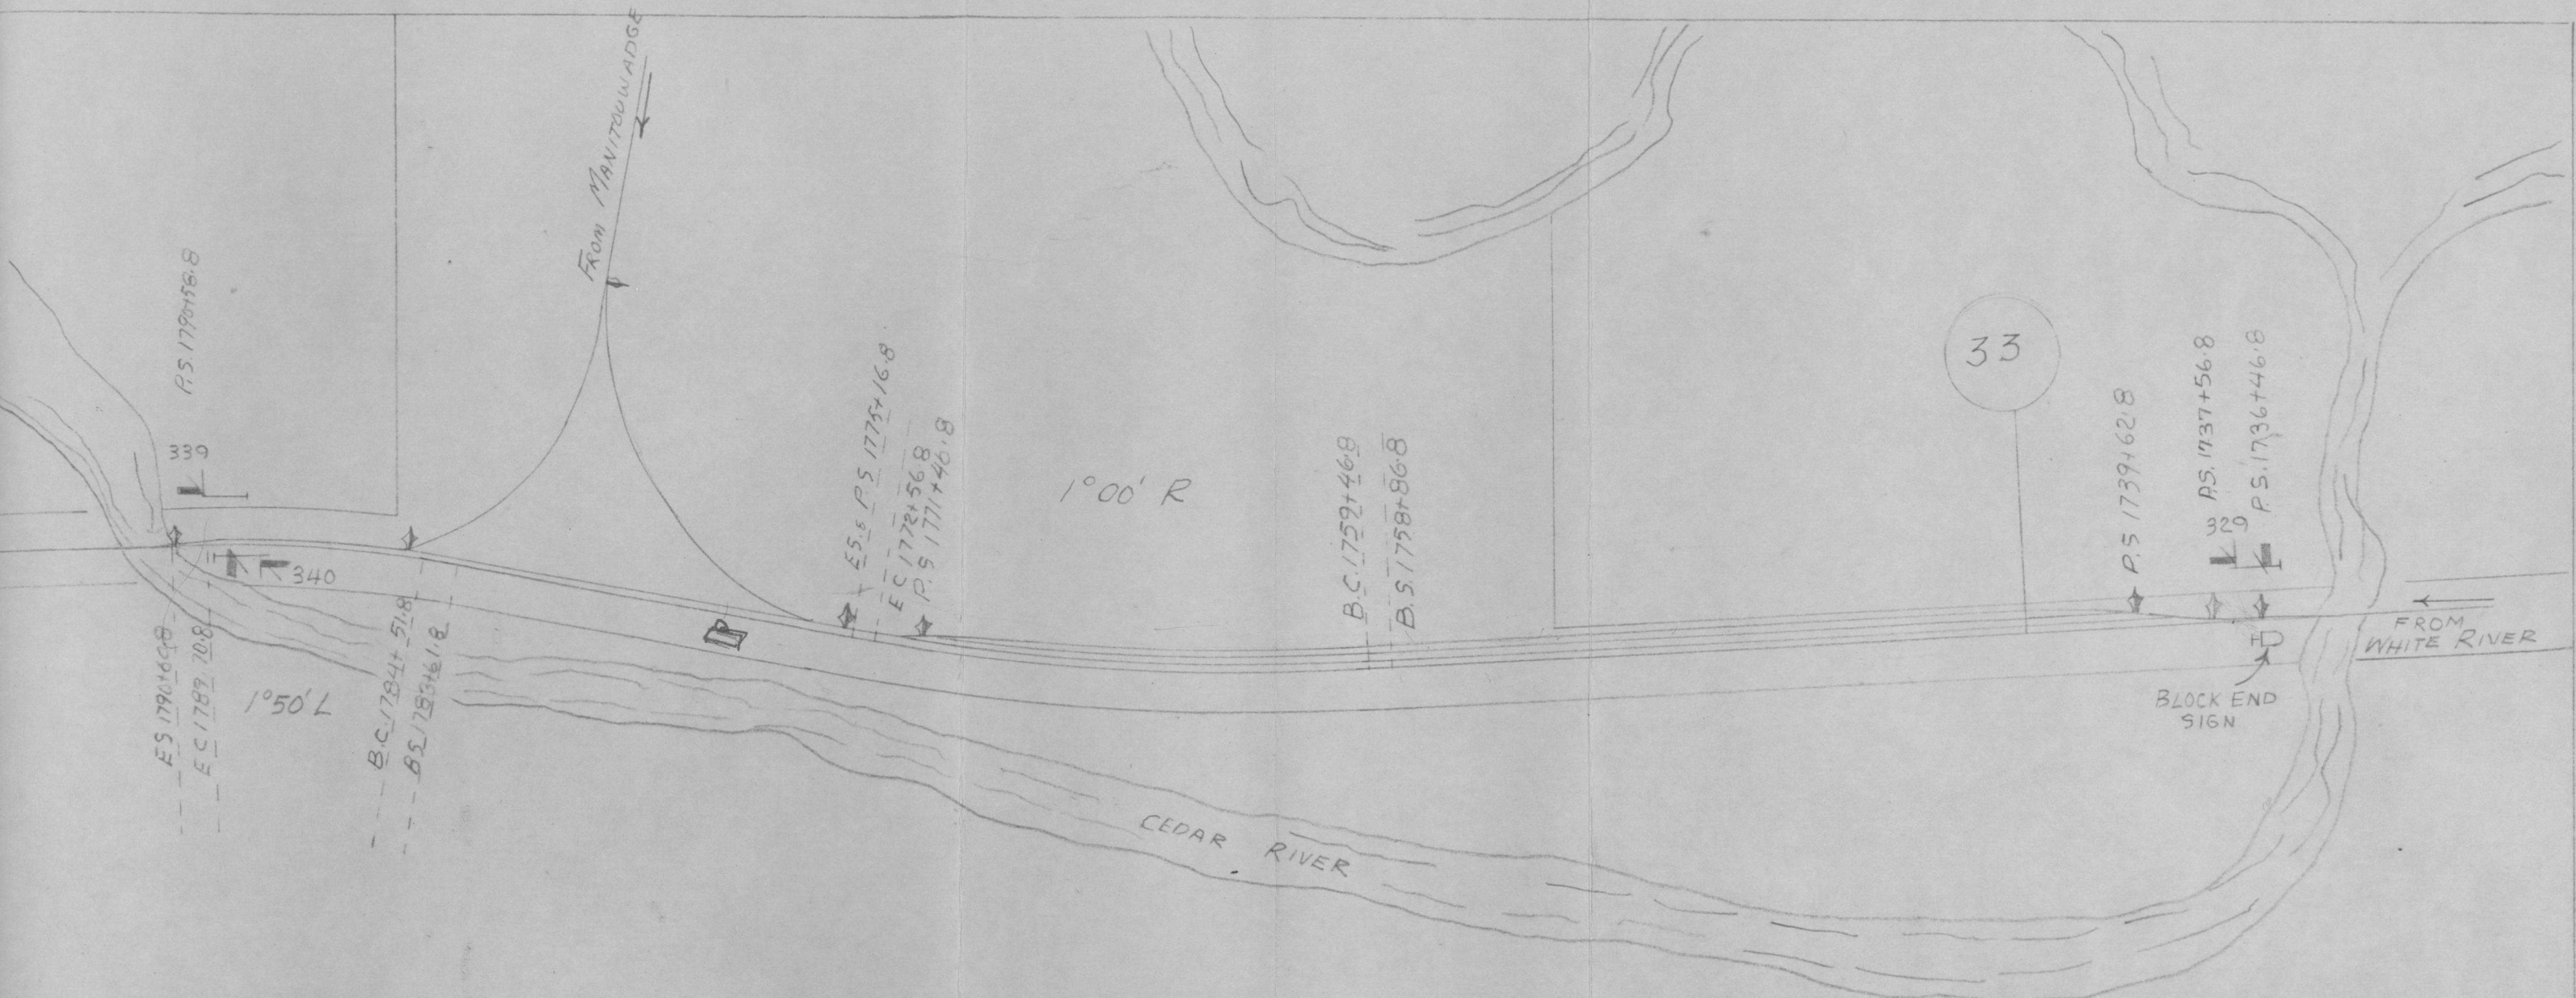
STRUTHERS ONTARIO
SCALE 1"=400'

CANADIAN PACIFIC RAILWAY
EASTERN REGION SCHREIBER DIVISION
MI 33.6 HERON BAY SUBDIVISION
