"This accident was investigated to provide guidance toward the prevention of a recurrence. The content of this report is confined to cause-related circumstances and is published for accident prevention purposes only".

DATE: 5 September 1976 1316 EST  
 OPERATION: Private-Air Show Demonstration DAMAGE: Substantial  
 PLACE: Toronto CNE waterfront, Ont. 43/38N 79/26W  
 LOCALE: Lake - high waves  
 WEATHER: Cloud 4000 scattered, wind NNW 22 gusting to 29 mph, vis 15, temp 17°C  
 PILOT: Airline Transport  
 TOTAL HOURS: 15,000 ALL 41 ON TYPE  
 LAST 90 DAYS: 158 ALL 41 ON TYPE  
 CASUALTIES: Crew: 1 serious; pass: 1 serious  
 OCCURRENCE: During an air display the vintage aircraft had just commenced a low level turn when it stalled and spun into the water.

At approximately 14:15 hours EDT, September 5th, 1976, a DeHavilland model DH-83C (Fox Moth) aircraft, CF-DJB, struck the surface of Lake Ontario in a nosedown, right wing low attitude, in a spin, approximately 30 to 50 feet west of the West island off Ontario Place in the Toronto Harbour. The pilot and one passenger were seriously injured and the aircraft substantially damaged as a result of the accident.

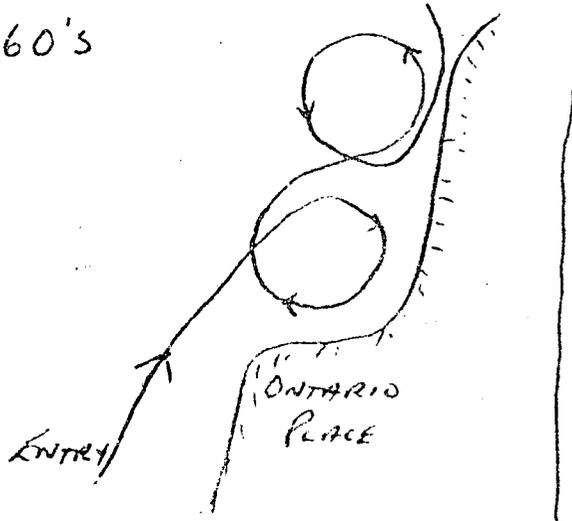
1. Two 360's

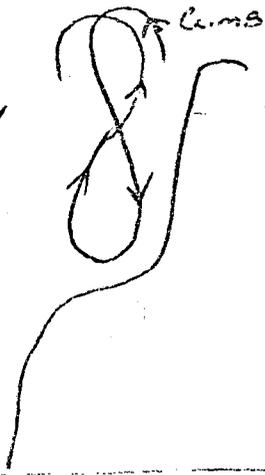
2. LAZY EIGHT WITH PRACTICALLY A STALL TURN AT EACH END

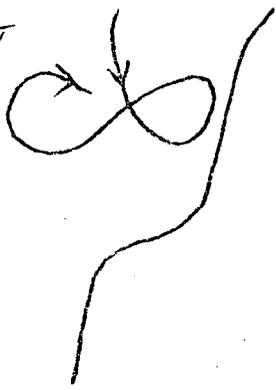
3. LAZY EIGHT IN OPPOSITE DIRECTION.

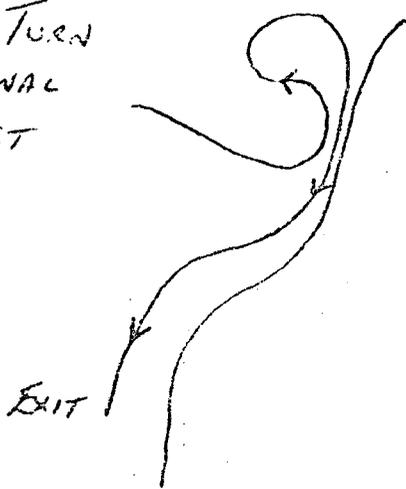
4. STALL TURN AND FINAL FLY PAST

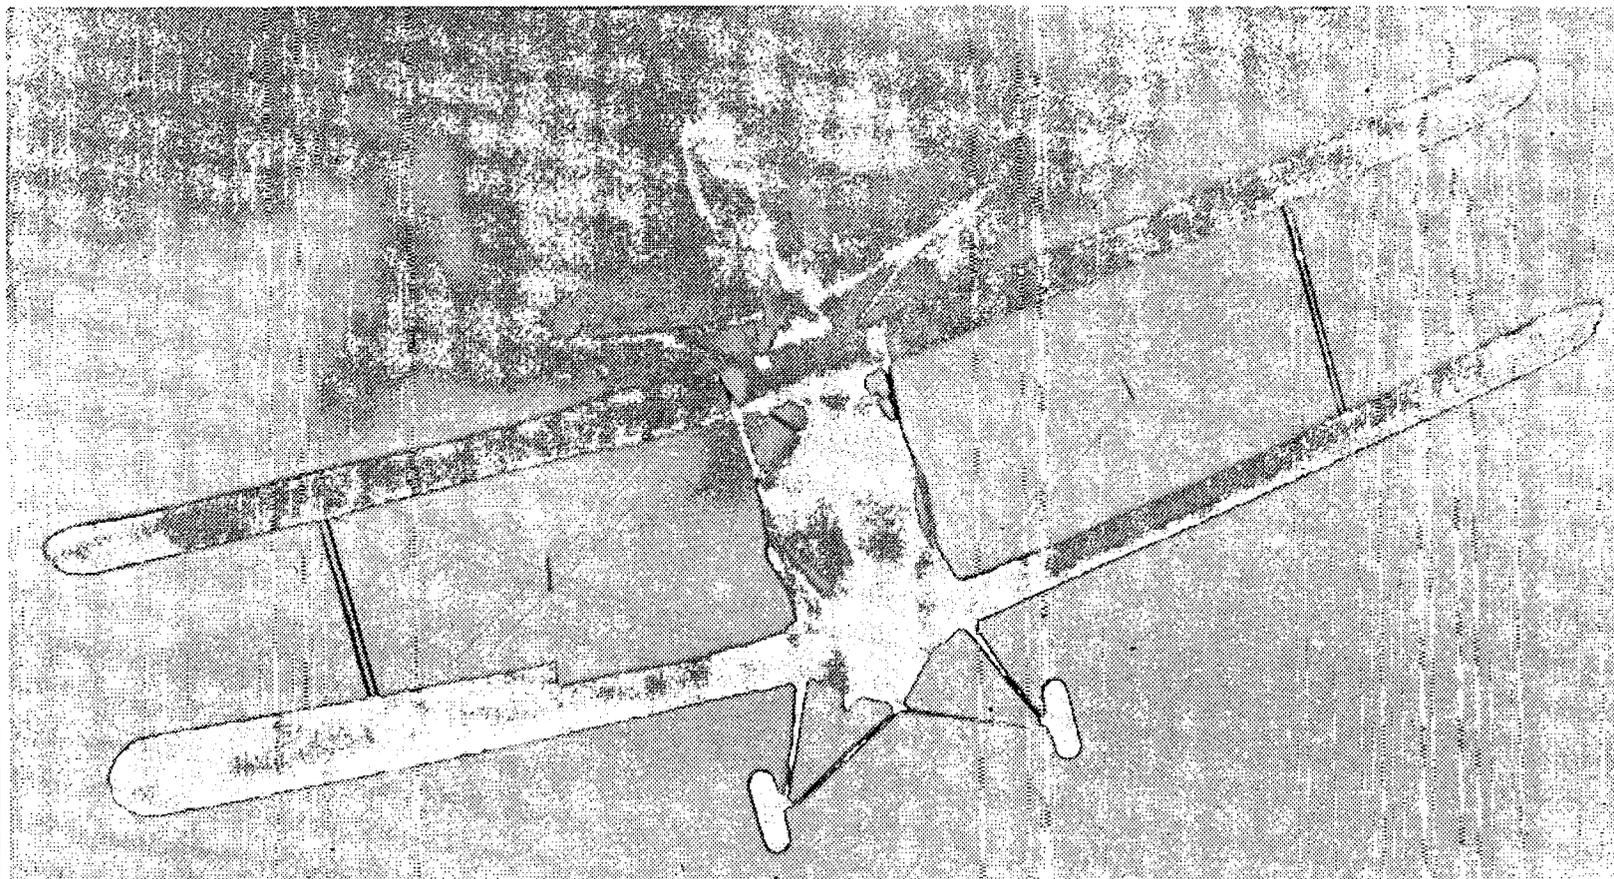
JUST BEFORE CRASHING into Lake Ontario at the CNE air show yesterday and narrowly missing hundreds of spectators, Fox Moth biplane banks over waterfront. One of 53 produced in Canada after
