LOSS OF THE "GULF MASTER" NEAR MERRY ISLAND, STRAIT OF GEORGIA, B.C..
WITH LOSS OF LIFE 11-1-67

"GULF MASTER"
Investigation of Tidal Streams in Area of Presumed Foundering

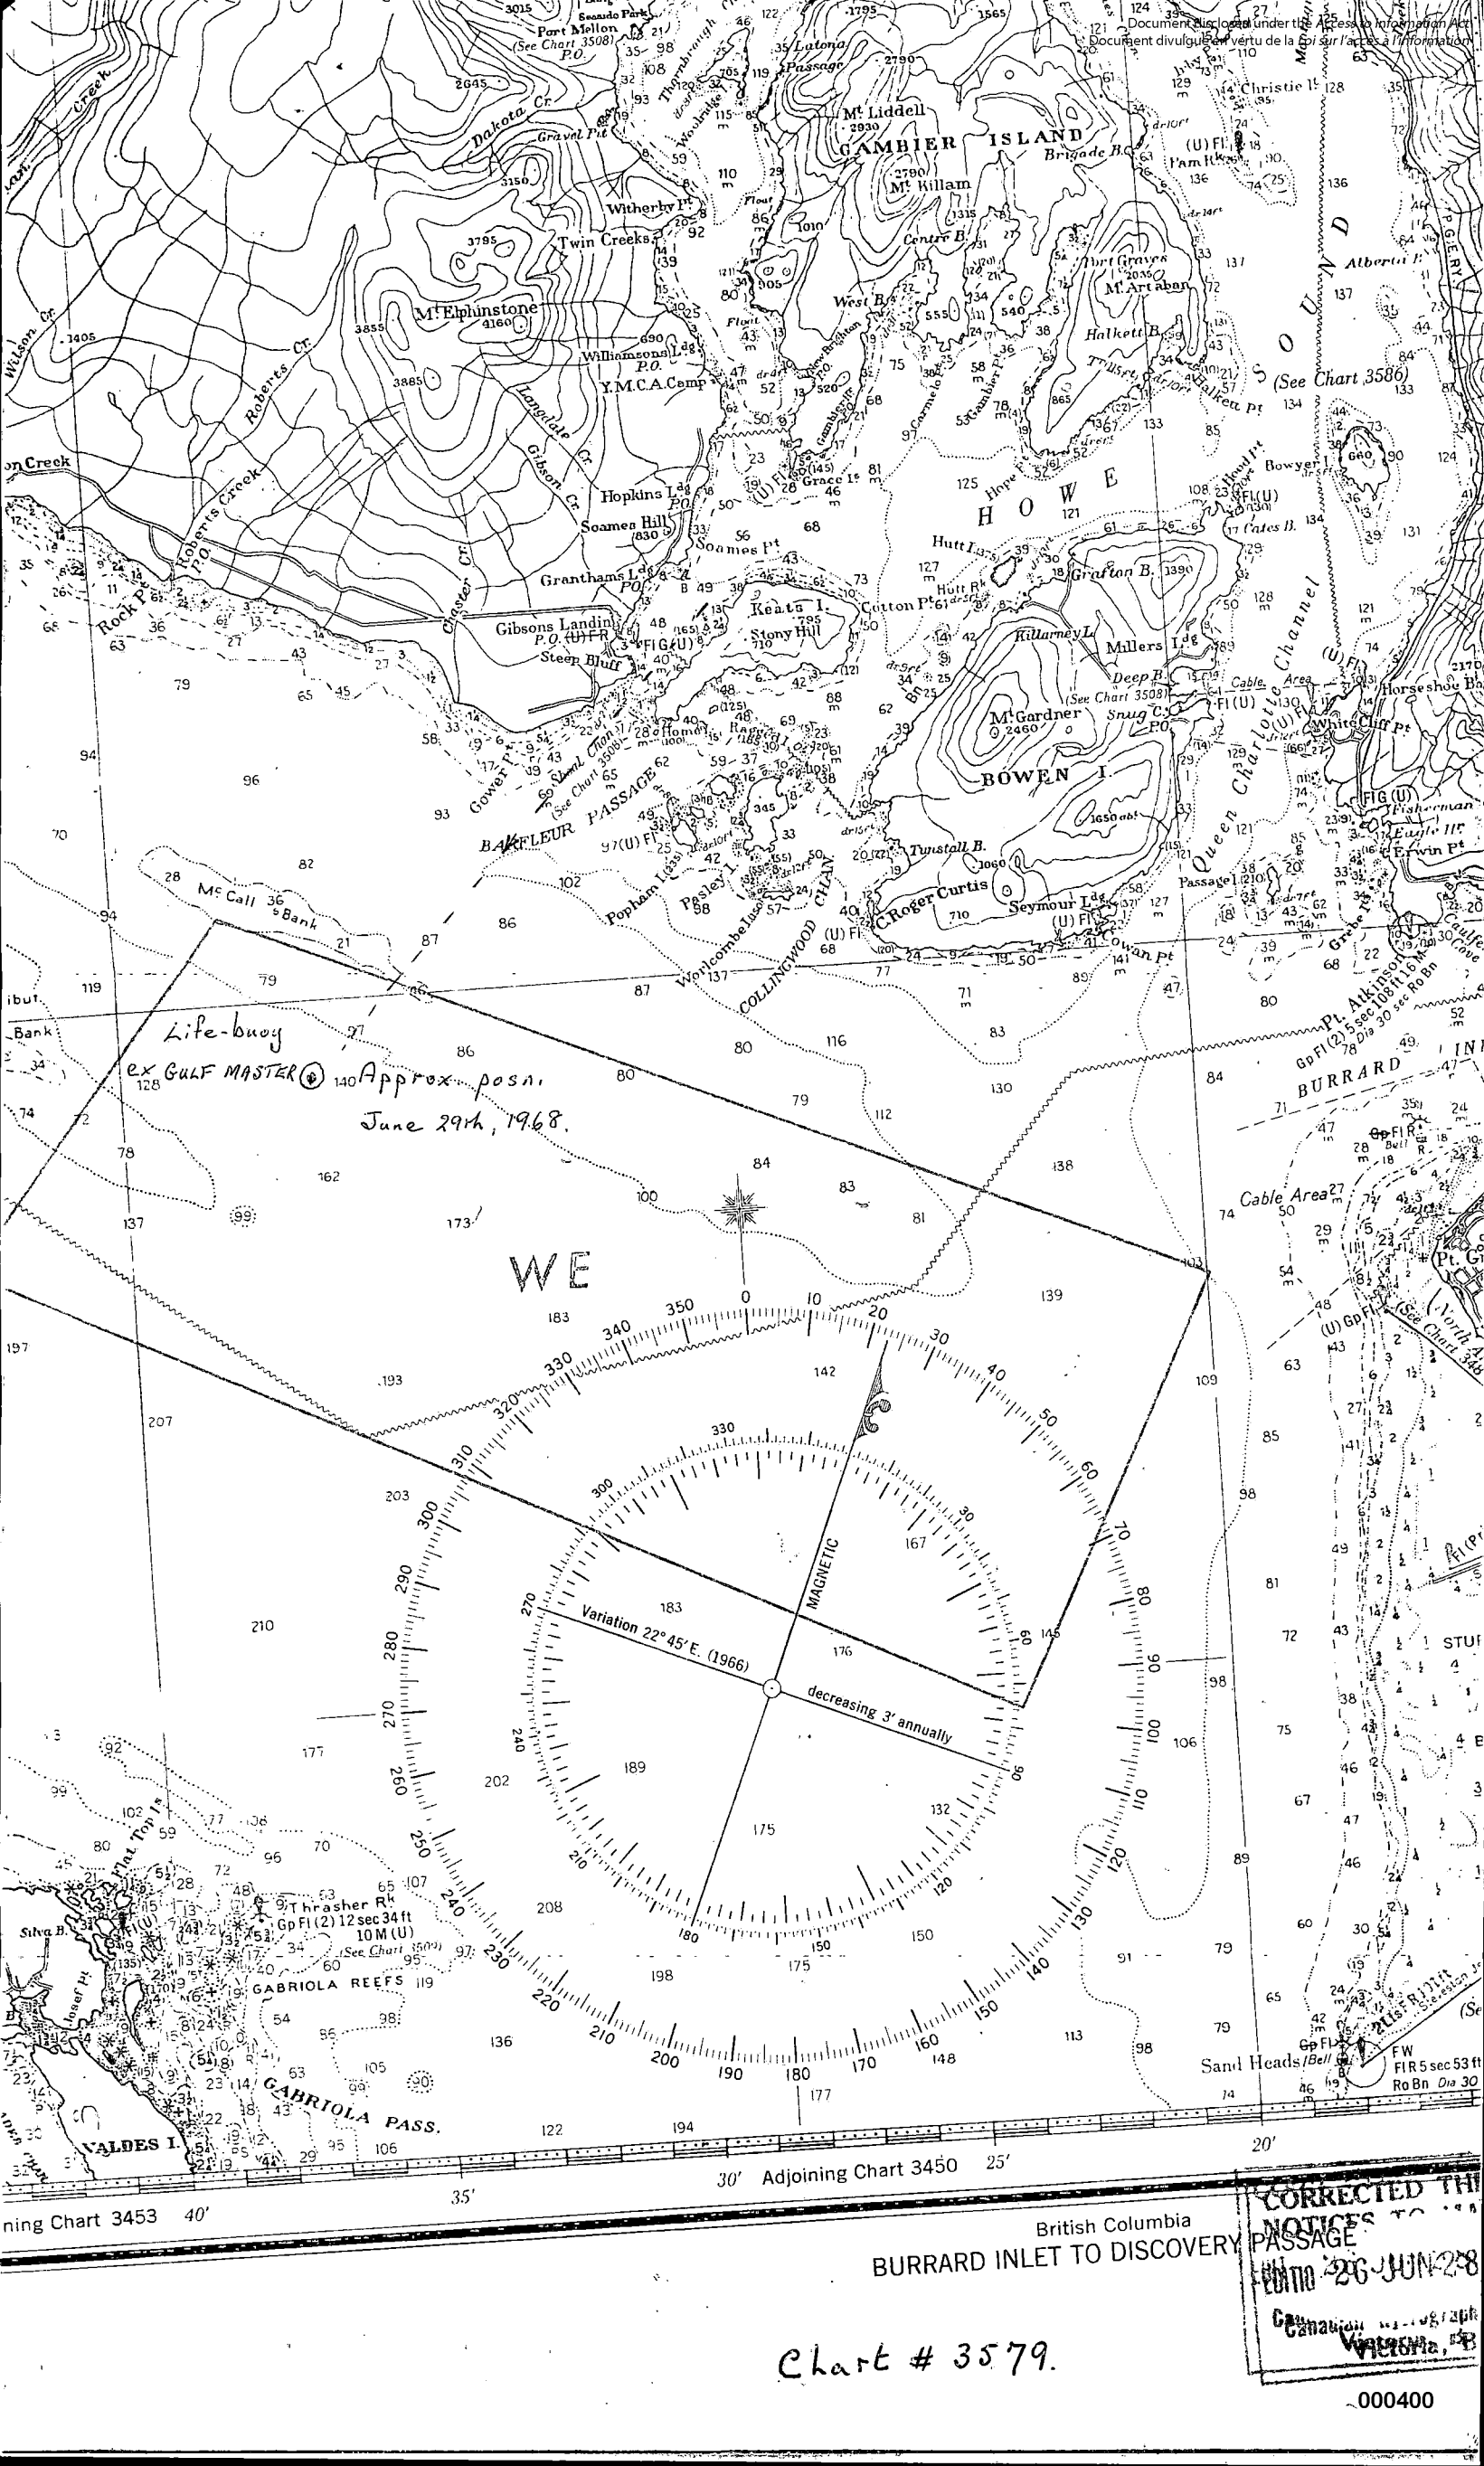
Life-buoy
ex GULF MASTER 140 Approx. posn.
June 29th, 1968.

The brown markings may have been caused by smoke but at that time it was thought more likely to be oil stains.

The buoy was covered with brown stains interlaced with indentations and scored in one or two places. On the reverse side there was a rust ring where the buoy may have been laying against the vessel. The brown stains and indentations were not so pronounced on the reverse side.

Showing rust markings and approval stamp.

Buoy covered with brown stains with small indentations between. (Similar to etchings)

A line was attached when found tangled up in the centre with approx. 6 ft. free end. Eye was still kinked from toggle.

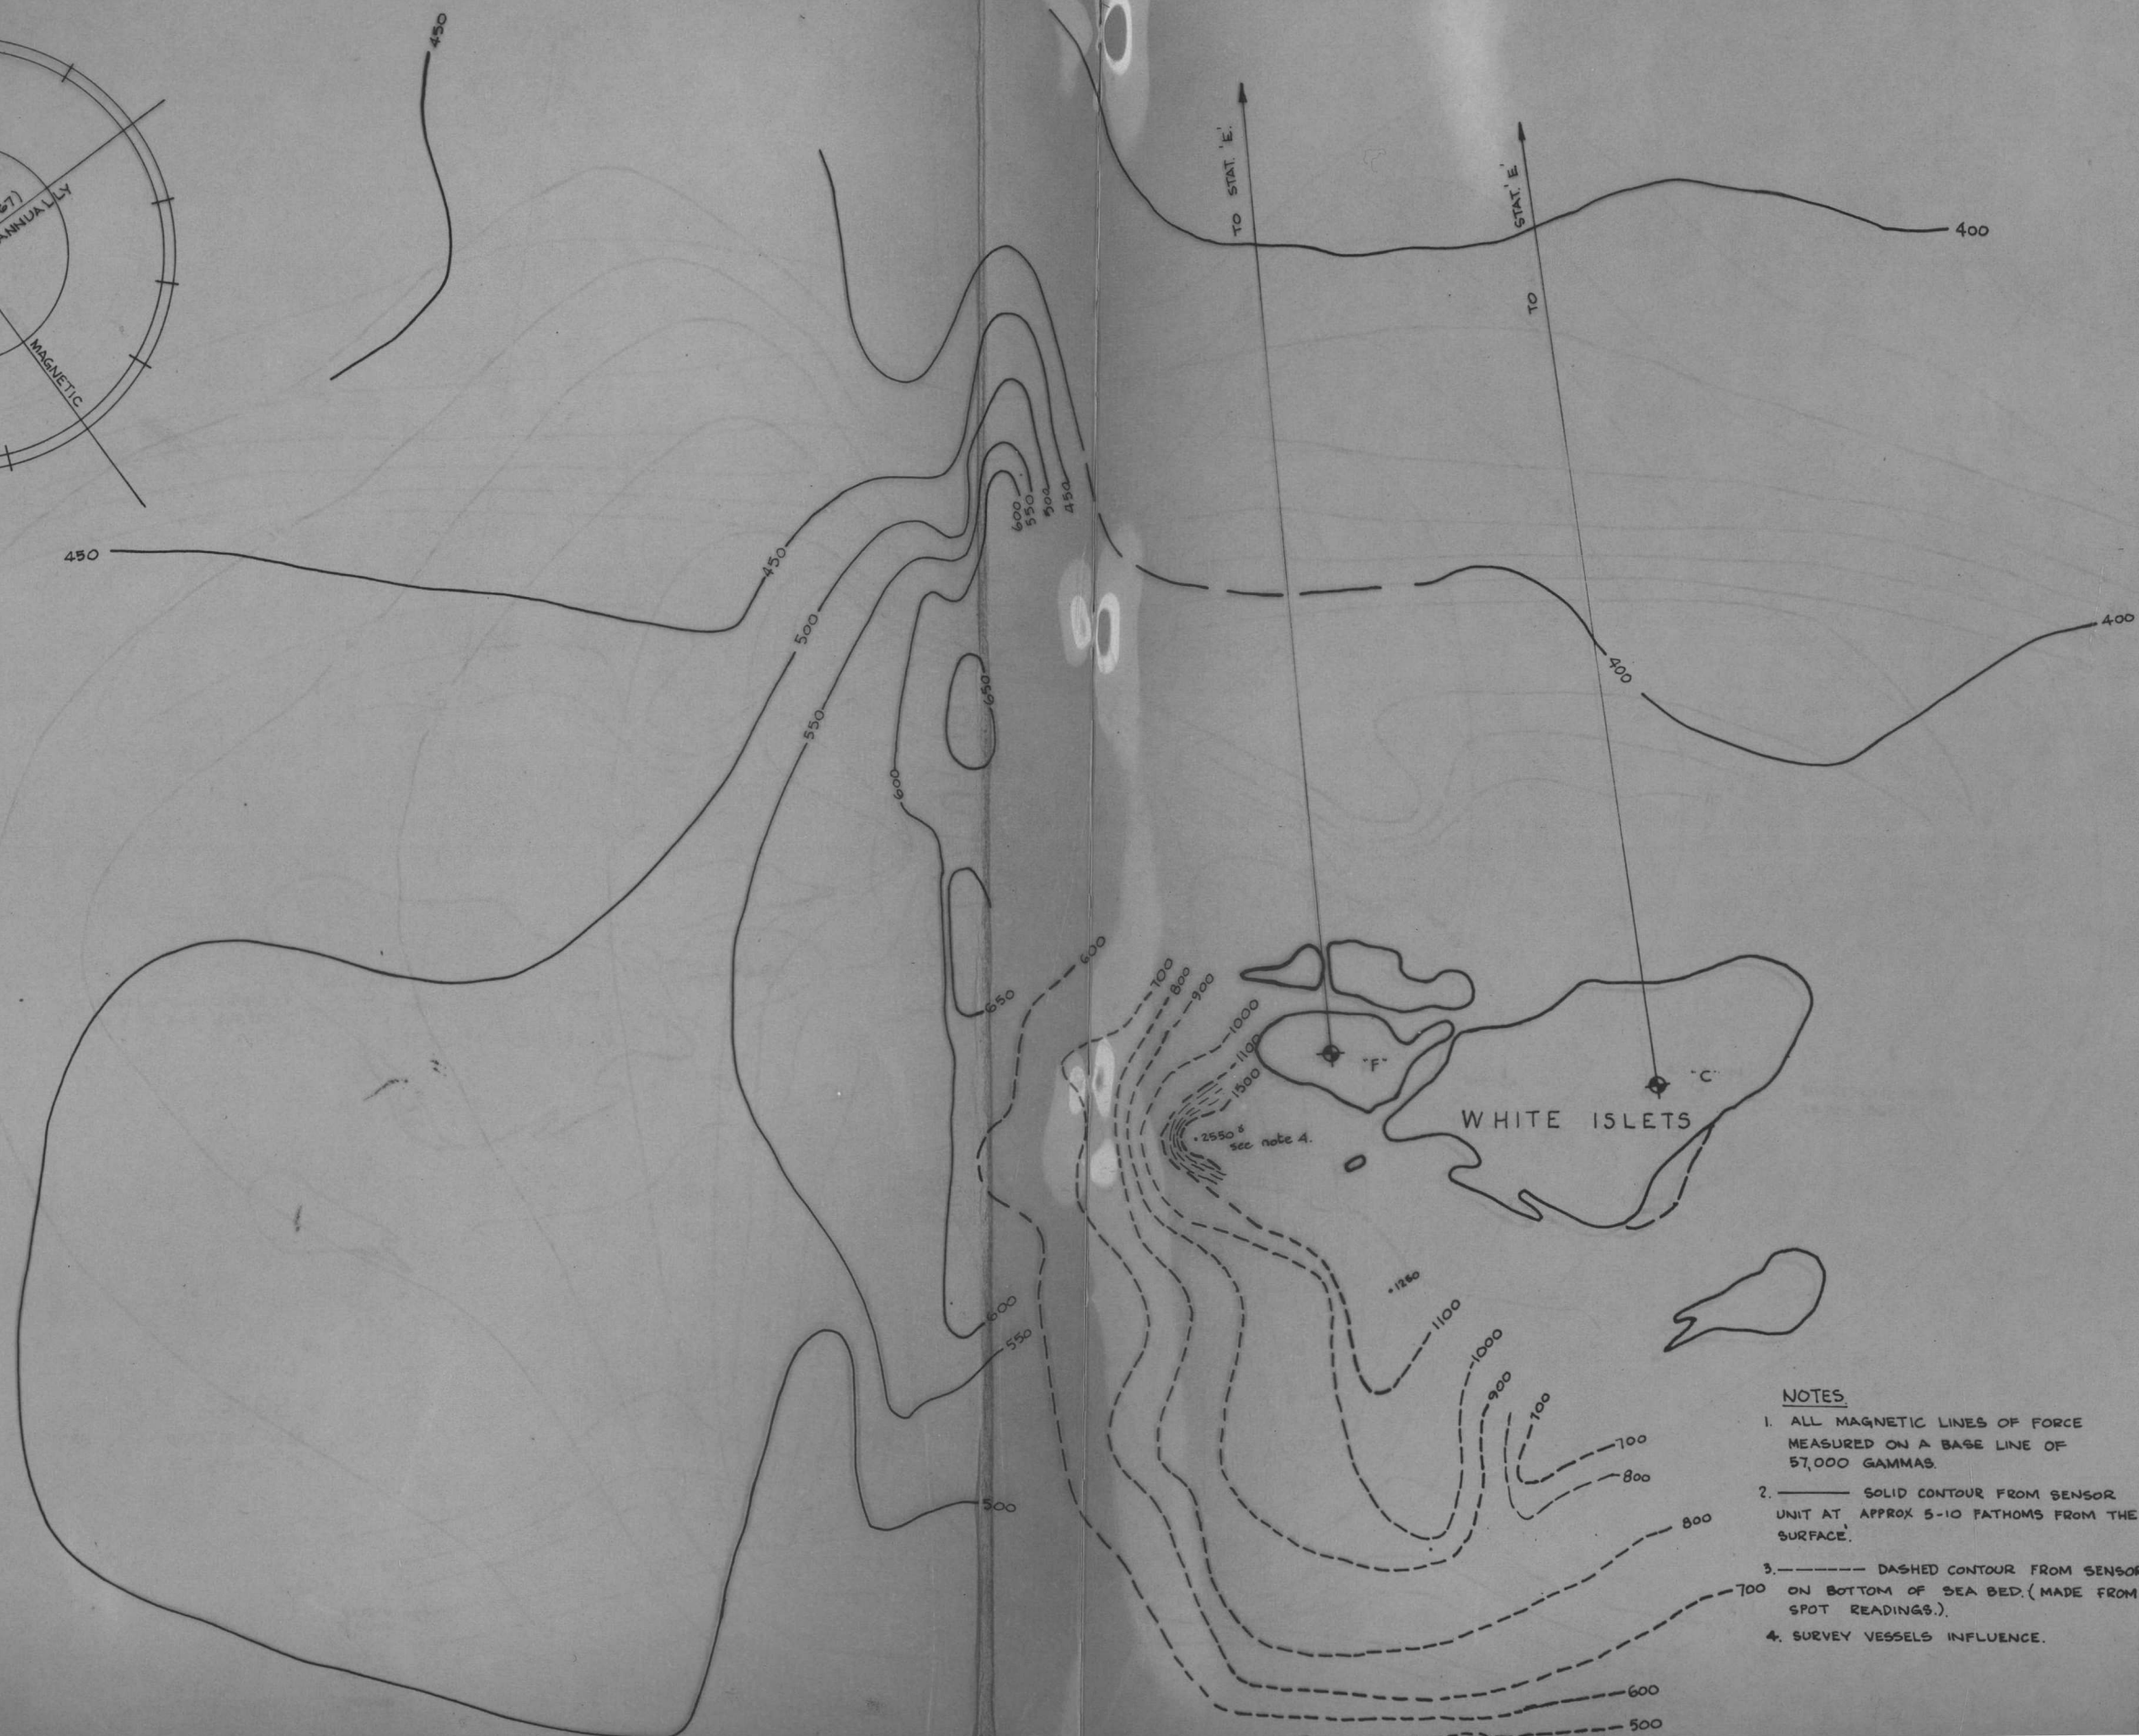
1. ALL MAGNETIC LINES OF FORCE MEASURED ON A BASE LINE OF 57,000 GAMMAS.
2. ——— SOLID CONTOUR FROM SENSOR UNIT AT APPROX 5-10 FATHOMS FROM THE SURFACE.
3. - - - - DASHED CONTOUR FROM SENSOR ON BOTTOM OF SEA BED. (MADE FROM SPOT READINGS.)
4. SURVEY VESSELS INFLUENCE.

TRITON ENGINEERING AND CONSTRUCTION LTD. VANCOUVER 4, B.C.	
CANADIAN DIVING SERVICES LTD.	
Gulf Master Search.	
AREA "A" - WHITE ISLETS. MAGNETIC LINES OF FORCE	
CERTIFIED FOR CONSTRUCTION	
T.E.C. PROJ. ENG.	
CODE No.	DRH OR 1 BIRCH. 27 3 68

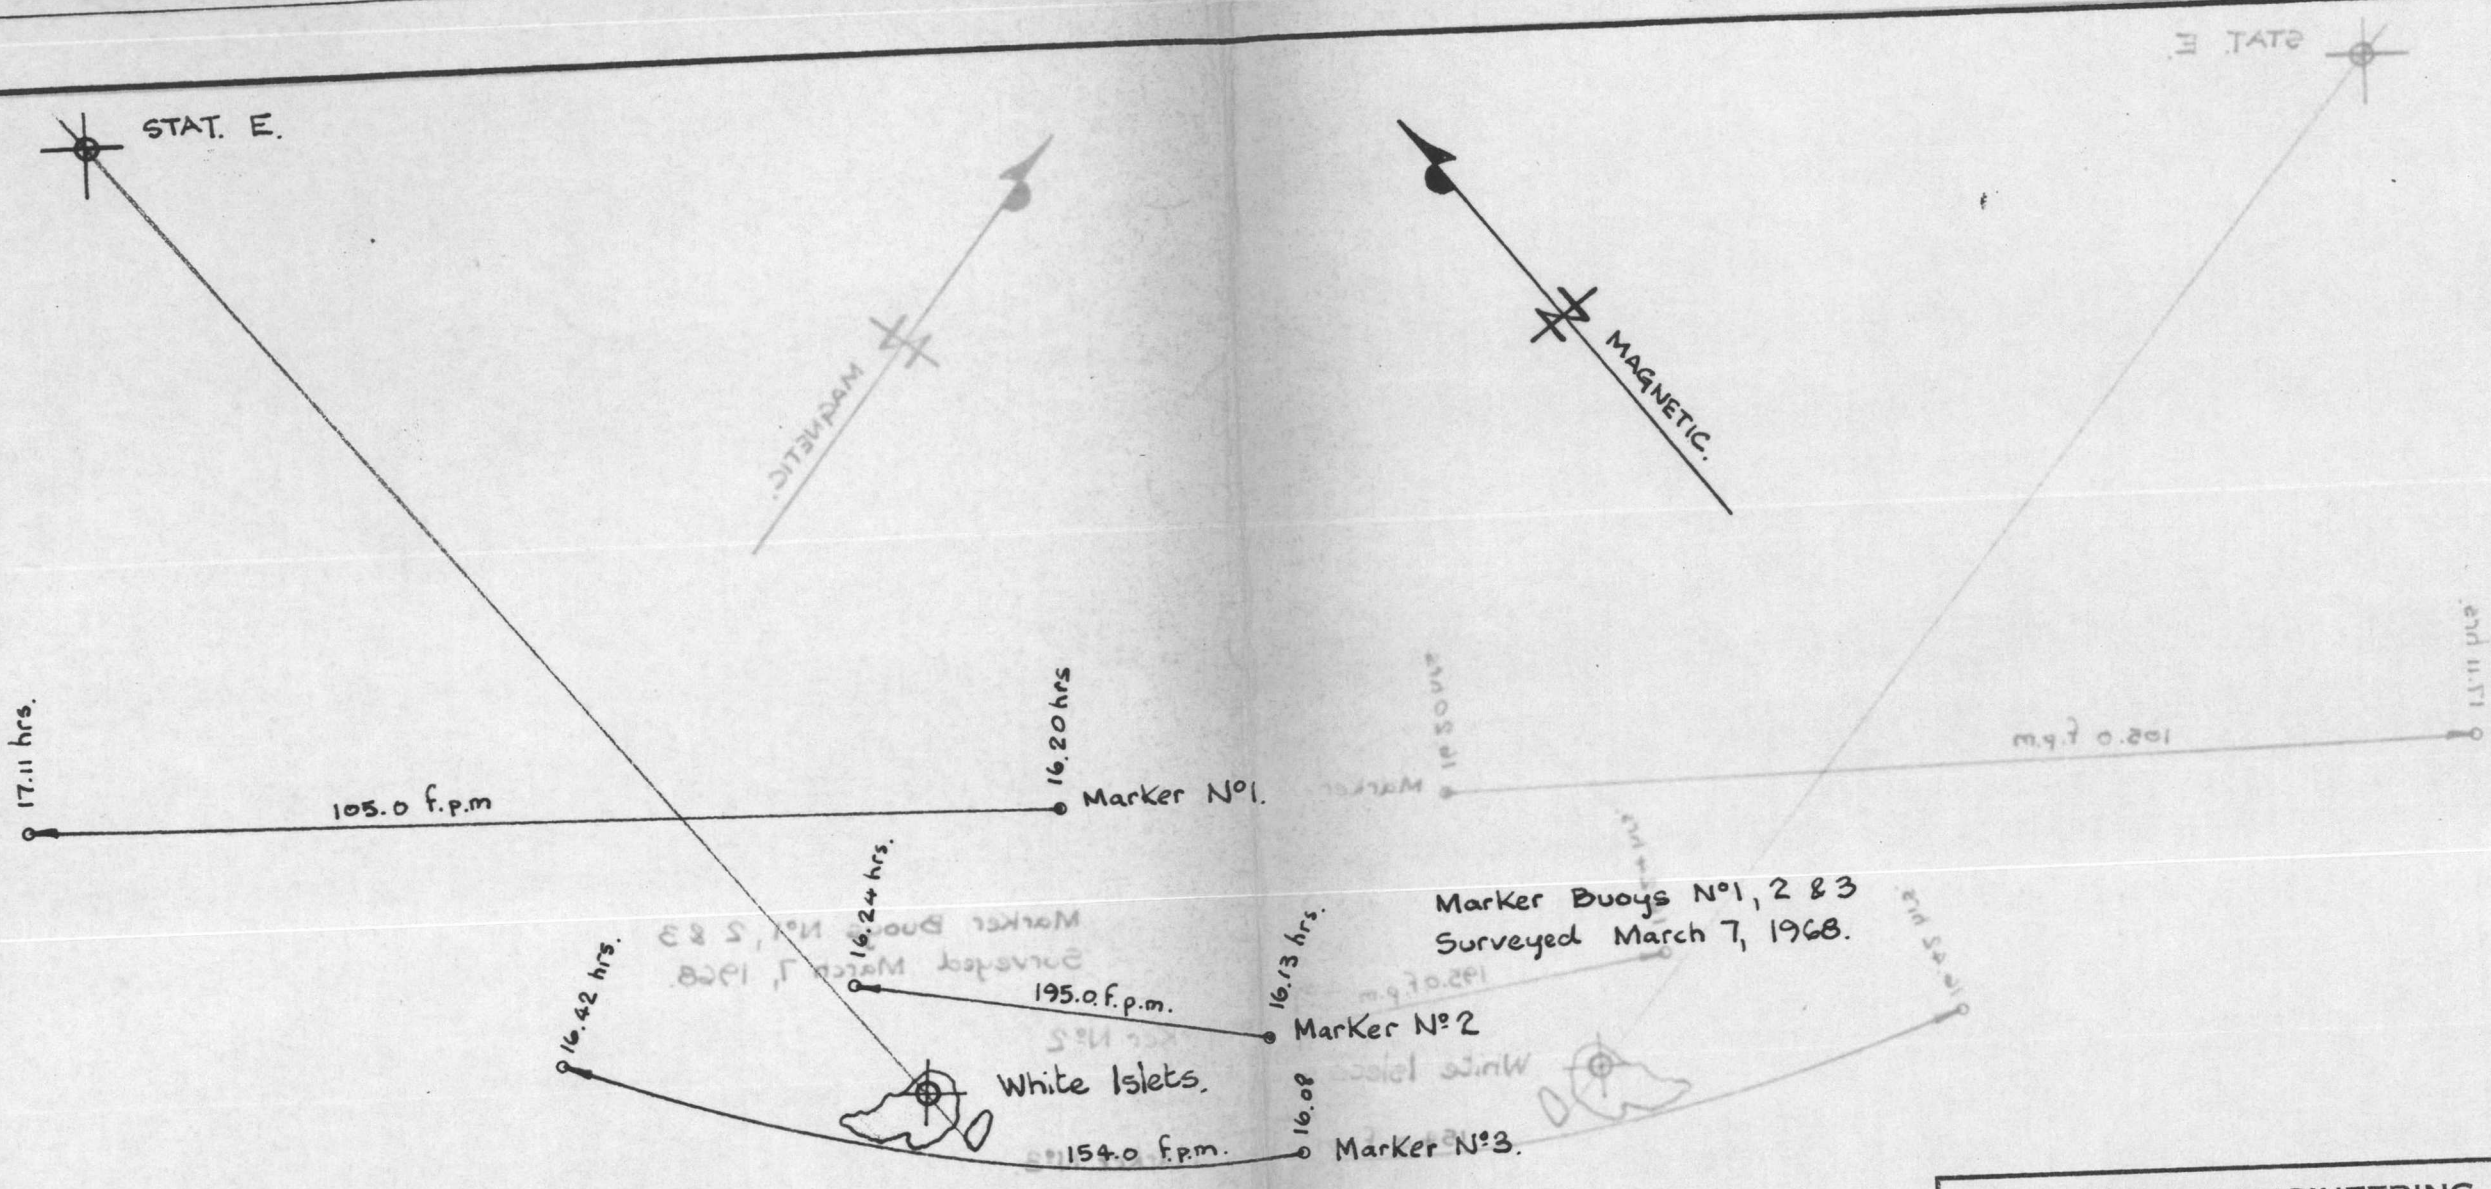
Marker Buoys No. 1, 2 & 3
Surveyed March 7, 1968.

No. 5 - Scotchman with large Sea Anchor attached. At 15.54 hrs. 1 pt diesel fuel poured out. Oil slick produced = 40' x 20' in center was Scotchman. At 16.34 hrs in 84 fathoms the Oil slick was 52 feet down current from buoy.

Marker Buoys No. 4 & No. 5
Surveyed March 9, 1968.

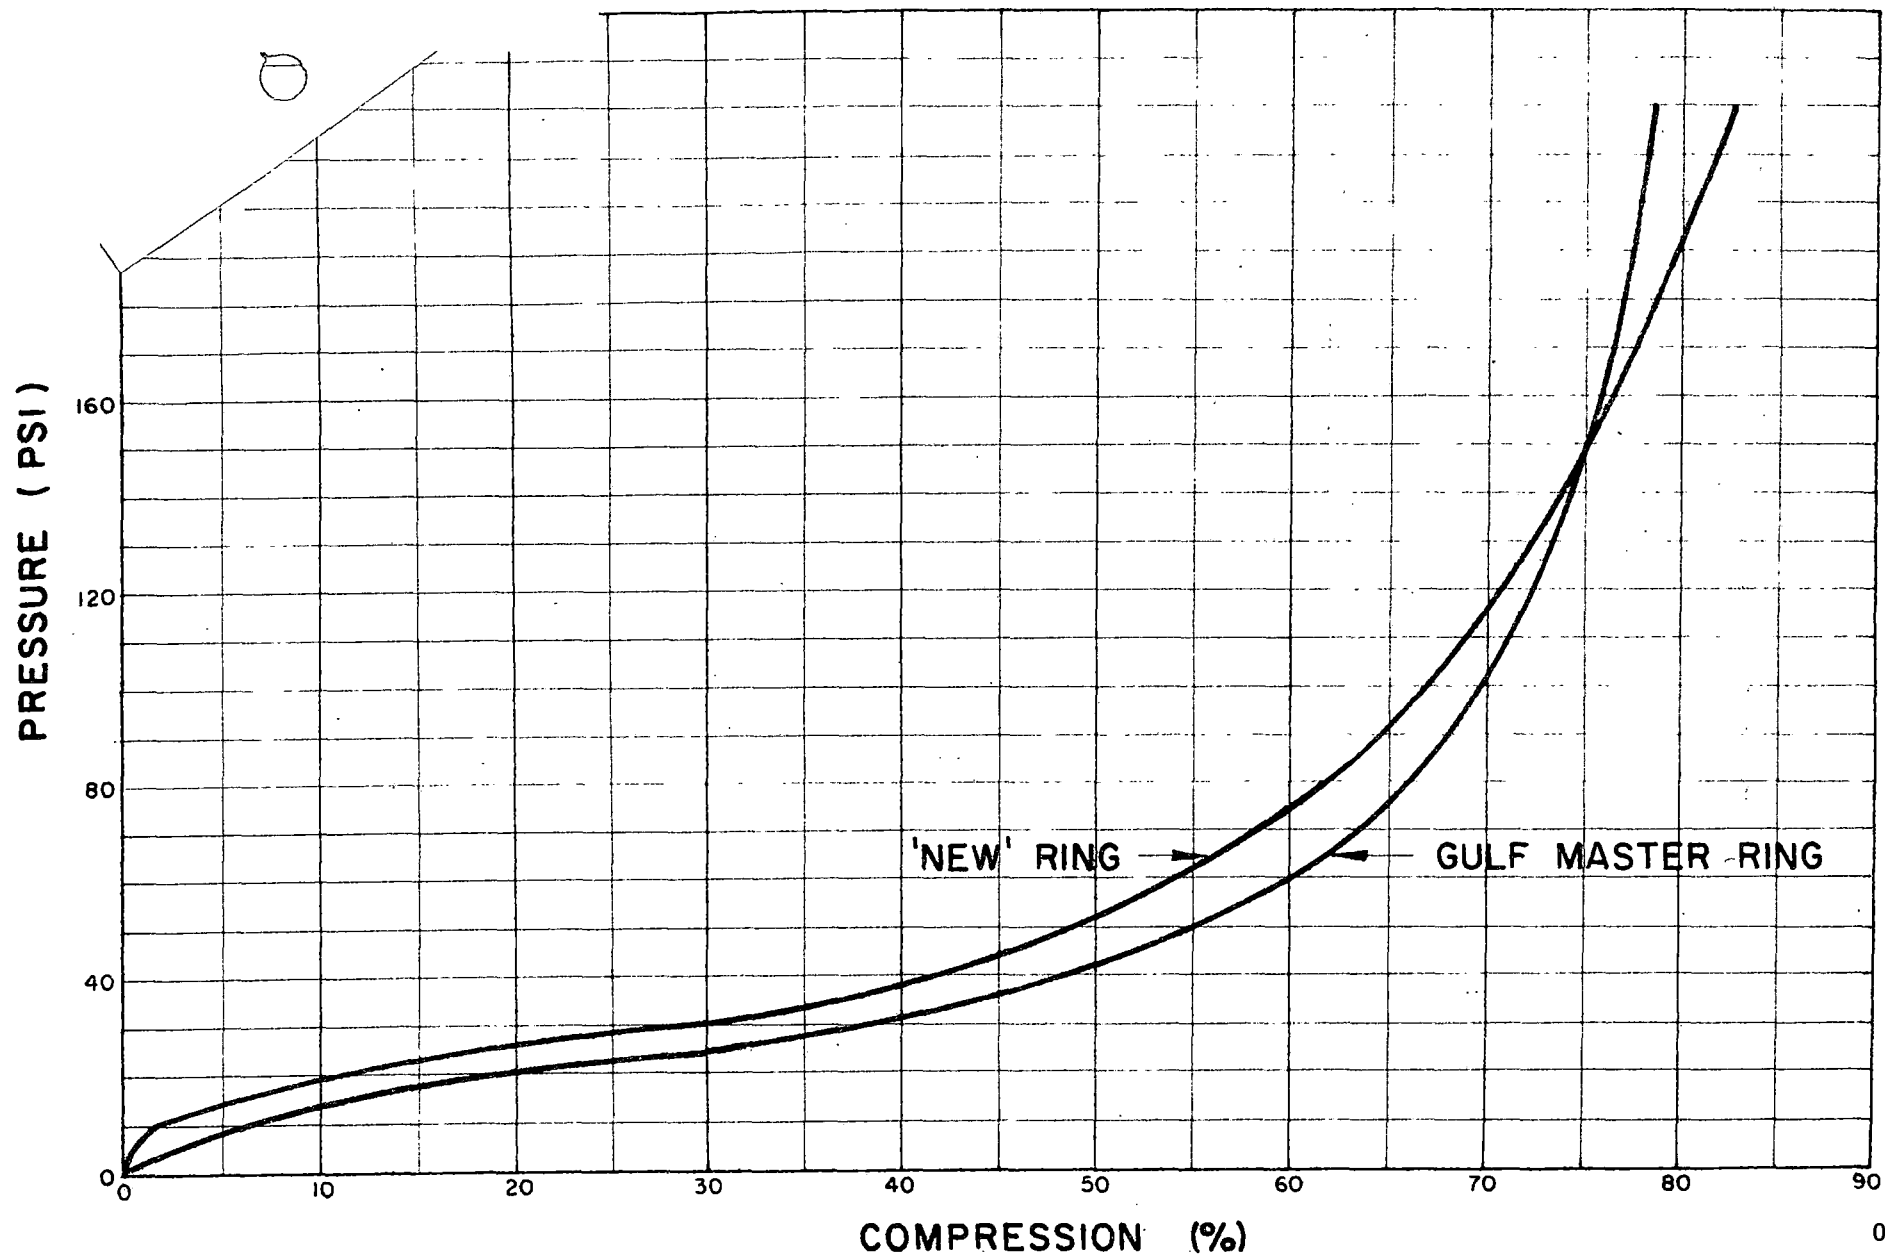
COMPRESSION TO PRESSURE IN LIFE RING FOAMS

2" X 2" Blocks in Triaxial Compression Machine)

All the test results lead toward the conclusion that the condition in which the life ring from the S.S. Gulf Master was received was due to fairly extended immersion in a considerable depth of water. The points to be considered are: the brown surface stain, the alligatoring and cracking of the paint film, and the shrinkage of the foam. The analysis of the stain showed that it did not result from fire or oil damage and water staining appeared to be the only likely cause. The other effects could not be duplicated on a new ring by heat or weathering but were approached quite closely through application of pressure.

It is not possible to estimate either the depth or time involved with any degree of precision. Our tests indicate that the pressure could not have been much less than 100 p.s.i. (approximately 200 ft. of water) but, on the other hand, it could have been almost any amount greater than this. The time factor is even more doubtful though we would expect that a heavy water stain would require at least several months to develop.

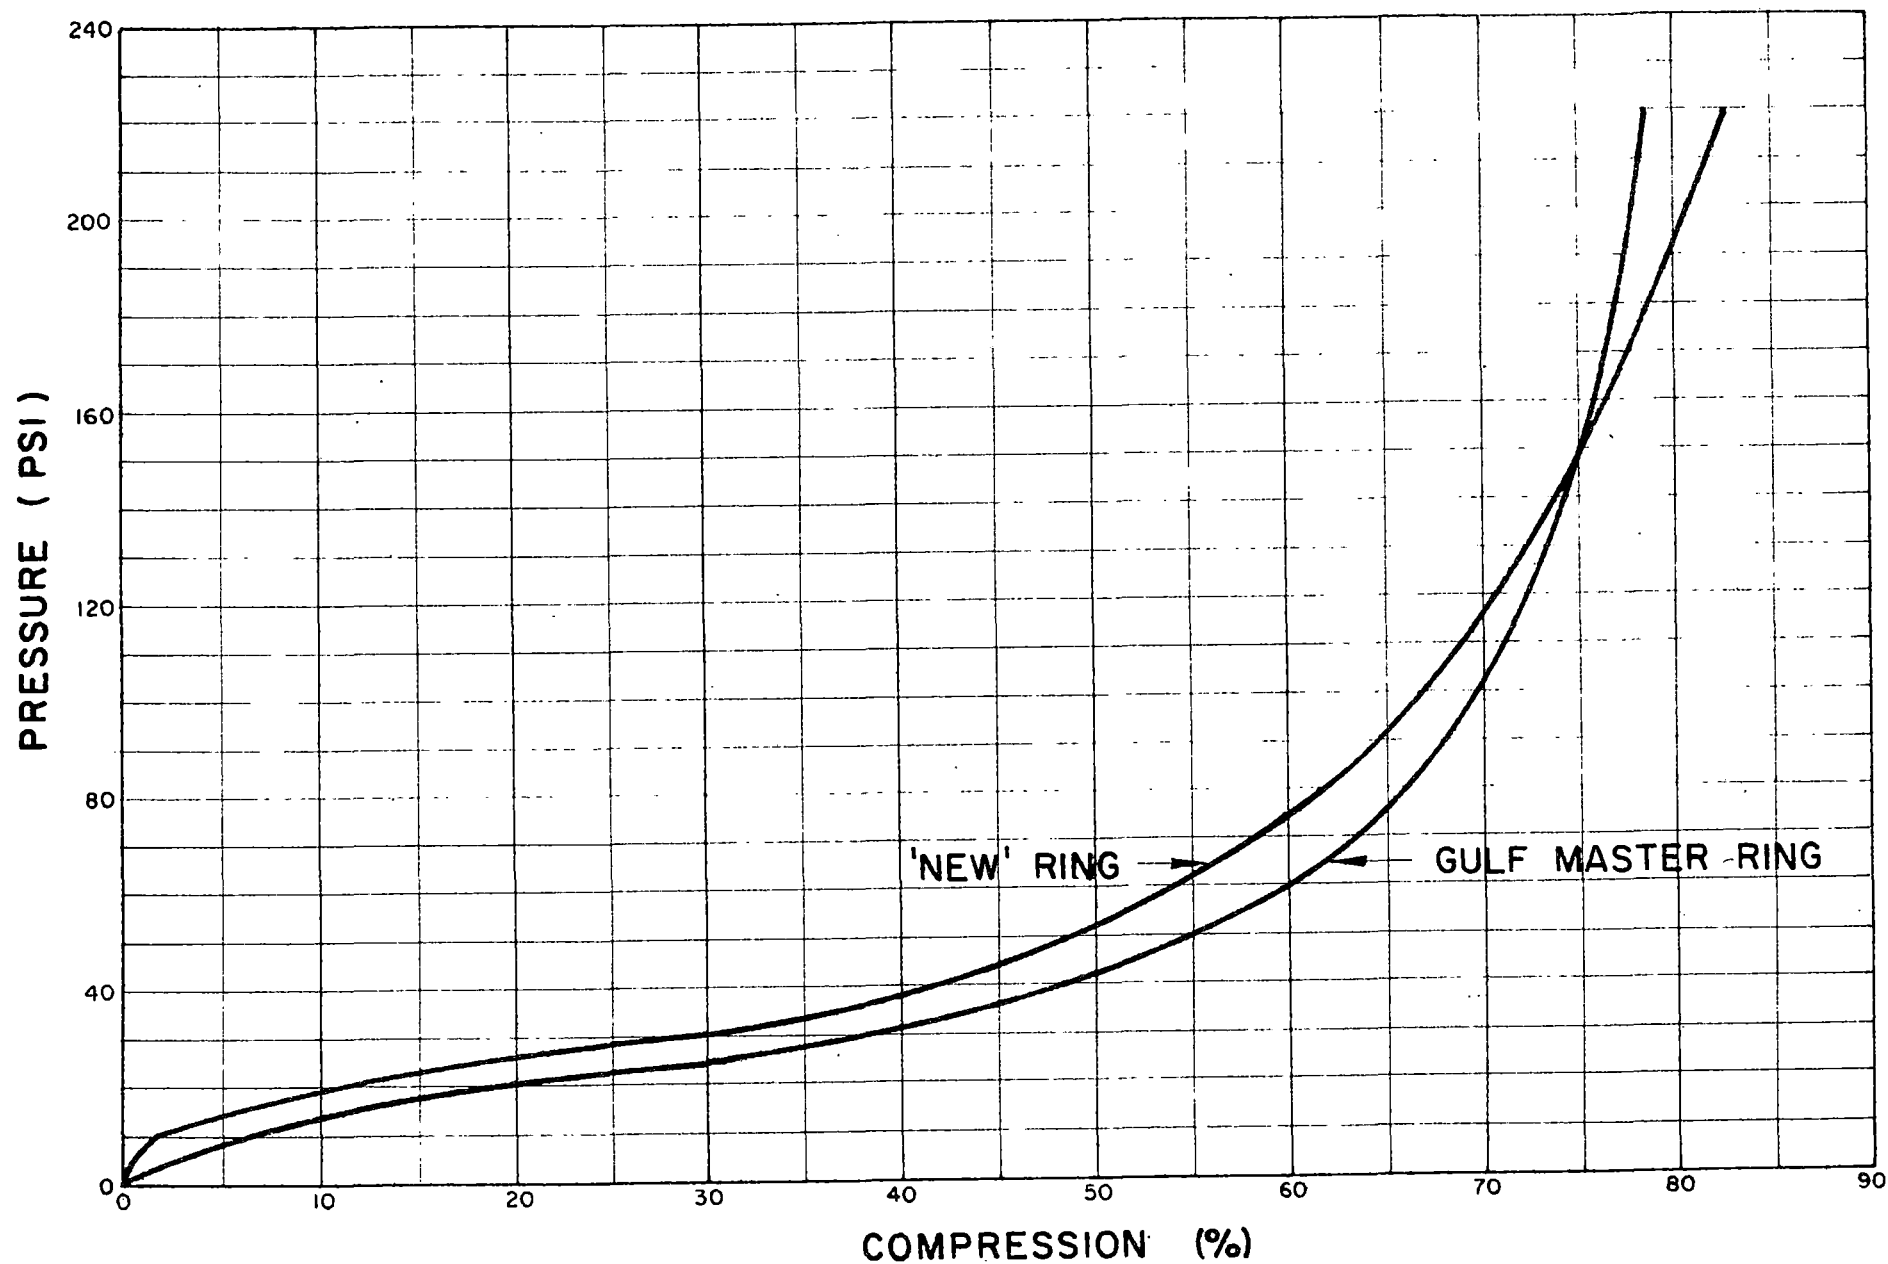
FIGURE 1

Visual examination showed the surface of the Gulf Master ring to be covered with a dark brown stain in a regular mottled pattern. The surface was alligatored and the ring showed an appreciable (approximately 10%) shrinkage as was evident from the looseness of the pins to which the rope was attached. (See Figures 1 and 3, Appendix I).

RELATIONSHIP OF COMPRESSION TO PRESSURE IN LIFE RING FOAMS
(4" X 2" X 2" Blocks in Triaxial Compression Machine)

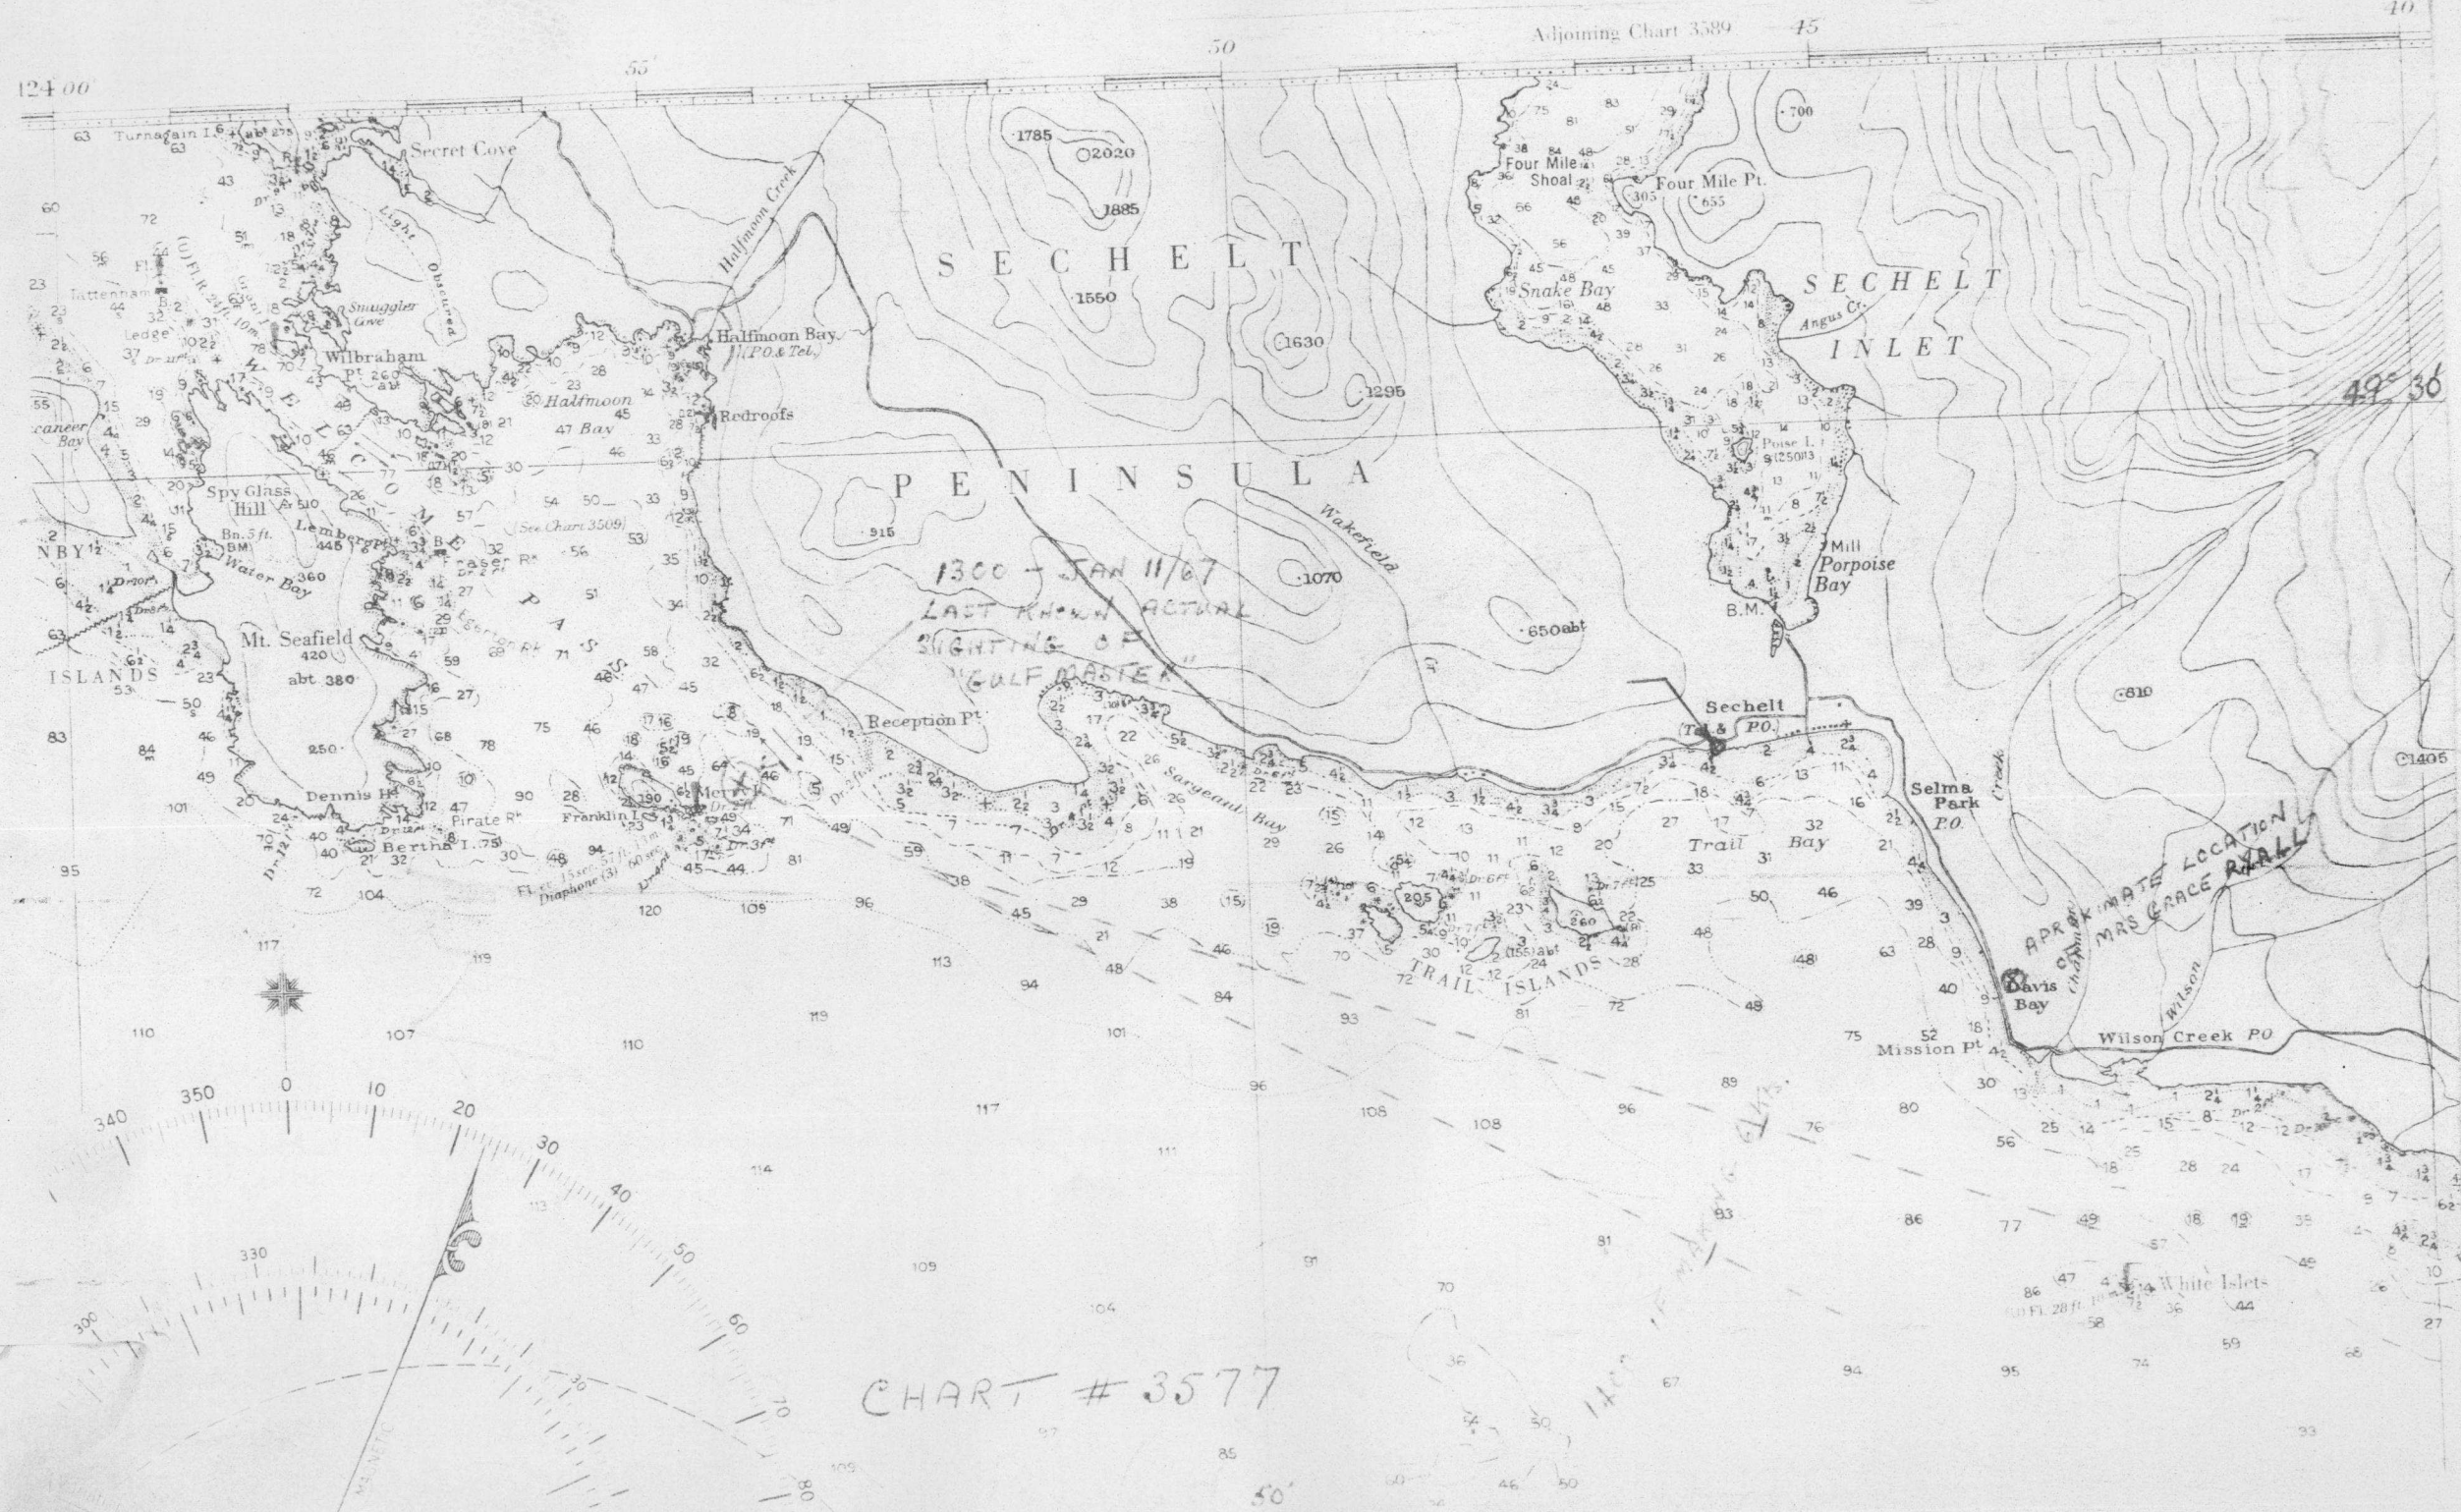
CHART #3579

"GULF MASTER"
SIGHTING OF LIFERAFT, OIL SLICK ON JANUARY 11th, 1967.
BY JOHN L. ROSS PILOT OF BEAVER
WESTERN BRIST AIRLINES

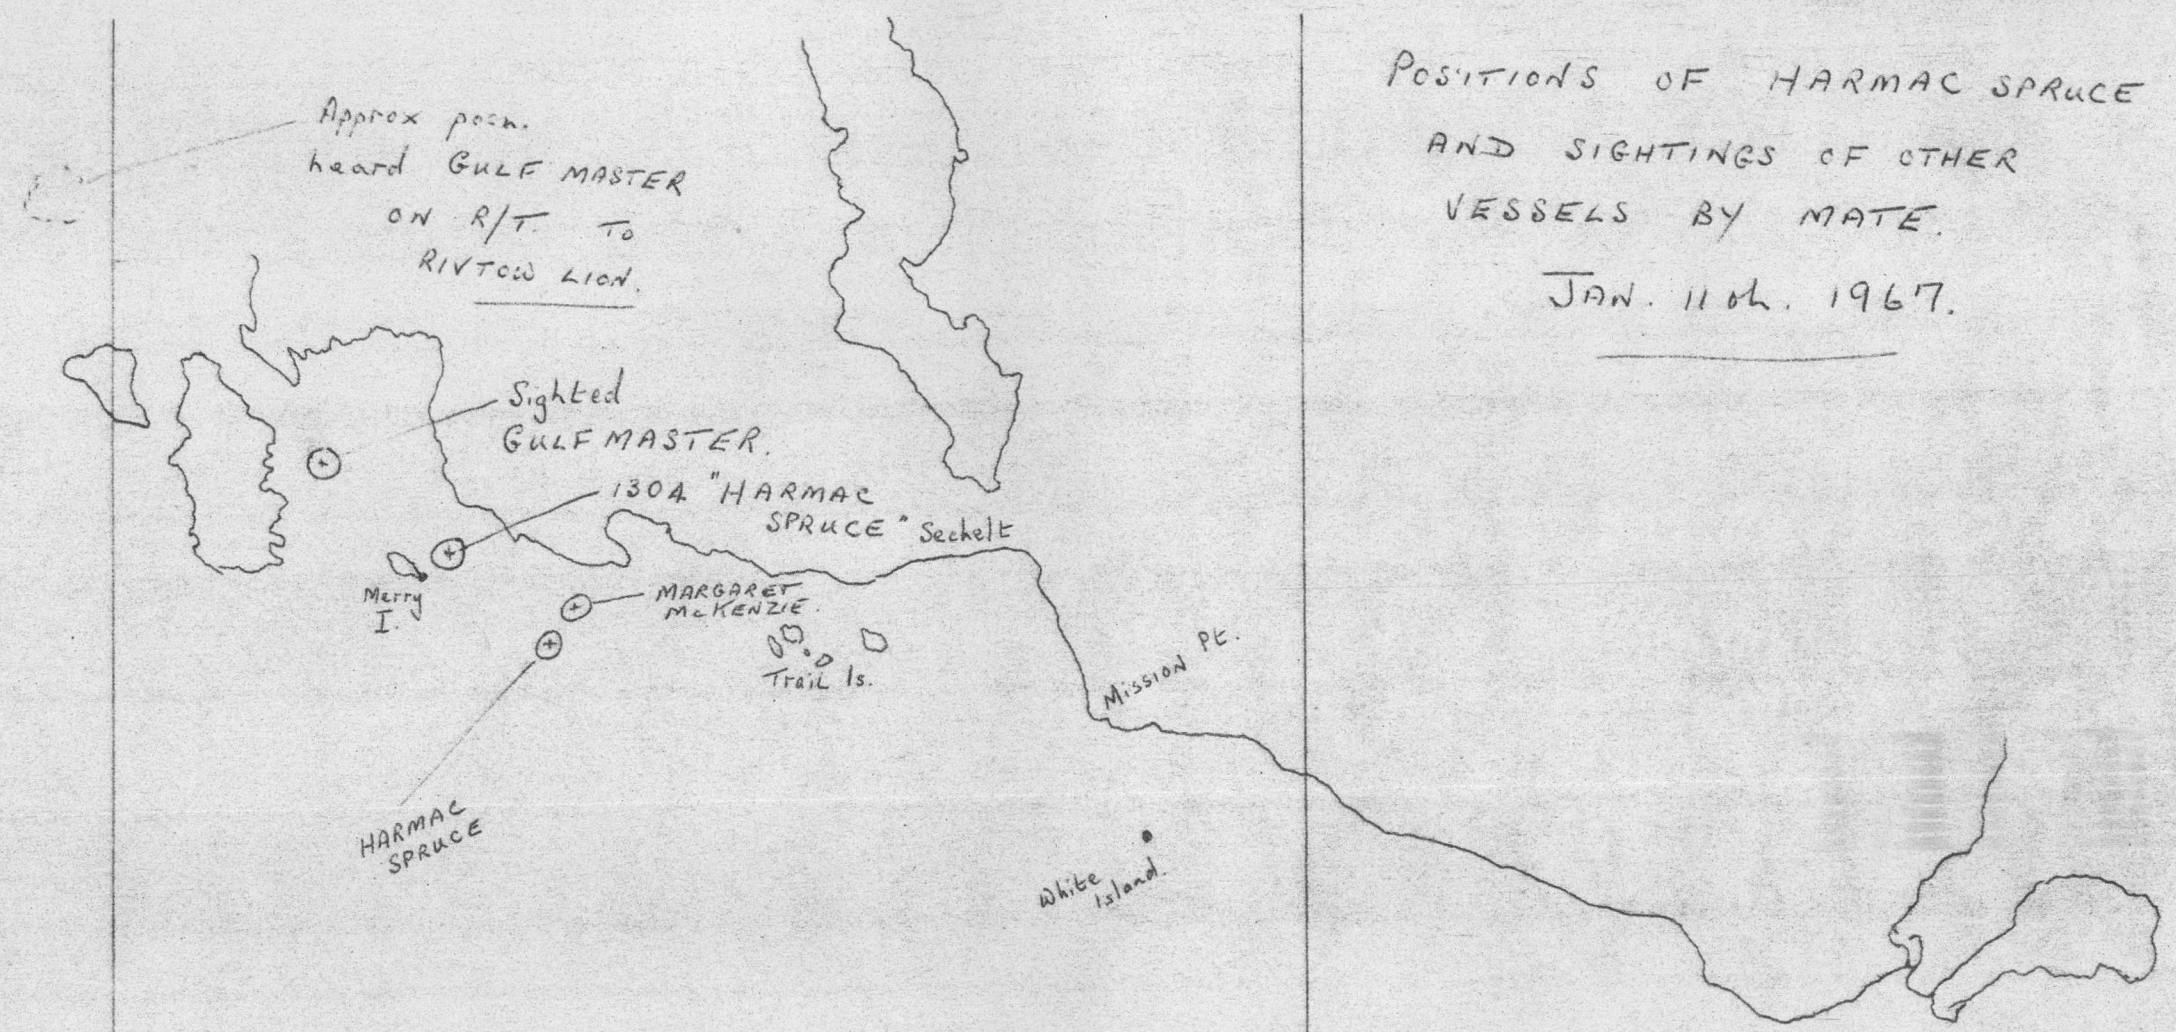
POSITIONS OF HARMAC SPRUCE
AND SIGHTINGS OF OTHER
VESSELS BY MATE.
JAN. 11th. 1967.
