DRB 105-15/0

DIRECTORATE OF CENTRAL REGISTRIES

Report of the Board of Enquiry on the
Accident at Bldg 240 on Wednesday 29th July 1959

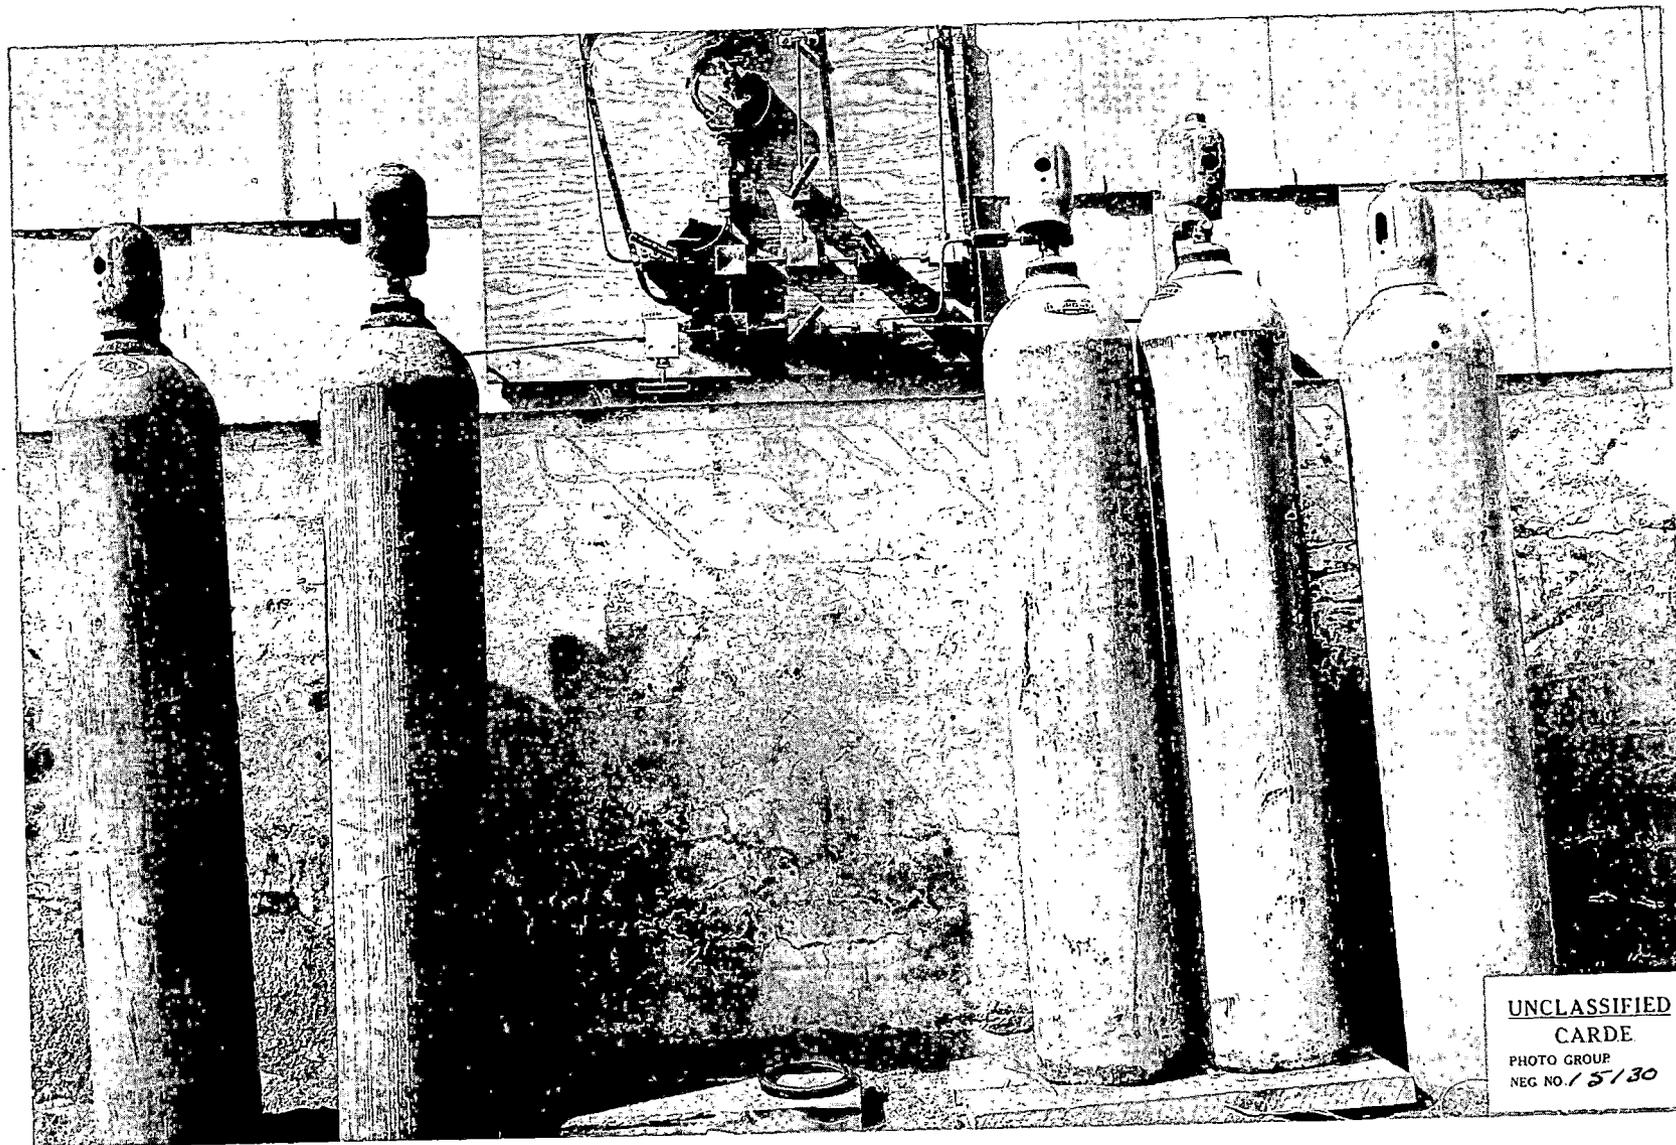
UNCLASSIFIED
CARDE
PHOTO GROUP
NEG NO. 15130

Photograph 15130, taken after the accident, shows the hydrogen and oxygen supply cylinders together with the control panel and photograph 15131 shows the control panel. Fig. 1 shows the overall layout of the range and Fig. 2 is a schematic of the principal sections of the gas gun and the control valves for the gas supply lines.

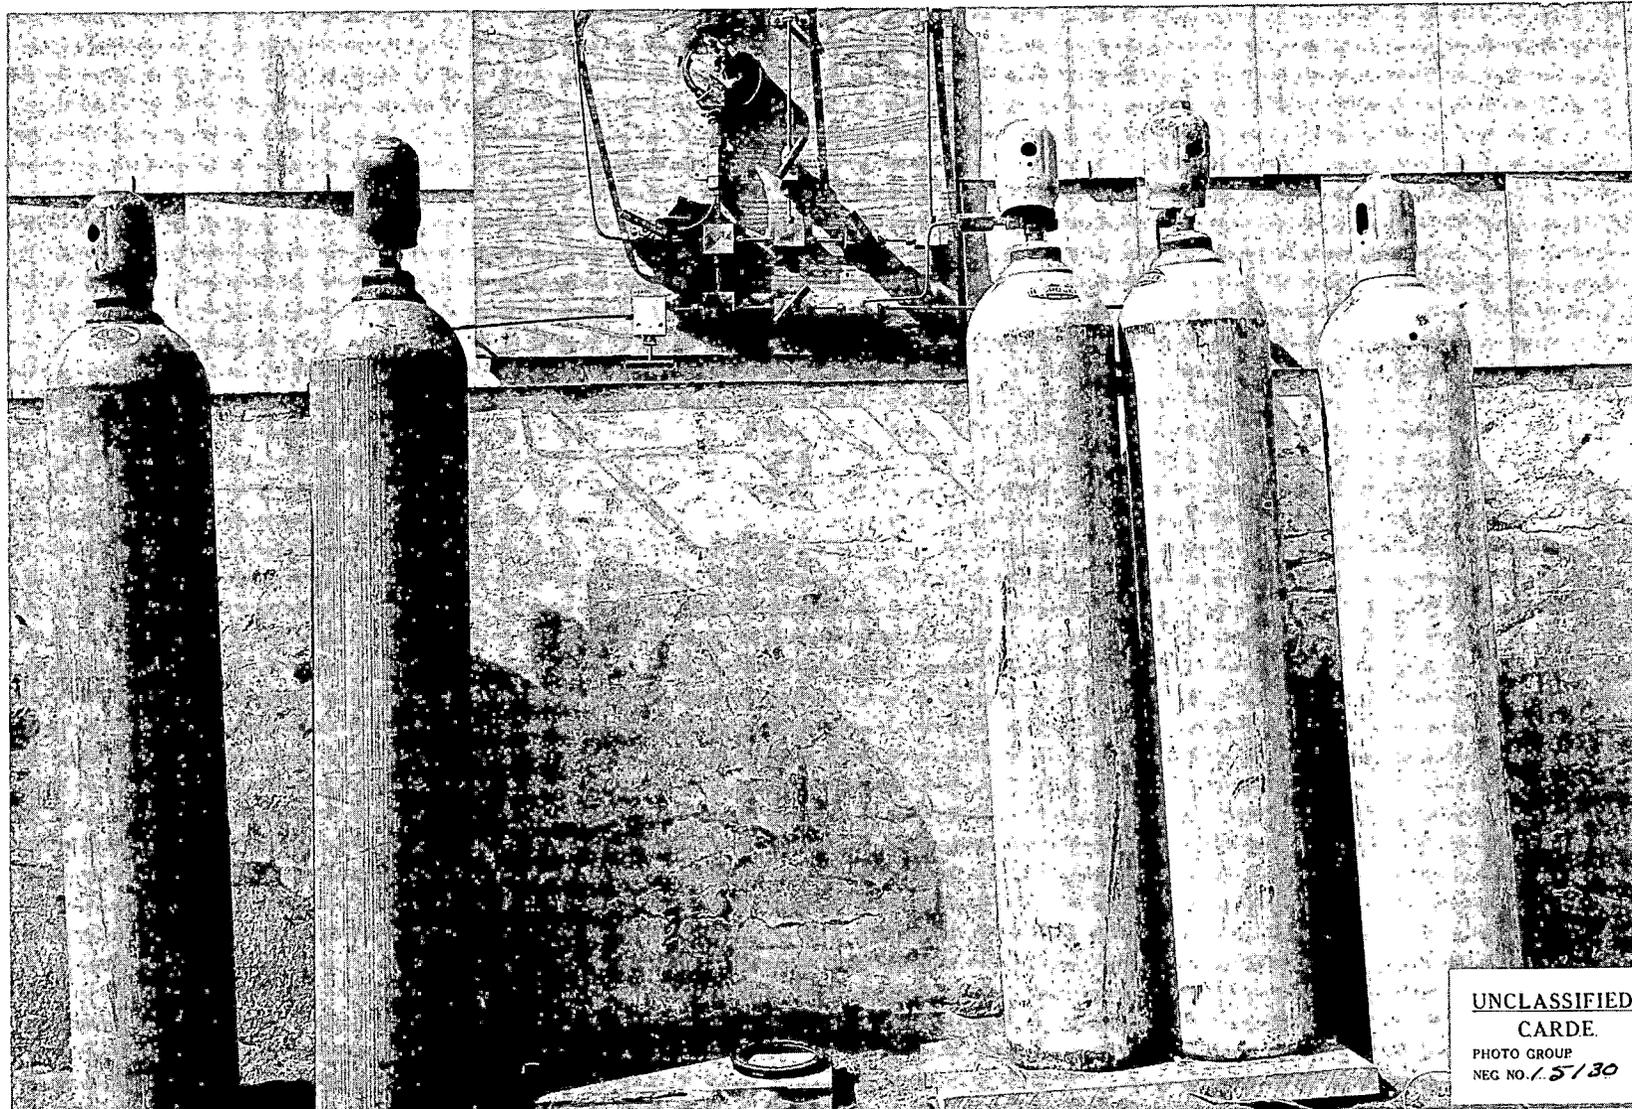
UNCLASSIFIED
CARDE.
PHOTO GROUP
NEG NO. 15130

Photograph 15130, taken after the accident, shows the hydrogen and oxygen supply cylinders together with the control panel and photograph 15131 shows the control panel. Fig. 1 shows the overall layout of the range and Fig. 2 is a schematic of the principal sections of the gas gun and the control valves for the gas supply lines.

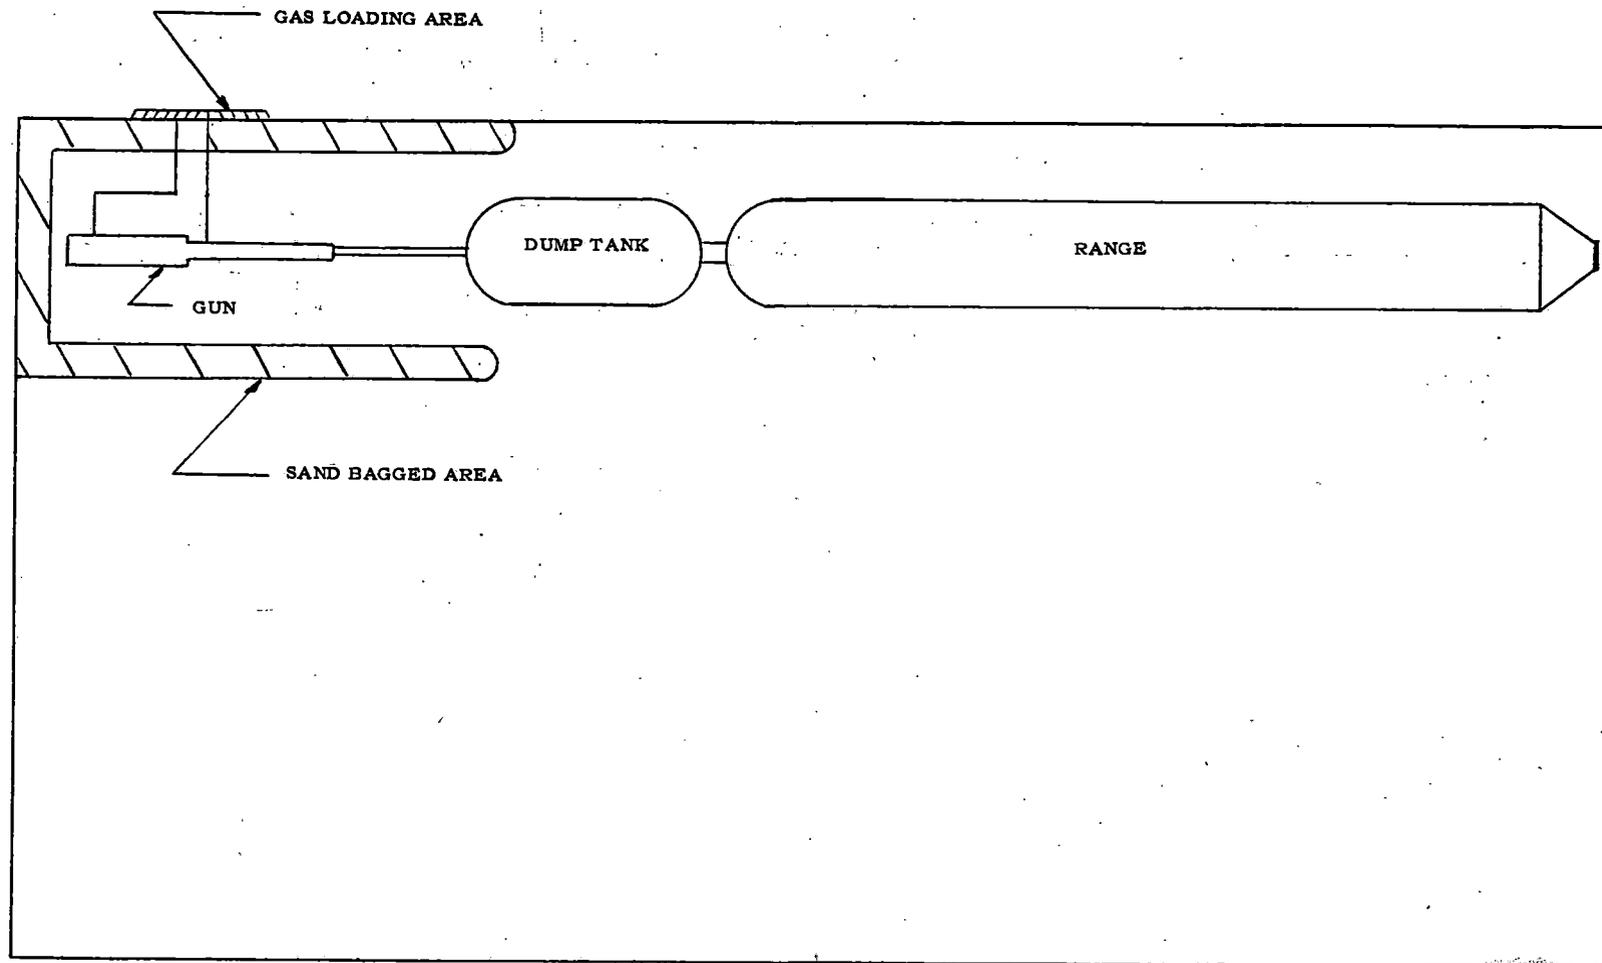
FIGURE 1

A diagrammatic representation of the gun plus gas loading system is presented in Fig. 1. The usual gas loading system is as follows. Valves B, C and D are closed and the main chamber is filled to 1,000 psi. Valve E is then closed, valve C opened and the oxygen is exhausted to the atmosphere. This flushing operation is then repeated. Again valves B, C and D are closed and the main chamber is loaded to 100 psi with oxygen. Valves A, C and E are then closed, valves B and D opened and the secondary chamber filled to 800 psi. with hydrogen. The last loading operation is then to close valve B, open valve A and load the main chamber with hydrogen to 1,000 psi.

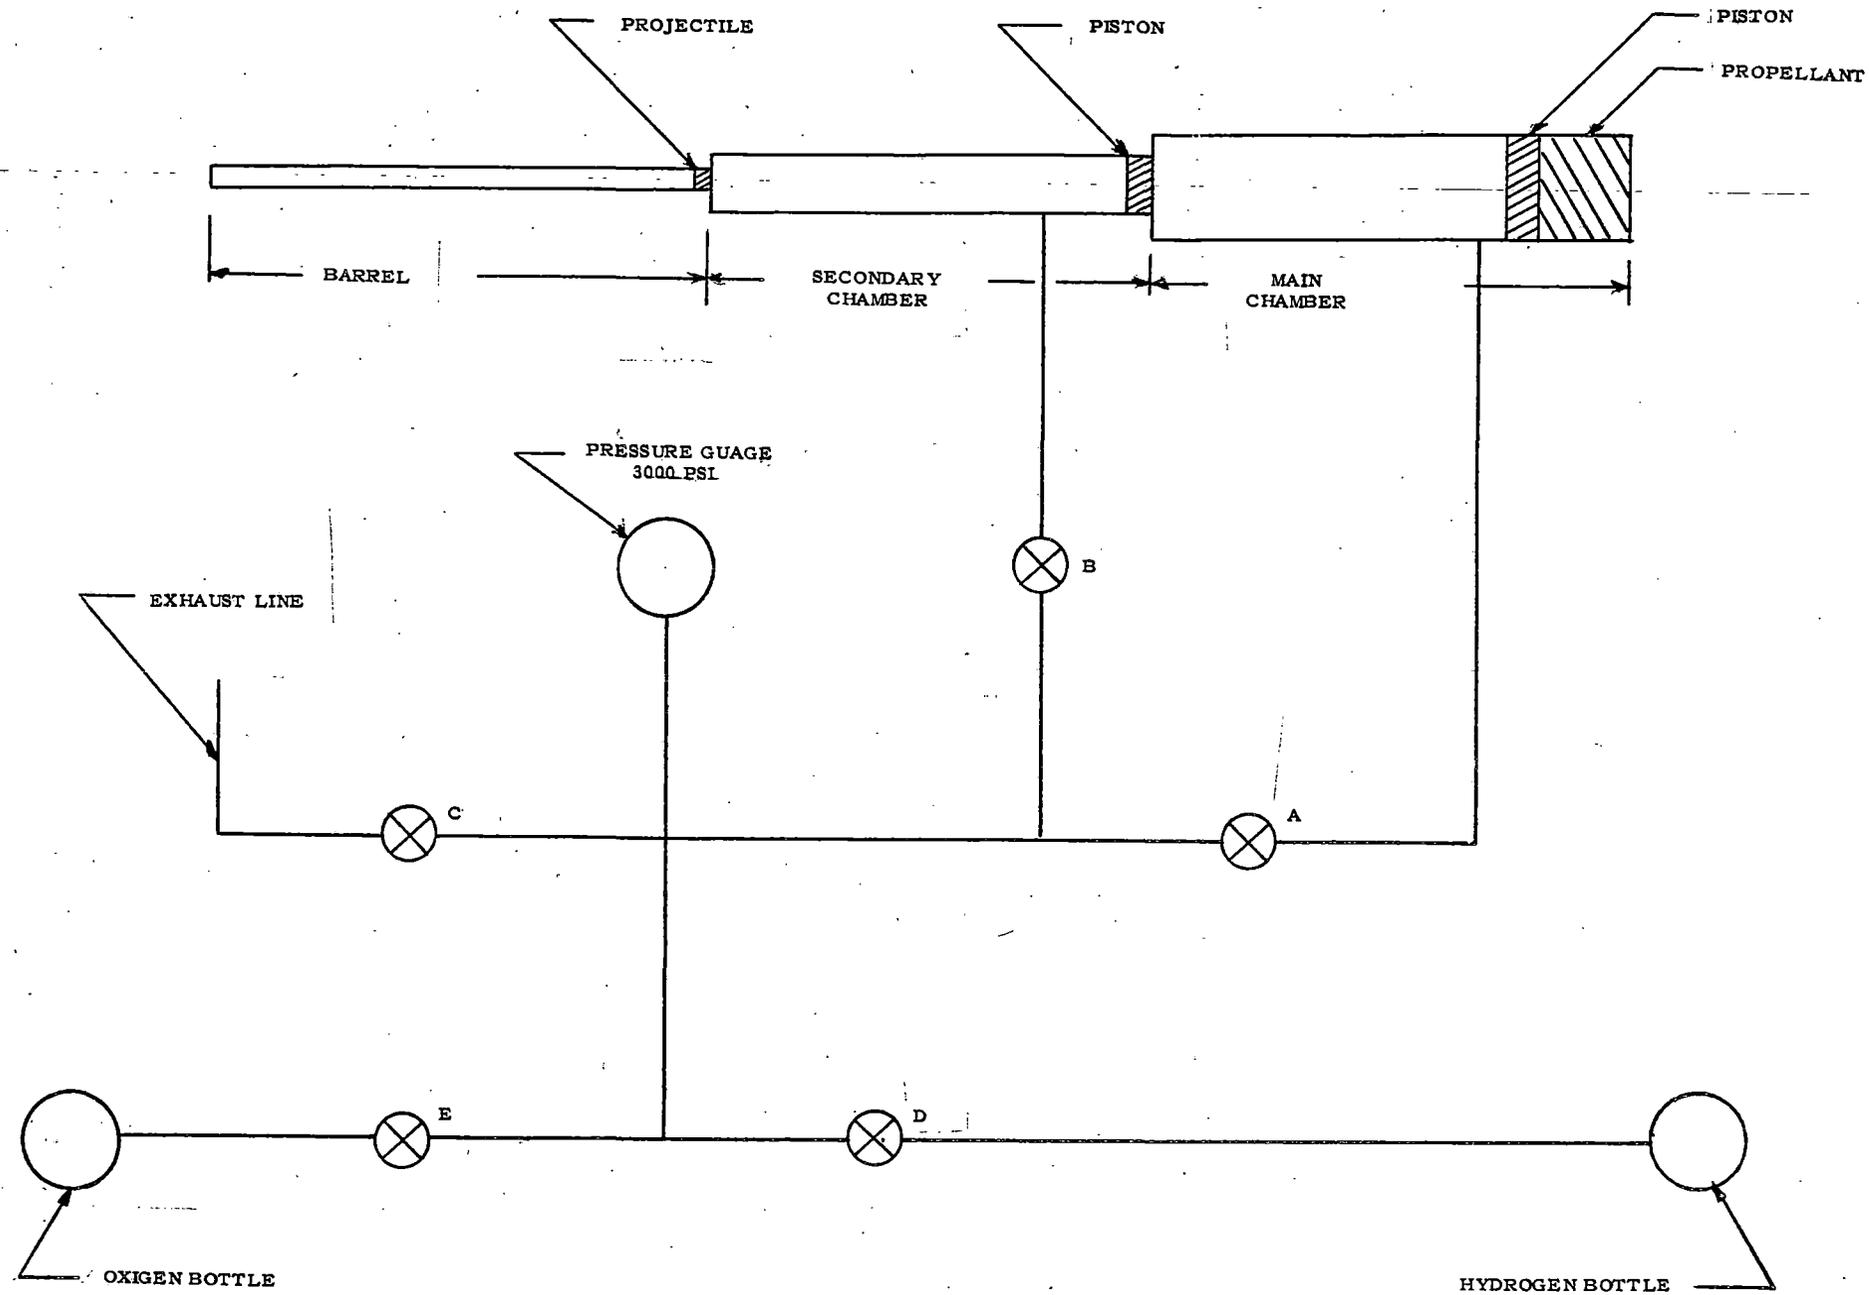
FIGURE 2

With reference to Fig. 2, valves E and D control the flow of gas from the oxygen and hydrogen supply cylinders respectively, connecting the cylinders to the common supply line feeding the main and secondary chambers of the gas gun. Valves A and B control the flow of gas between the common supply line and the main and secondary chambers of the gun respectively. A pressure gauge, graduated from 0-3000 psi, is located on the common supply line and the valve C permits gas in the common line to be exhausted to the atmosphere.

The propellant had been loaded in the gun. [REDACTED], [REDACTED] and [REDACTED] went outside of the building to the gas loading area. (see Fig 2). [REDACTED] and [REDACTED] were to load the gun, Maiden to supervise. The first oxygen filling of the main chamber commenced at about 5:35 P.M. Standing left to right in front of the loading area were [REDACTED], [REDACTED] and [REDACTED]. Valves B, C and D were closed, valves A and E open and the main chamber commenced to fill with oxygen. At this stage of the operation, [REDACTED] entered the loading area to presumably ask some question on firing time as he was operating a spectograph on the range. He stood next to [REDACTED].
