SUBJECT AIRCRAFT

FILE TITLE N9812R BEECH 35U

NR OSHAWA AIRPORT, ONT.

AIRCRAFT ACCIDENT REPORT
RAPPORT D'ACCIDENT D'AVIATION

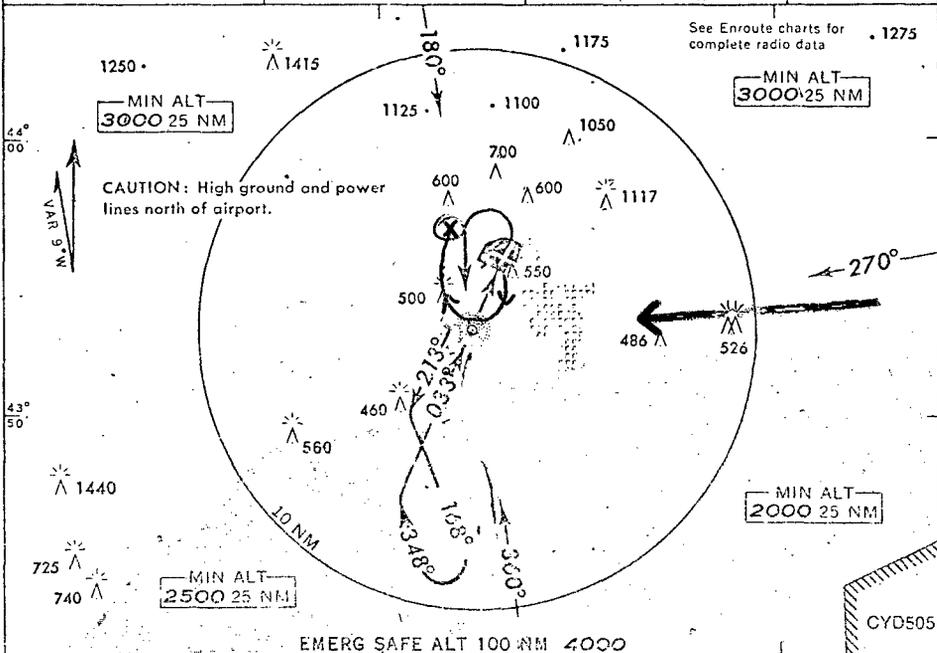
PLAN VIEW OF LOCA

At 17:15Z (12:15 EST) the pilot was asked what his flight conditions were and stated he had a heavy load of ice. Toronto ATC asked if he would like to try an approach into Oshawa to which he replied 'Affirmative' and at 17:17Z (12:17 EST) was cleared to the Oshawa Airport for an approach and given the Oshawa weather as four hundred feet overcast, visibility 1/2 miles in light snow. Fifteen miles east of Oshawa, N9812R contacted the Oshawa Control Tower on frequency 120.1. The pilot was issued the current altimeter setting, runway conditions and weather conditions by the Oshawa Control Tower and was requested to report by the Beacon on initial approach for Runway 04.
